INVESTIGATION REPORT

on the **AMMONIUM NITRATE EXPLOSION**

Angellala Creek, Charleville Queensland Australia

on 5 September 2014

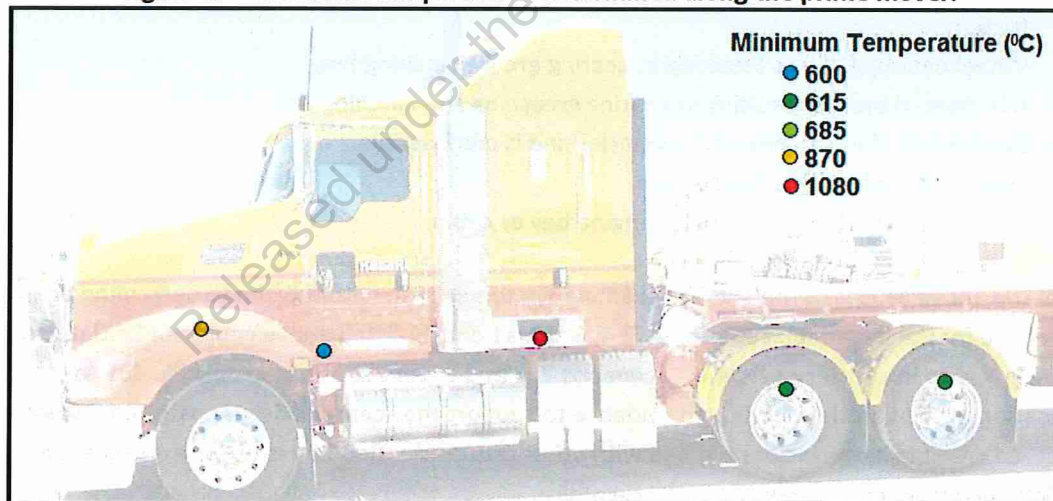
Samples of metal components from the vehicle were selected and analysed to confirm the temperature profile along the vehicle (Annex 70, 71 and 72). It is likely the maximum temperatures measured were reached as a result of the fire before the explosion. Table 10 and Figure 39 show the temperature profile along the prime mover and the first trailer (Annex 25). Different temperatures were reached across the prime mover, the highest being around 1080 °C. These temperatures are near or in excess of the melting point of copper (1080 °C) and aluminium (660 °C). Different temperatures were reached across the first trailer, the highest being around 685 °C. This temperature is in excess of the melting point of aluminium (660 °C).

Sample #	Description	Estimated Minimum Temperature Range (Average) (°C)	Colour coding for Figure 39
TKC1	Molten metal found in chassis rail (Ex Engine Mounting)	550-650 (600)	Blue
TKC4	Rims on both rear axles (Sample from another rim that didn't melt)	580-650 (615)	Green
TKC6	Axle U-bolt (Unknown axle) on 1 st trailer	650-720 (685)	Light Green (Not shown in Figure 39)
TKC8	Molten battery cable	1080	Red
TKC10	Failed injector pipe	870	Yellow

Figure 39 – Minimum temperatures determined along the prime mover.

- the fire burned for over one hour
- the fire was very intense for a sustained period of time
- a significant amount of combustible material on the truck has burned
- the prime mover and first trailer sustained significant heat, reaching temperatures in excess of 1000 °C on the prime mover and up to 720 °C on the first trailer
- molten copper and aluminium were found at the site in proximity to the prime mover

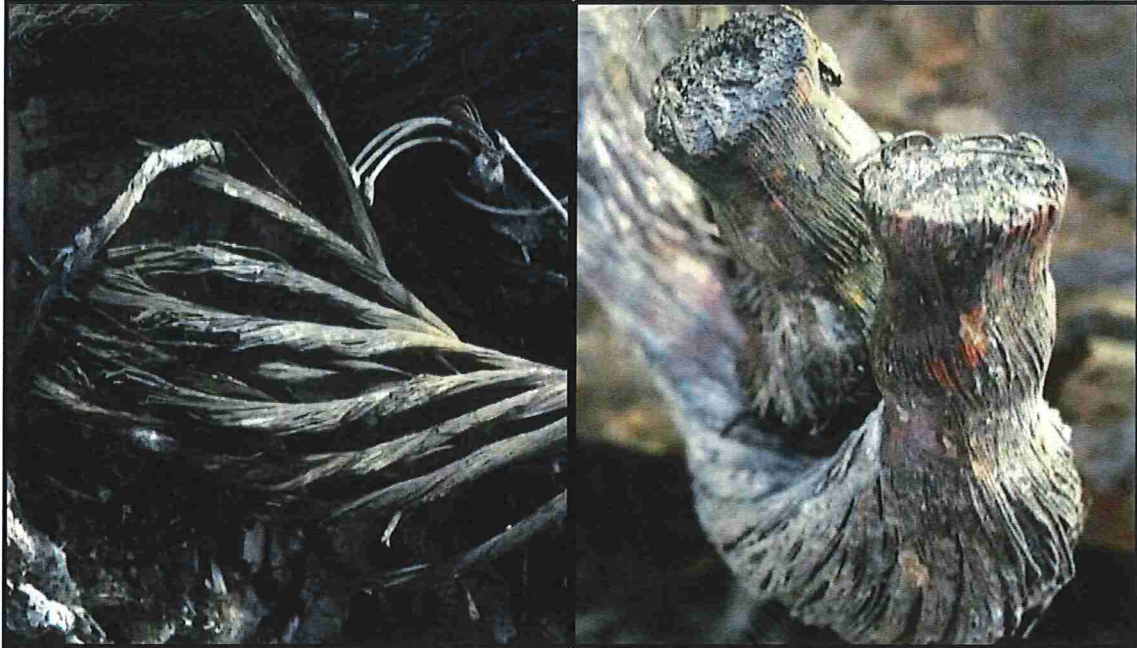
Figure 44 – Copper cable showing (a) pulling and stretching (b) separation from battery terminal.

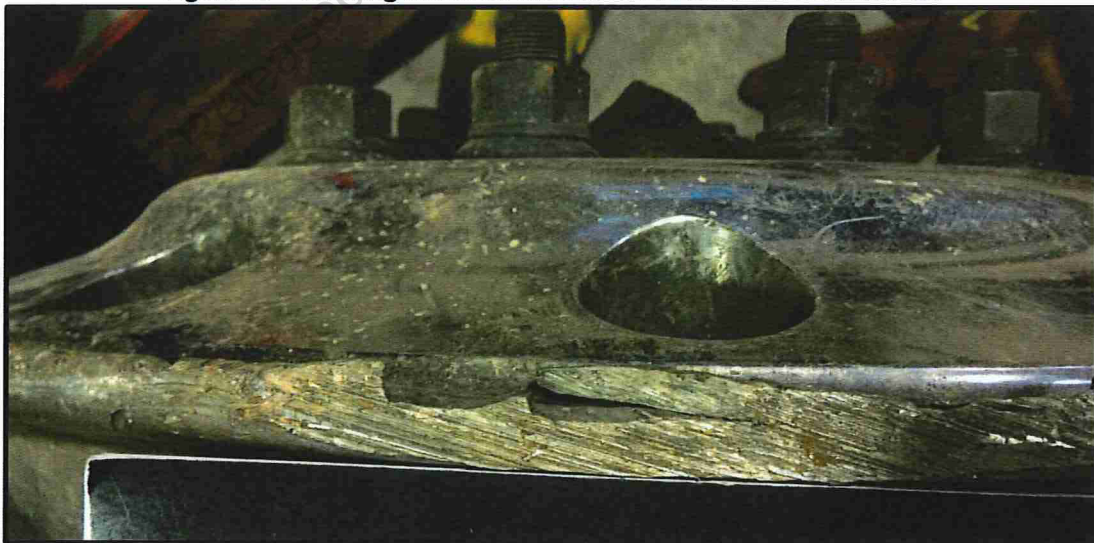
The left hand front wheel rim showed signs of grinding on the edge of the rim (Figure 45). These marks are at an angle of about 15 degrees to the direction that the wheels would normally be travelling on a straight road.

The aluminium has a relatively low melting point of about 660 °C. An auto-ignition temperature of 760 °C has been reported for aluminium powder. Potentially the powdered/molten grinding products could have ignited from friction experienced during the process of grinding the rims.

Figure 45 – Grinding marks on the rim of the left hand front wheel.

With the presence of diesel it is possible this may have been an ignition source for a fire. Given the location of the diesel tanks and expected speed of approximately 90 km/h that the truck was

travelling at the time of the crash, it is unlikely that diesel would have been in the vicinity of the tyre rim while the heat was sufficient to cause auto ignition of the diesel (i.e. above 240 °C). Hot and molten grinding products could have travelled back towards the location of spilt diesel fuel. See section 3.2 of the report by Inspector Theo Kahl in Annex 25 for a further description.

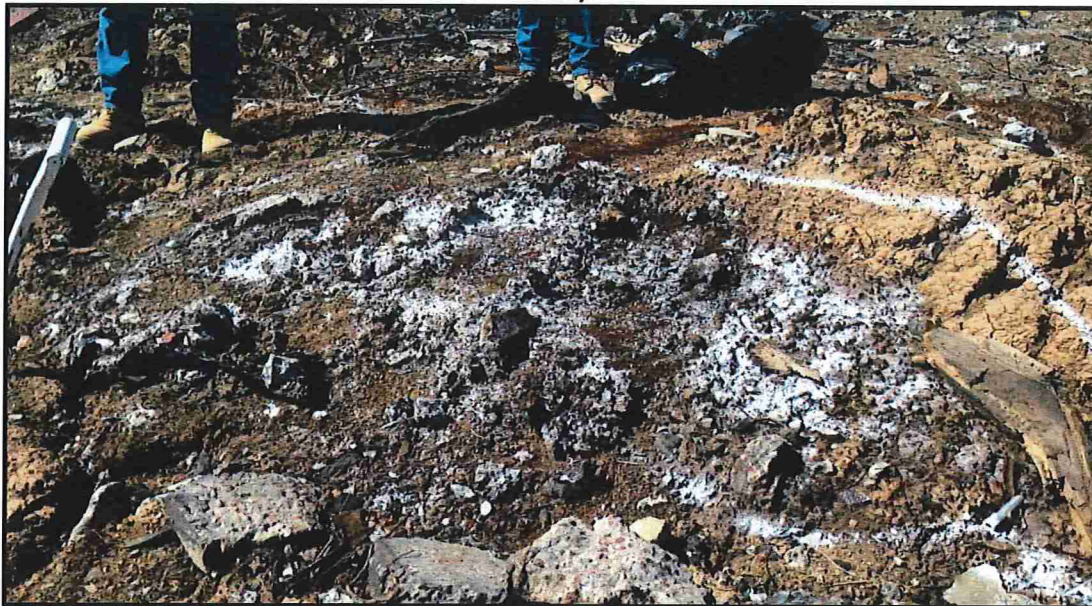
Figure 53 – Ammonium nitrate samples RB010, RB011 and RB012 under prime mover (white areas).

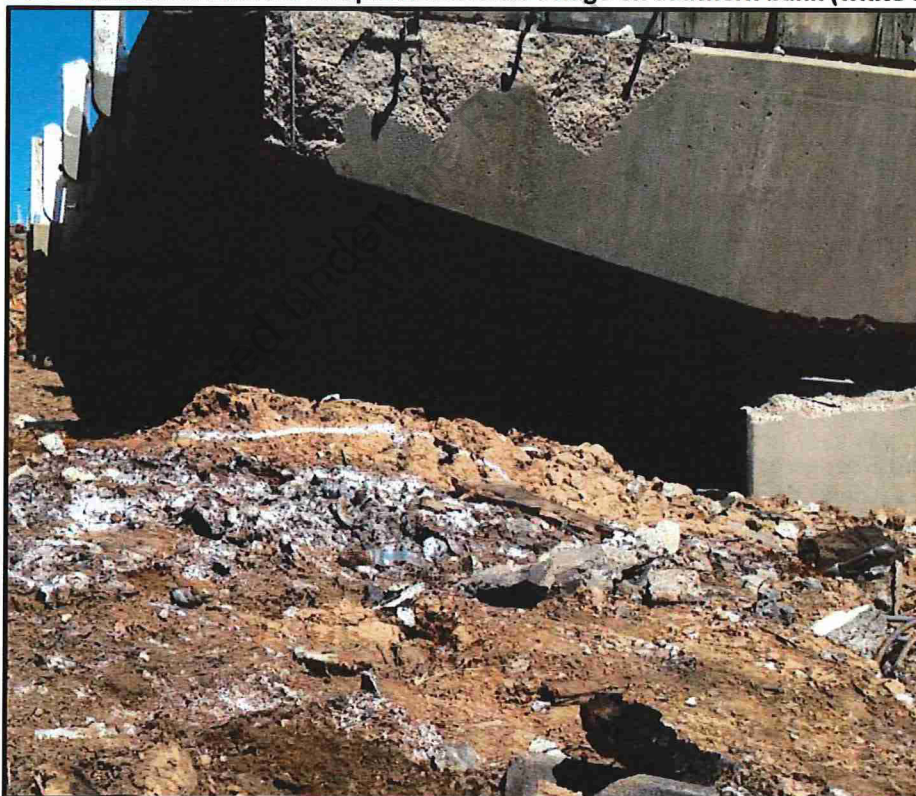
Figure 54 – Ammonium nitrate sample RB008 near bridge on southern bank (white areas).

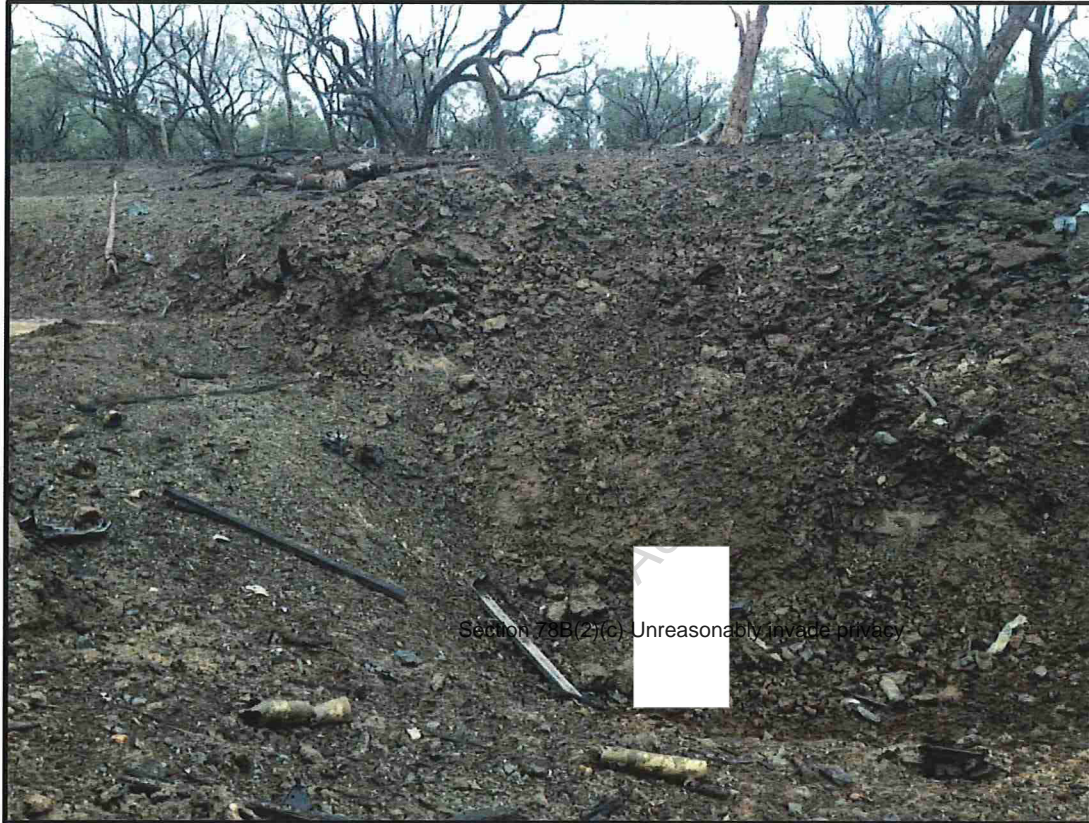
Based on an observation of the blast crater, it is possible that the two trailers were overlapping each other (Figure 56). A detailed analysis of the blast crater profile was not undertaken as this is unlikely to provide an accurate assessment of the orientation of the load prior to the explosion or an accurate assessment of the size of the explosion.

An estimation of the crater dimensions was determined to be approximately 6 metres across the creek bed, 12 metres along the creek bed and 5 metres below the creek bed. An accurate measurement of the crater was not possible as significant rain on 6 and 7 September 2014 filled the creek and the blast crater, destroying the original profile of the crater.

Figure 56 – Blast crater with original creek bed profile in top left.
