Subject: Rockfall at Development Face

Miner struck by rockfall at a development face

Mines safety alert no. 330 | 12 August 2016 | Version 1

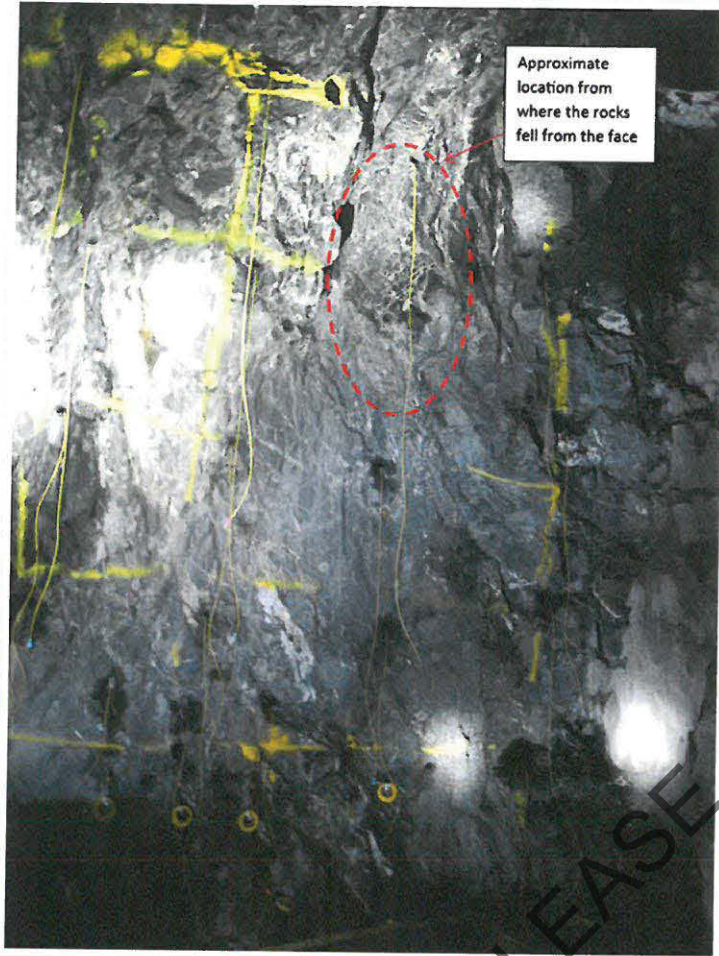
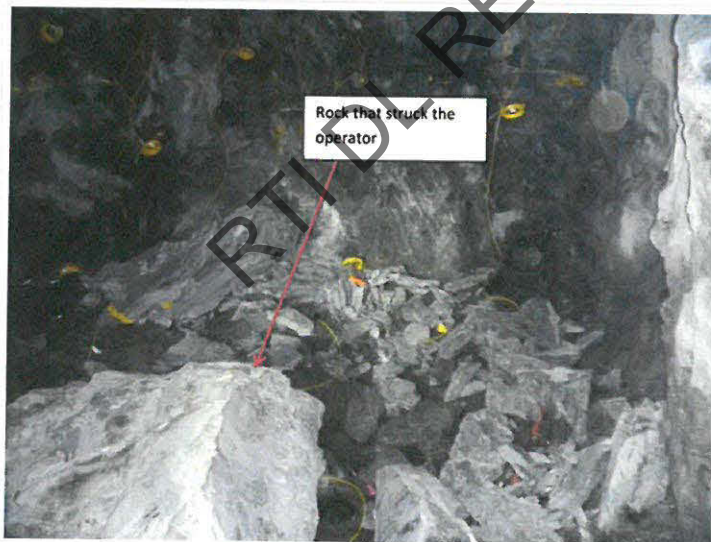
While preparing to charge lifter holes at a face approximately 475m below the surface at a metalliferous mine, an underground operator was struck by rocks that fell from the face, (see photos 1 and 2), and sustained serious injuries including a broken collar bone, broken ribs and facial lacerations. The face was 6m high and 5.3m wide. The rocks fell from a height of approximately 5m and included a large rock weighing approximately 650kg. This rockfall had the potential to have resulted in a fatality.

The stress regime would likely have been a time-dependent post-excavation stress re-distribution.

- The rock type was predominantly arenite schist with some pyrrhotite and chalcopyrite, with calcite veining and chloritic foliations.
- The development was an incline heading where the shoulder of the face arched over into the back. It was not highly fractured or faulted and the rock mass conditions appeared good. Post the rockfall two distinct failure planes could be seen; these may not have been recognisable prior to the rockfall. There were two drill holes in the location from where the rocks fell, one which could not be cleaned past approx. 0.5m during charging. This may have indicated a failure zone / crack behind the face.

- The face was not meshed or supported. Meshing the face would likely have prevented this incident. Even if the mesh would not have held such a rockfall it would have controlled and delayed the manner in which it fell.

- There were rattle marks from mechanical scaling on the face, including a rattle mark on the main large rock that fell. The rock large rock measuring approximately 1.5m x 1 m and varied in thickness up to 0.4m.
- The rockfall pulled a 'J' hook off a nonel detonator and a rock landed on top of the detonator cord and a box of powergel.
- When inserting lifter tubes or cleaning and charging lifters, operators are in a bent over head down position at the face. This results in them having limited ability to retreat from the face, minimal vision of the face and backs and exposure to the maximum fall distance of rocks.

- Use of face support to prevent rocks from falling or control the manner in which they fall.
- Visual assessment may not identify a potential for a rock fall.
- Blocked holes may indicate broken / cracked ground that has the potential to fail.
- To minimise the risk of detonating cord being impacted and inadvertently initiated by falling rock, the tie in should only be completed after all blast holes have been charged.
