Mine Name	Mine ID	Operator	Activity Type	Activity Date
Peak Downs	MI01190	BM Alliance Coal Operations Pty Ltd	Postal Mine Record Entry	13/04/2021

The meeting purpose to discuss Structural failures of buildings during severe weather events.

Mine Name	Mine ID	Operator	Activity Type	Activity Date
Peak Downs	MI01190	BM Alliance Coal Operations Pty Ltd	Investigation	18/11/2020

Wednesday 18 November I Michael (Mick) Scully Inspector of Mines attended Peak Downs Mine for the purpose of inspecting damage to Igloos and other structures caused by a severe weather event on the afternoon of Friday 13 November. On arrival I participated in the site drug and alcohol screening programme and was escorted to a meeting room.

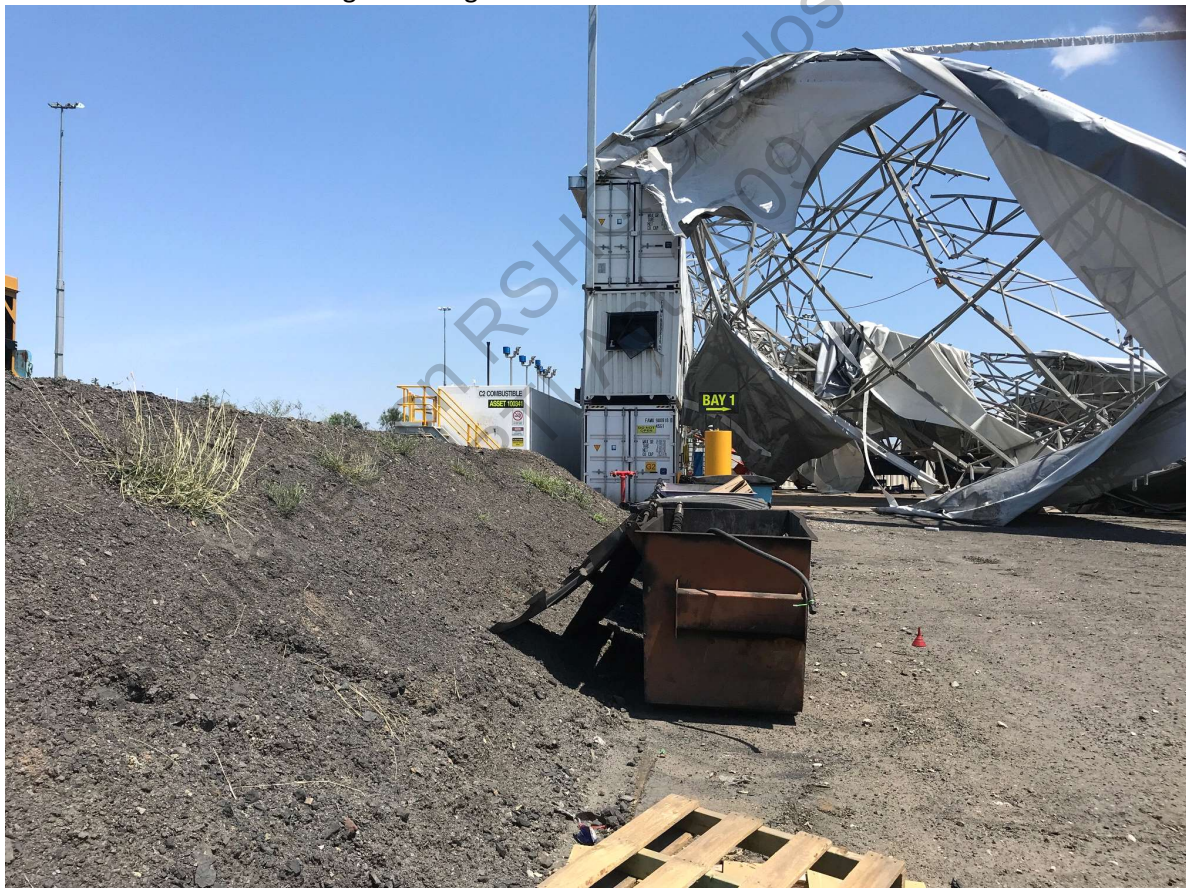
Figure 1

We proceeded to the Thiess workshop and were joined by sch4p4(6) Personal inform (Project Manager) sch4p4(6) Personal in (Operations Manager) and sch4p4(6) Personal in (Maintenance Superintendent). We reviewed the failed “main” Igloo see figure 1.

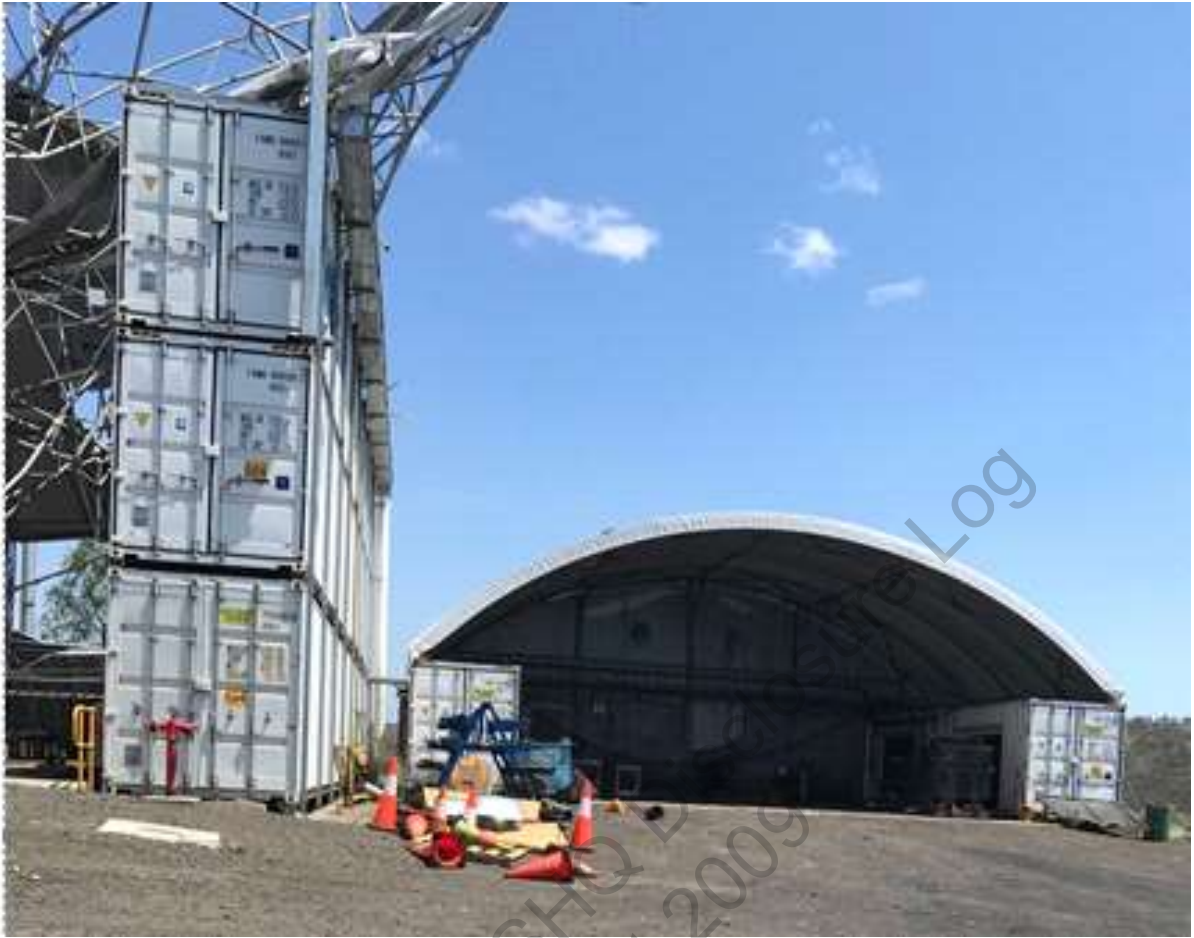
Figure 2

I note that the smaller Igloo adjacent to the main Igloo appeared to have little if any damage see figure 2.

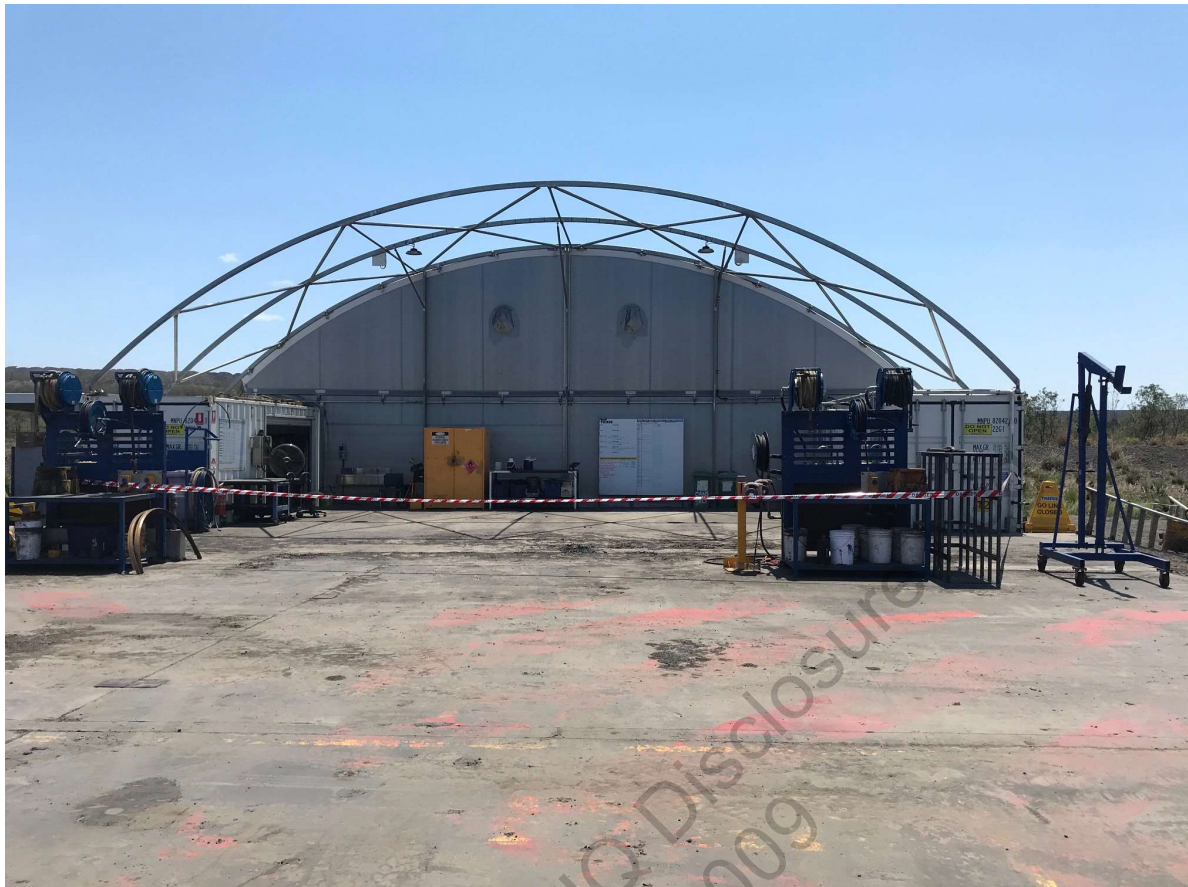
Figure 3

We inspected the tyre bay Igloo which had lost its cover see figure 3,

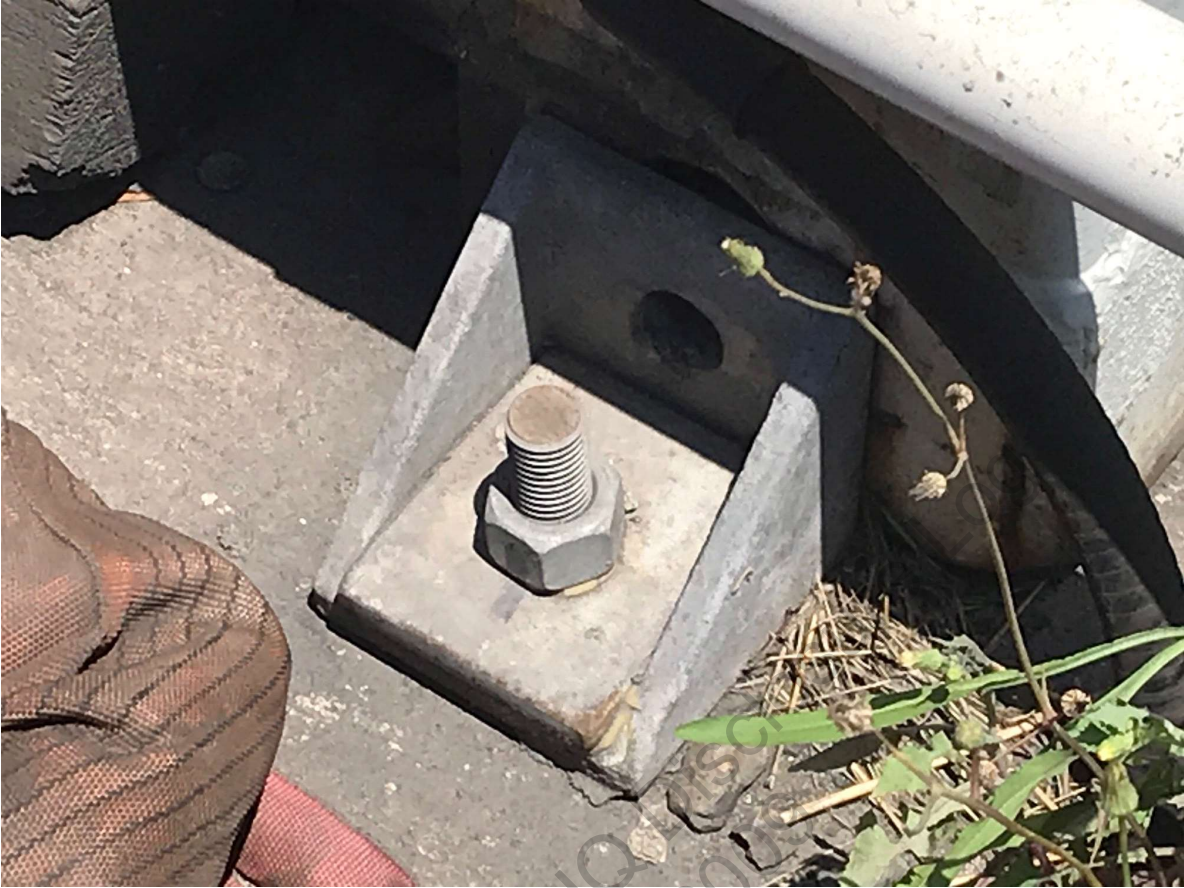
Figure 4

I note that the footings that hold the containers to the ground appeared to be substantial and undisturbed see figure 4.

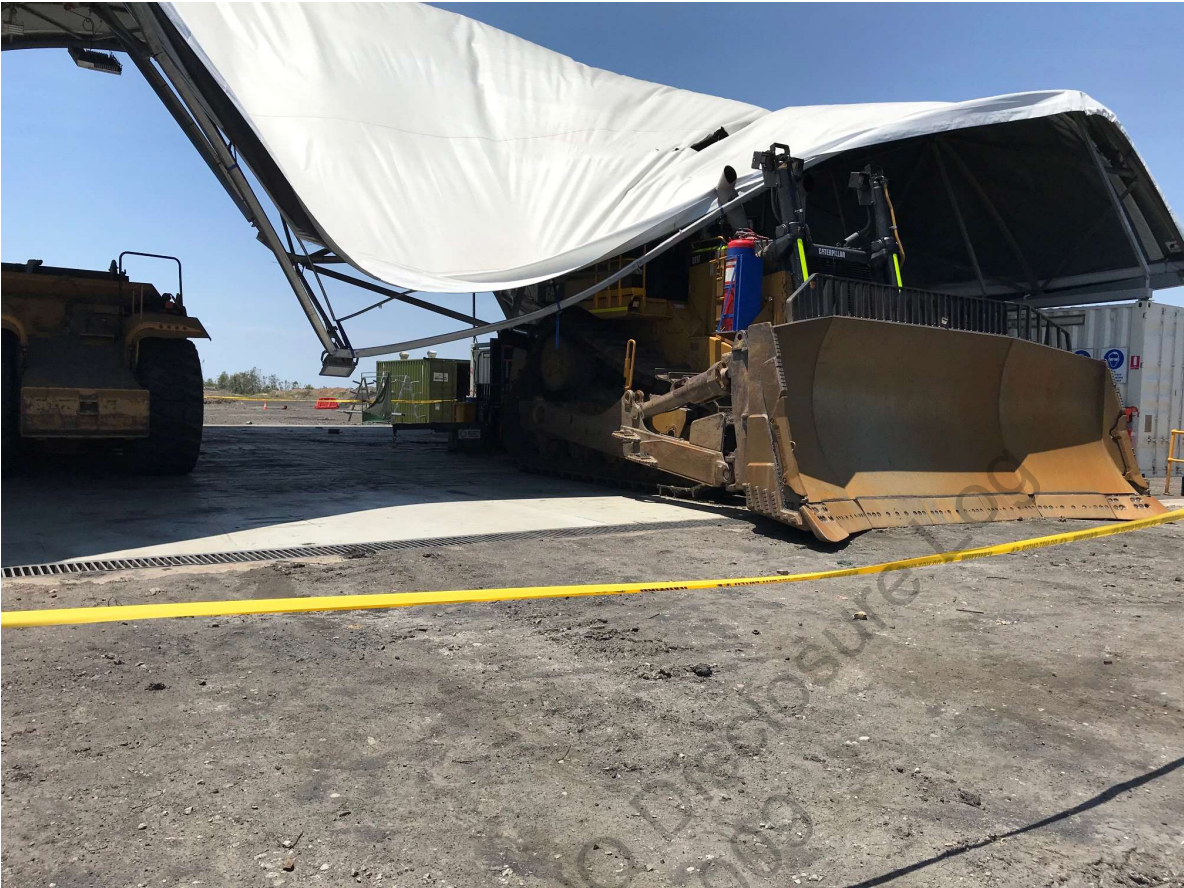
Figure 5

We proceeded to The National Mine service igloo, it appears to have structural damage and cover damage see figure 5.

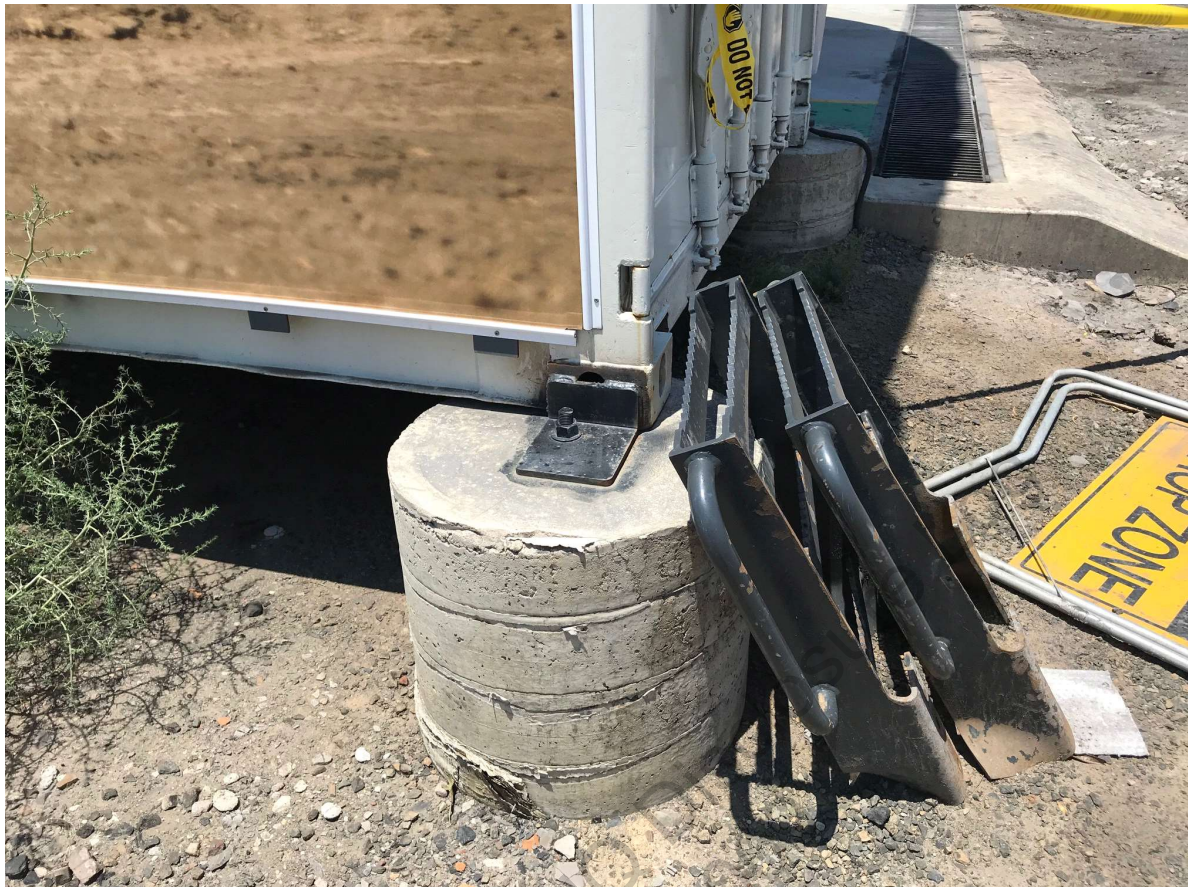
Figure 6

I note that the footings holding the containers appear to be very substantial see figure 6

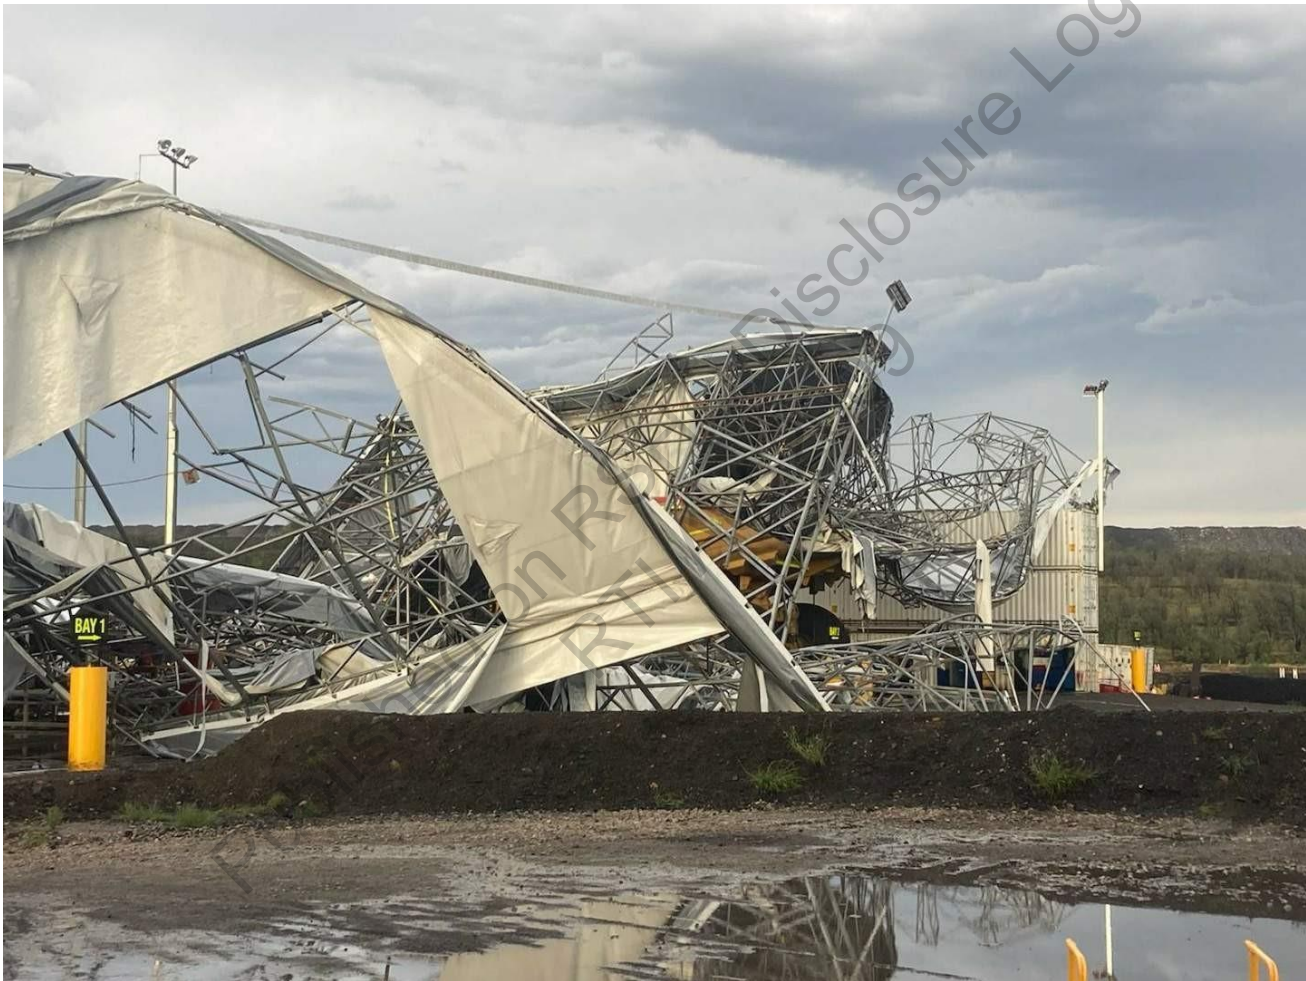
Thiess Workshop

Thiess Igloo Structure: Independent engineering report identified that either a roof bracing member(s) or connection failed, or a truss arch buckled, or both. These items exhibit theoretical failure loads at wind speeds of approximately 16 and 30 m/s which is below the Australian standard. NMS Igloo Structure: Independent engineering report concluded that the primary structural members were code compliant for the design wind loads, however the structural support systems were found to be deficient. The ICAM Team have concerns around the assumptions used and are obtaining a further engineering review to verify this conclusion. JJ Richards Shed: Independent engineering report identified that the columns were found to have a utilization of approximately 70% to 110%. Similarly, rafters were found to have utilization ratios in the range 30% to 210%.

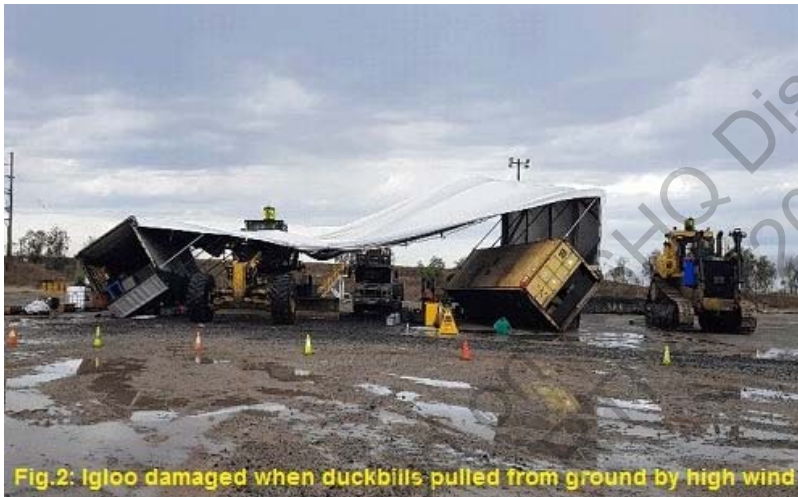
1. An igloo structure was destroyed when the shipping container duckbill earth anchors pulled from the ground during high winds (see figures 2 and 3).
2. An igloo structure was destroyed when the anchor chains broke (see figures 4 and 5).
3. In 2007 at a Western Australian mine, two people were killed when the tie-downs for the dongas they were in failed during a cyclone.
4. A product coal radial stacker broke its anchoring chains during a storm, resulting in the stacker moving and impacting a concrete bollard.

Fig.2: Igloo damaged when duckbills pulled from ground by high wind

- Duckbill earth anchors should be appropriately rated and installed to the correct depth for the compaction and soil type. Holding capacity of different soils can vary substantially and may also change with moisture content e.g. after rain events.

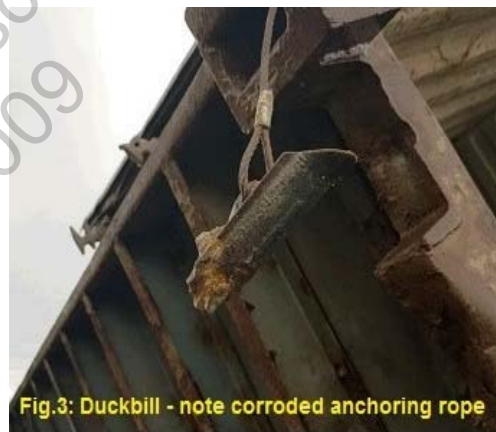
Fig.3: Duckbill - note corroded anchoring rope

- Anchors and tie-down materials should be chosen for their corrosion resistance to their environment, especially if it is soil or a corrosive atmosphere.

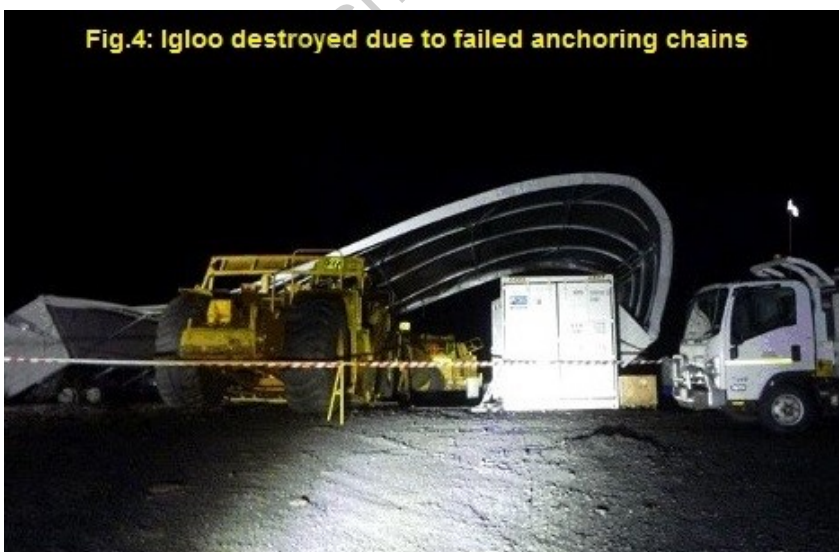
Fig.4: Igloo destroyed due to failed anchoring chains

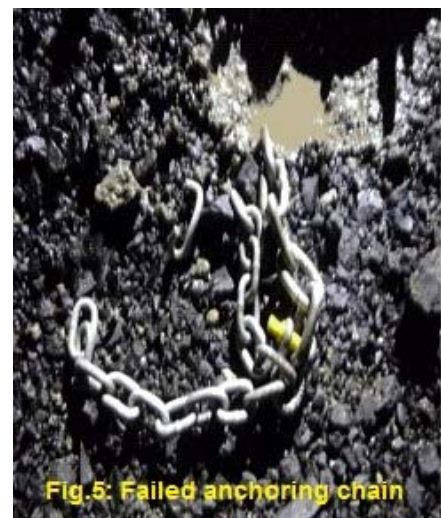
Fig.5: Failed anchoring chain
