**Subject: INVESTIGATION INTO FIRE FROM FIREWORKS DISPLAY AT PENGARI STEINER SCHOOL**

INVESTIGATION REPORT  
TO  
CHIEF INSPECTOR OF EXPLOSIVES

ON THE  
**FIREWORKS DISPLAY FIRE ON 15 NOVEMBER AT NOOSA  
PENGARI STEINER SCHOOL, 86 NYELL ROAD DOONAN  
INVOLVING KC FIREWORKS DISPLAYS AUSTRALIA PTY  
LTD**

At  
86 Nyell Road, Doonan QLD  
on  
15 November 2012

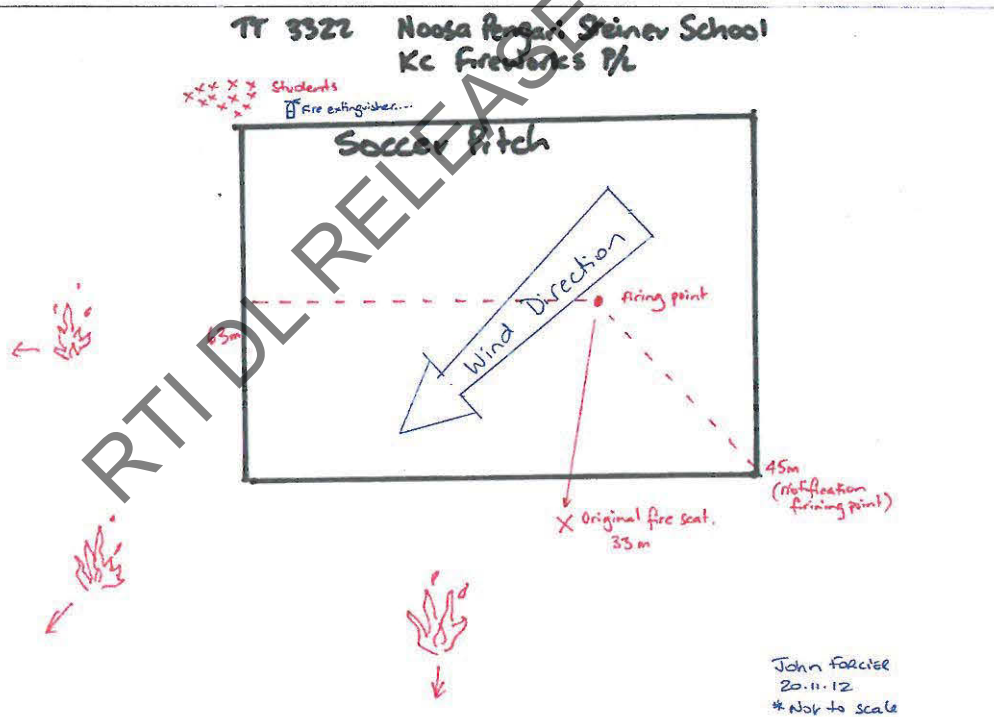
**Diagram 1. Investigator's Sketch of playing field and approximate distances**

4.3.4 A position was taken up based on where teacher s78B(2) identified the majority of products were located. The original tire seat (as estimated by fire officers) was measured by rangefinder to be 33 meters away. However it is impossible to say precisely where the alleged misfired product landed relevant to where it was fired from and this could account for a 2-3 meter discrepancy.

4.3.5 It was clear that the fire had progressed in a south to south-west direction away from the playing field.

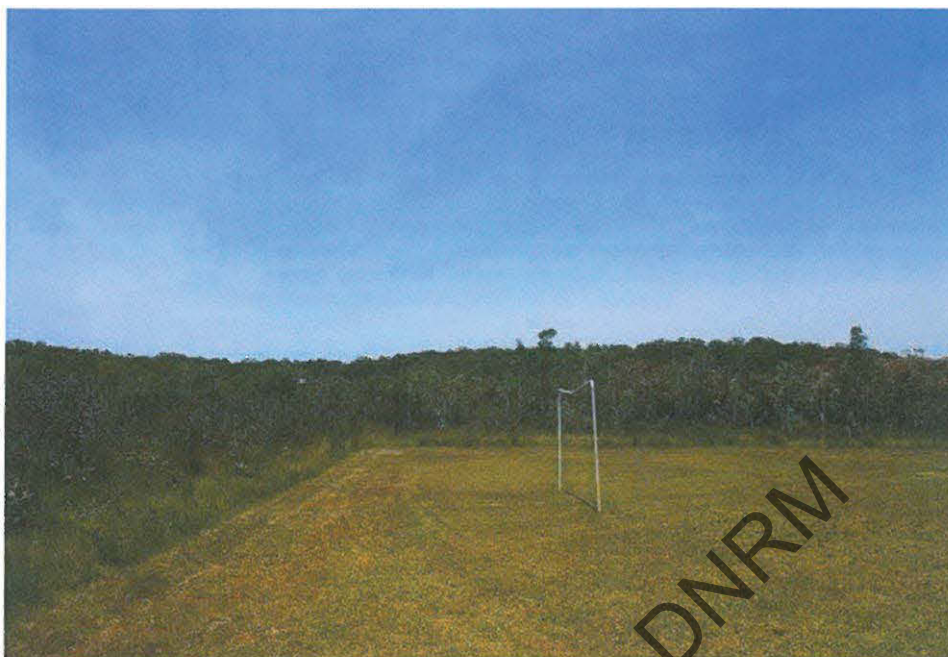
4.4.1 Photograph 1 depicts North East corner looking to South East corner

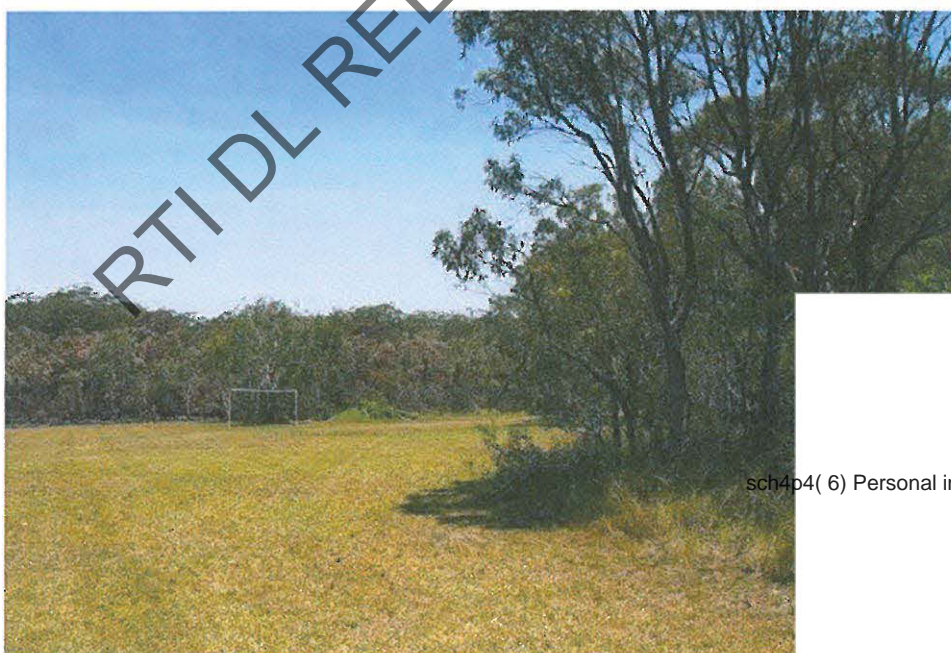
4.4.2 Photograph 2 depicts the North East corner looking to North West corner

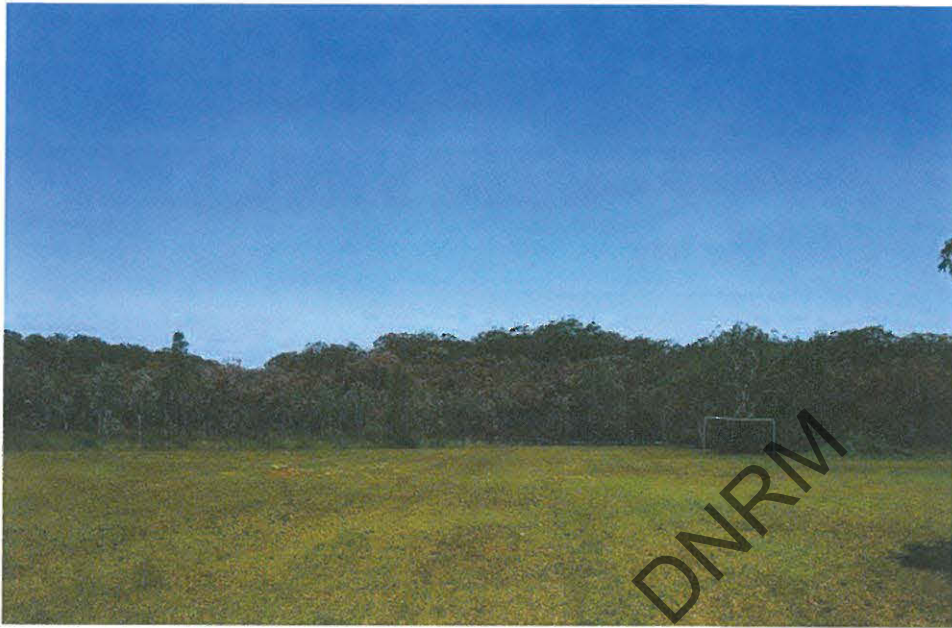
4.4.3 Photograph 3 depicts North East corner looking to South West corner

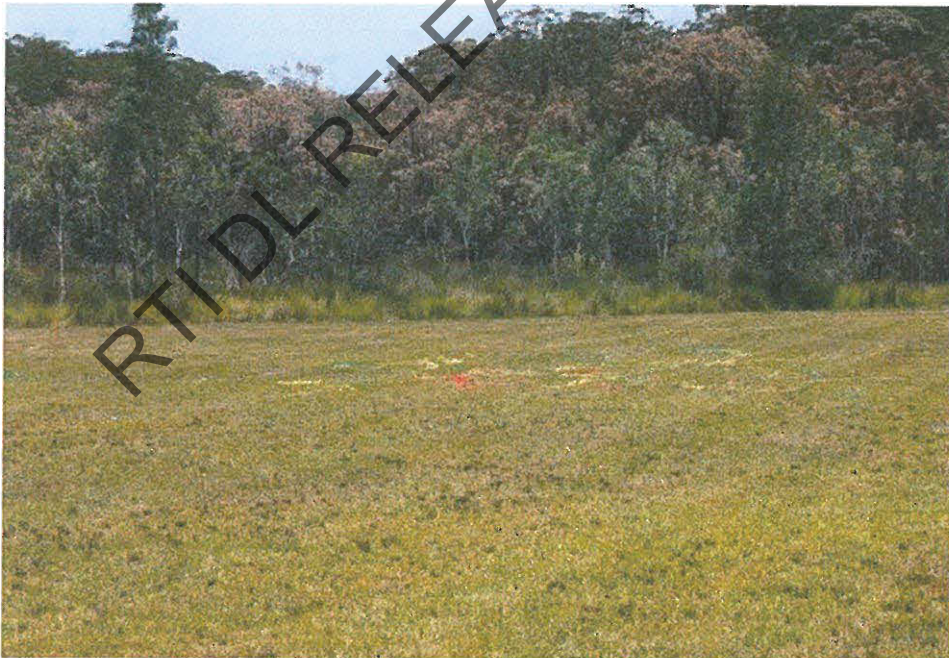
4.4.4 Photograph 4 depicts streamers from effects remaining on ground.

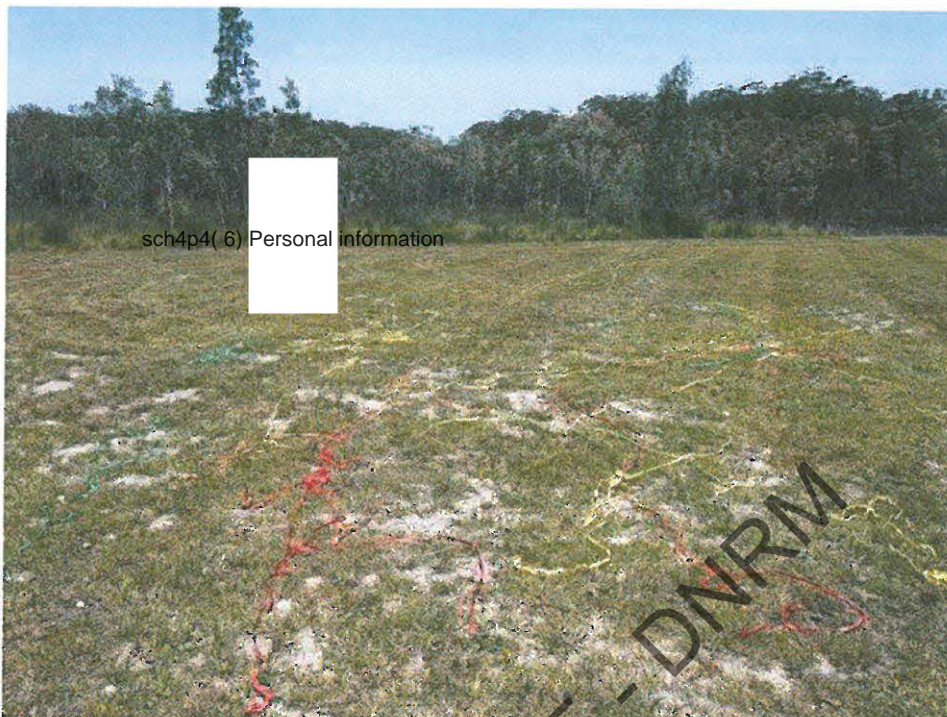
4.4.5 Photograph 5 depicts location of streamers on ground. It is estimated that the photo is taken at the approximate firing point of the products.

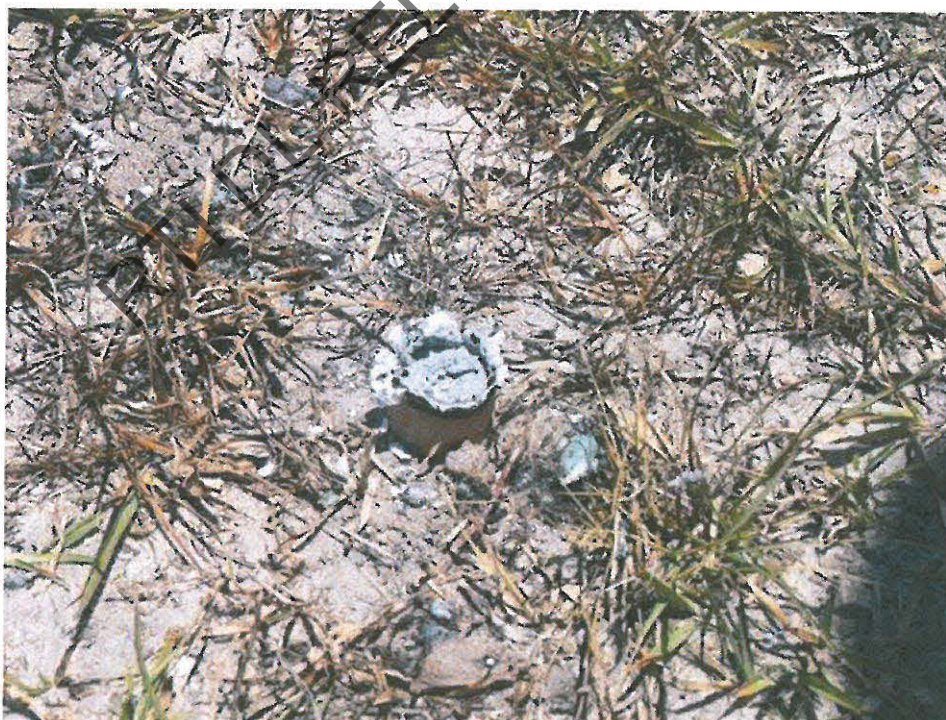
4.4.6 Photograph 6 depicts remains of used product

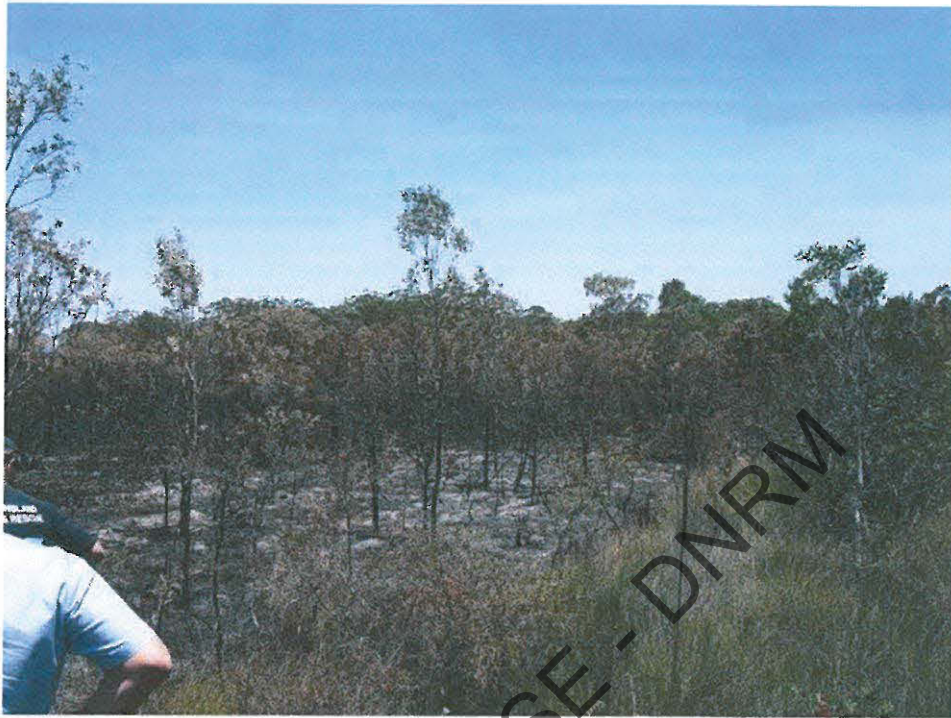
4.3.2 To the south of the playing field it was noted that the vegetation was brown in the foreground and burnt in the background.

4.4.7 Photograph 7 depicts the southern boundary of the playing field looking south westerly and the fire seat.

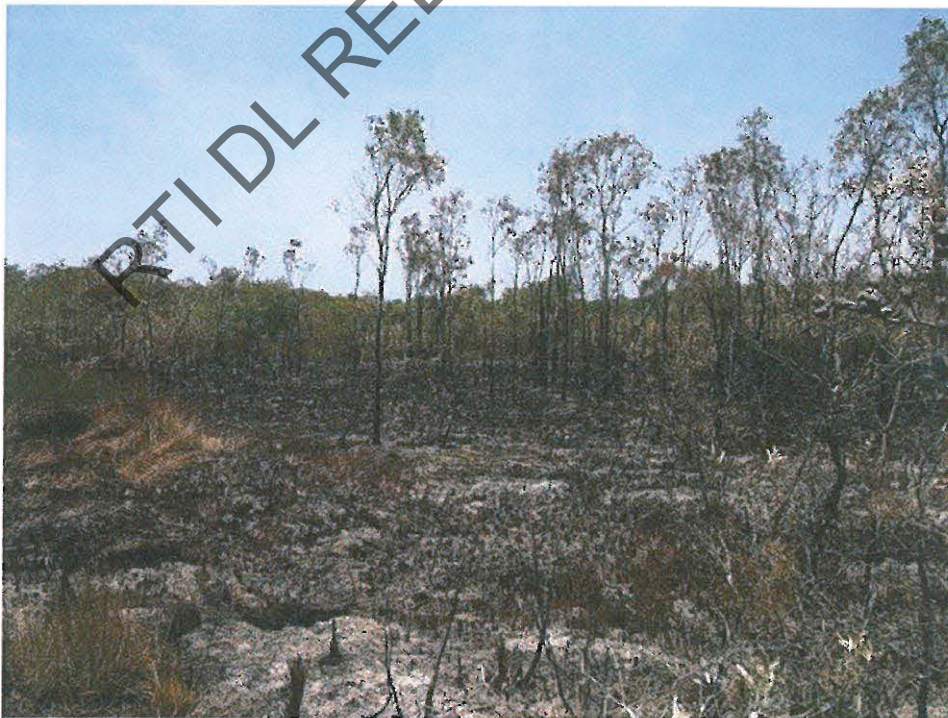
4.4.8 Photograph 8 depicts view directly south from border of playing field

- 4.17 The vegetation to the south and south west was brown and burnt.

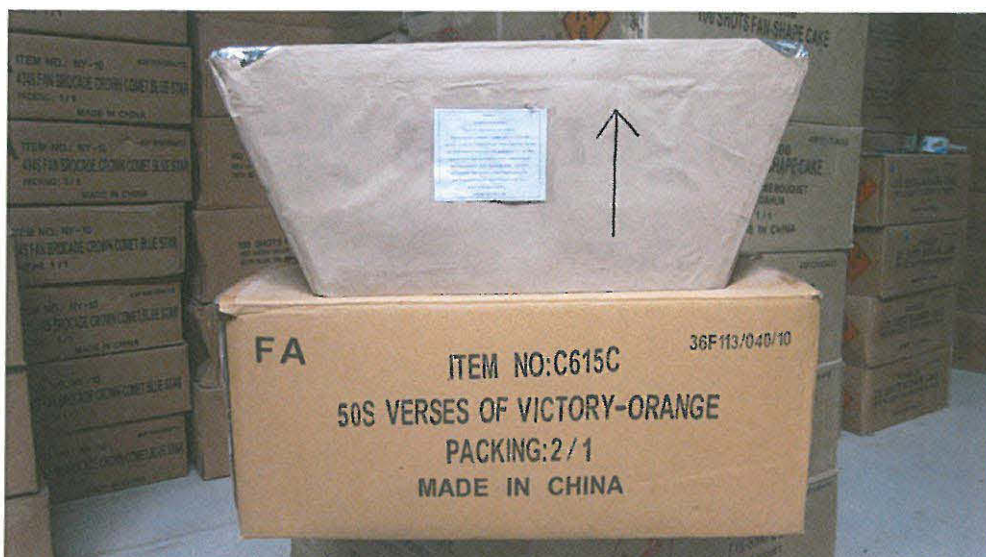
4.11 The product is a ground based cake containing 50 x 30mm tubes arranged in a V configuration in two banks of 25 tubes. The dimensions are 600mm x 200mm x 250mm (refer photograph below). The product is delay chain fused.

Photograph 9 depicts a “Versus of Victory” orange smoke cake product from the same batch number as the product alleged to have failed.

- 4.12 s78B(2) avers that the product ‘misfired’ by firing a cluster of tubes instantaneously and burst their tubes causing the projectiles to take an unintended trajectory into low scrub 35 meters away. s78B(2) was unable to control the fire that was caused by the product.
- 4.13 There is no evidence available to prove or disprove that the product misfired or malfunctioned. Despite an audience, there are no witnesses available with fireworks knowledge to offer an opinion on their observations.
