# Venting 9kg Cylinder Butchers Deagon

Notification No GPN 5950

## Deacon Bulk Meat

Reference No	GPO 25075
Business Name	Deacon Bulk Meat	Status	In Progress
Contact Name	The Manager	Region	Southern Regional Office
Address	116 Barclay street Deacon Qld 4017	Telephone No.	
Industry Type	Domestic Type A	Reason for Inspection	Follow-up
Gas	LPG	Check List Item	
Inspection Date & Time	14/01/2014 03:00:00 PM	Inspector	Rob Lloyd
		Supporting Inspector(s)	
Assessment	Unacceptable		
Compliance Tool Used	Inspection/Audit report	Keywords	Butcher Shop
Danger Tag Used? (Y/N)	No

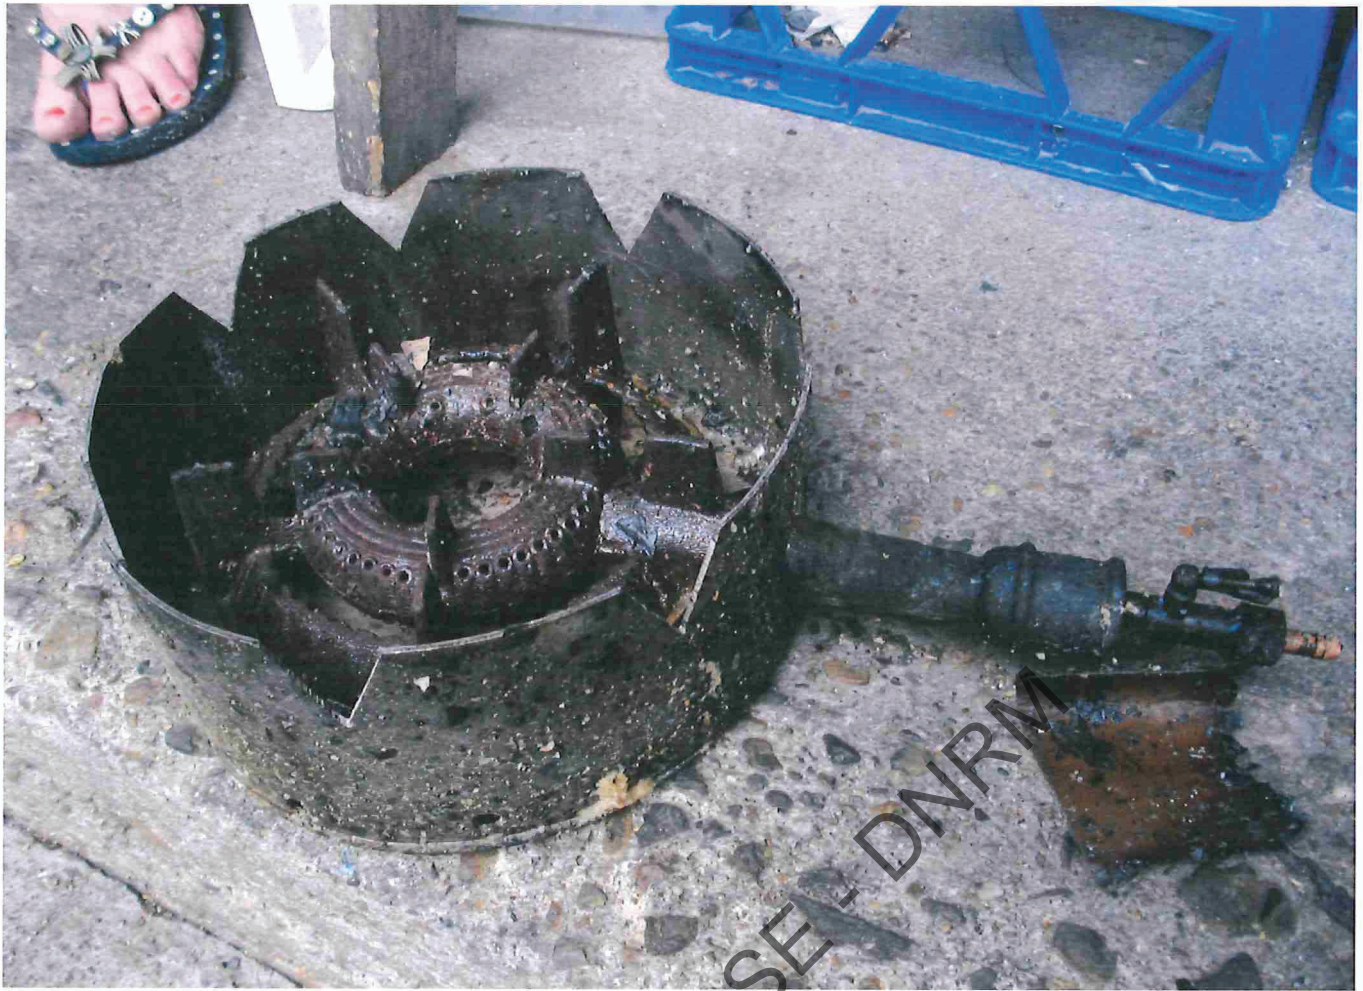
The single ring burner(photo 1) was found at the back of the small room (photo 2). sch4p4( 6) Personal information stated this is the usual area they operated the burner. The single burner had a small isolating valve, no flame failure and was manually lit with a BBQ gas lighter. The single ring burner was purchased in last 12 months from an army disposable store called "Bushys" in Strathpine, Brisbane. stated that no operating instructions, data, hose or regulator came with the burner. The hose and regulator was fitted to the single burner by stated that he had a old hose and regulator from home that he fitted. was unaware if it was an indoor or outdoor appliance. The regulator could not be retrieved at the stage due to debris etc but stated it was a single stage regulator. and stated that the hose assembly was approximately 500mm long.

The indoor use of the single ring burner that is intended for outdoor use also may have contributed to the fire. The single ring burner was not being used in an outdoor area and as such gas may have accumulated in the enclosed area. The location of the gas cylinder in relation the ring burner may also of been a contributing factor as it is recommended that the length of hose be 1000mm and this may reduce the likelihood of a fire in the event of a gas leak. The appliance was not being operated in its intended use.

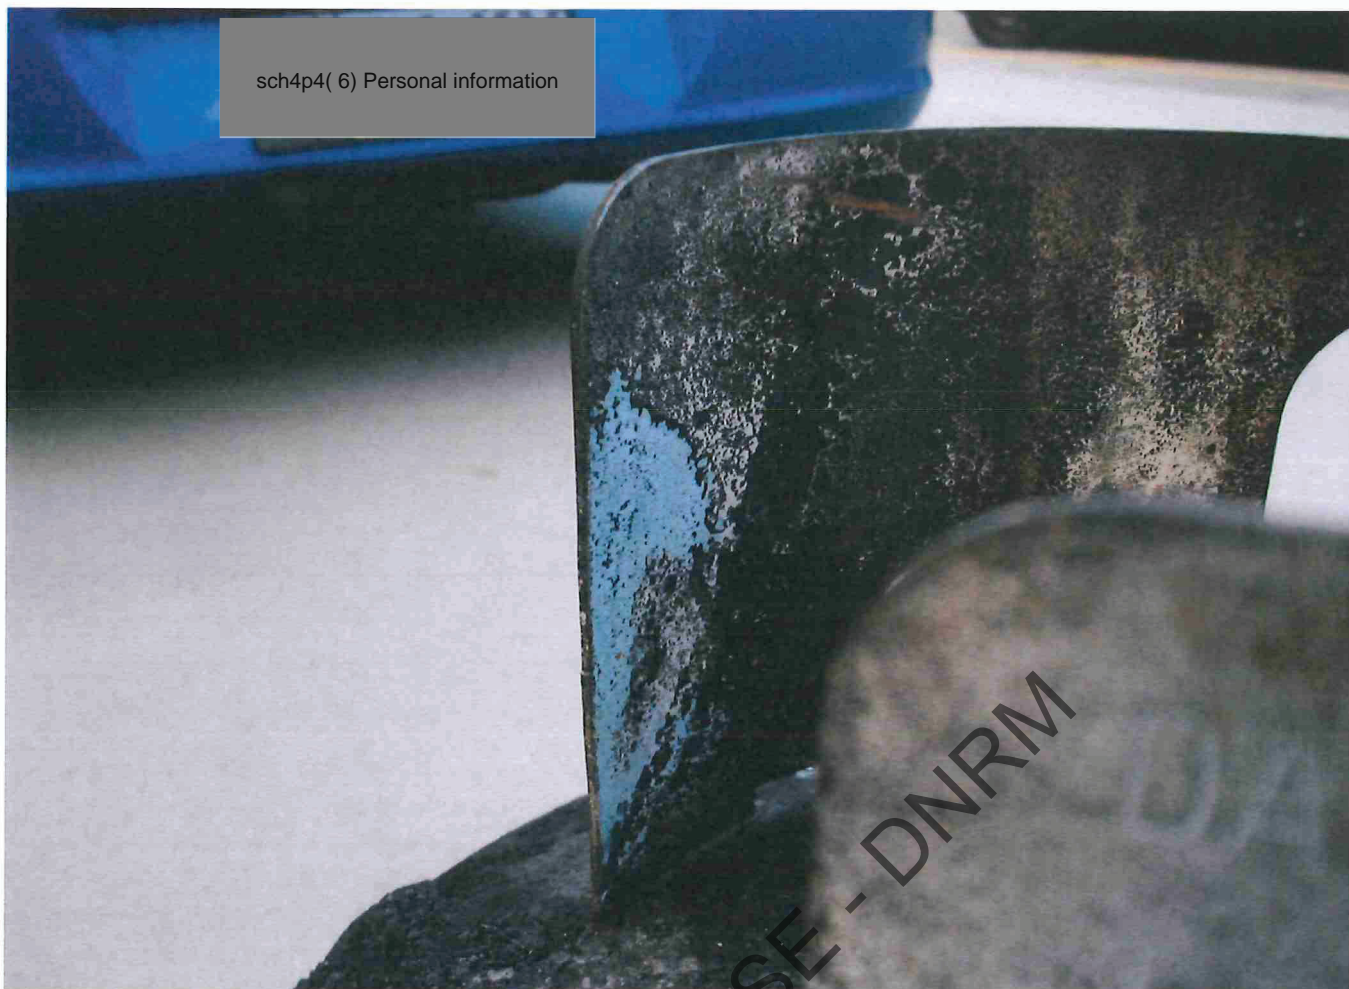
15/1/14- 4.45pm Sandgate Fire station, FO Bruce Ford and SI Lloyd conducted inspection on the Customer owned 9kg Liquid petroleum gas Cylinder and valve assembly. It was noted that there was increased heat patterns at different points around the base of the gas cylinder collar (photo 3). The valve stem assembly with 2 "O" rings was not damaged and on inspection provided no evidence of a leak (photo 4). This evidence suggest that gas was not likely to be leaking from the valve stem as stated from witnesses. The valve assembly on inspection was not in its usual orientation, this is likely to be caused from excessive heat

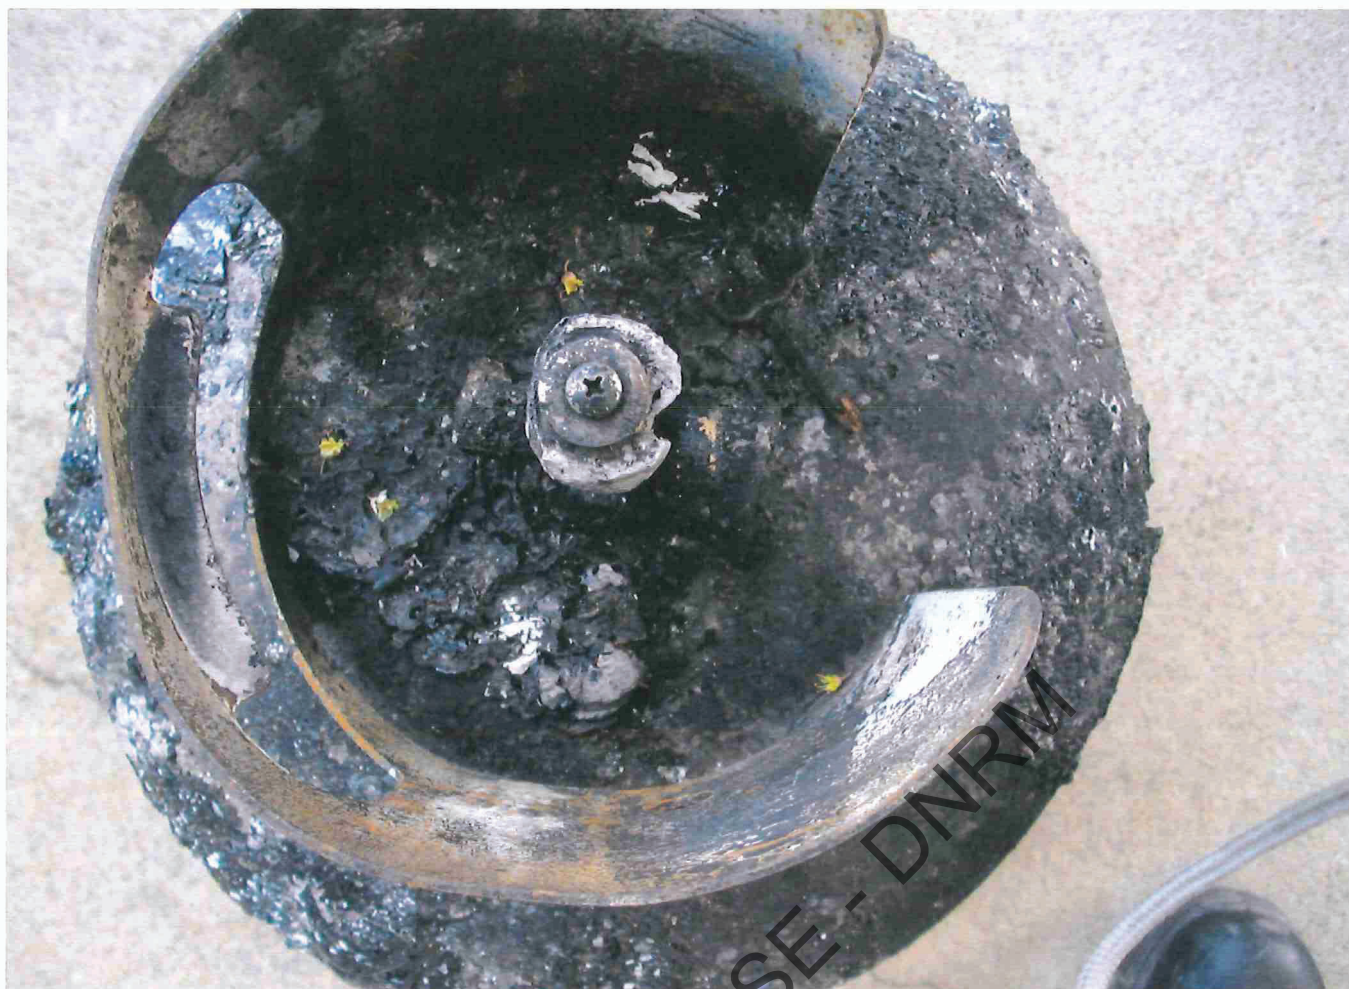
to the thread body and possibly been bumped in extinguishing the cylinder (photo 5) . FO Ford stated that he had witnessed the first removal of the POL fitting from gas cylinder valve and no evidence of the rubber domed ring that seals fitting was evident. Based on the evidence provided I believe this is the likely cause for the gas leak (photo 6).

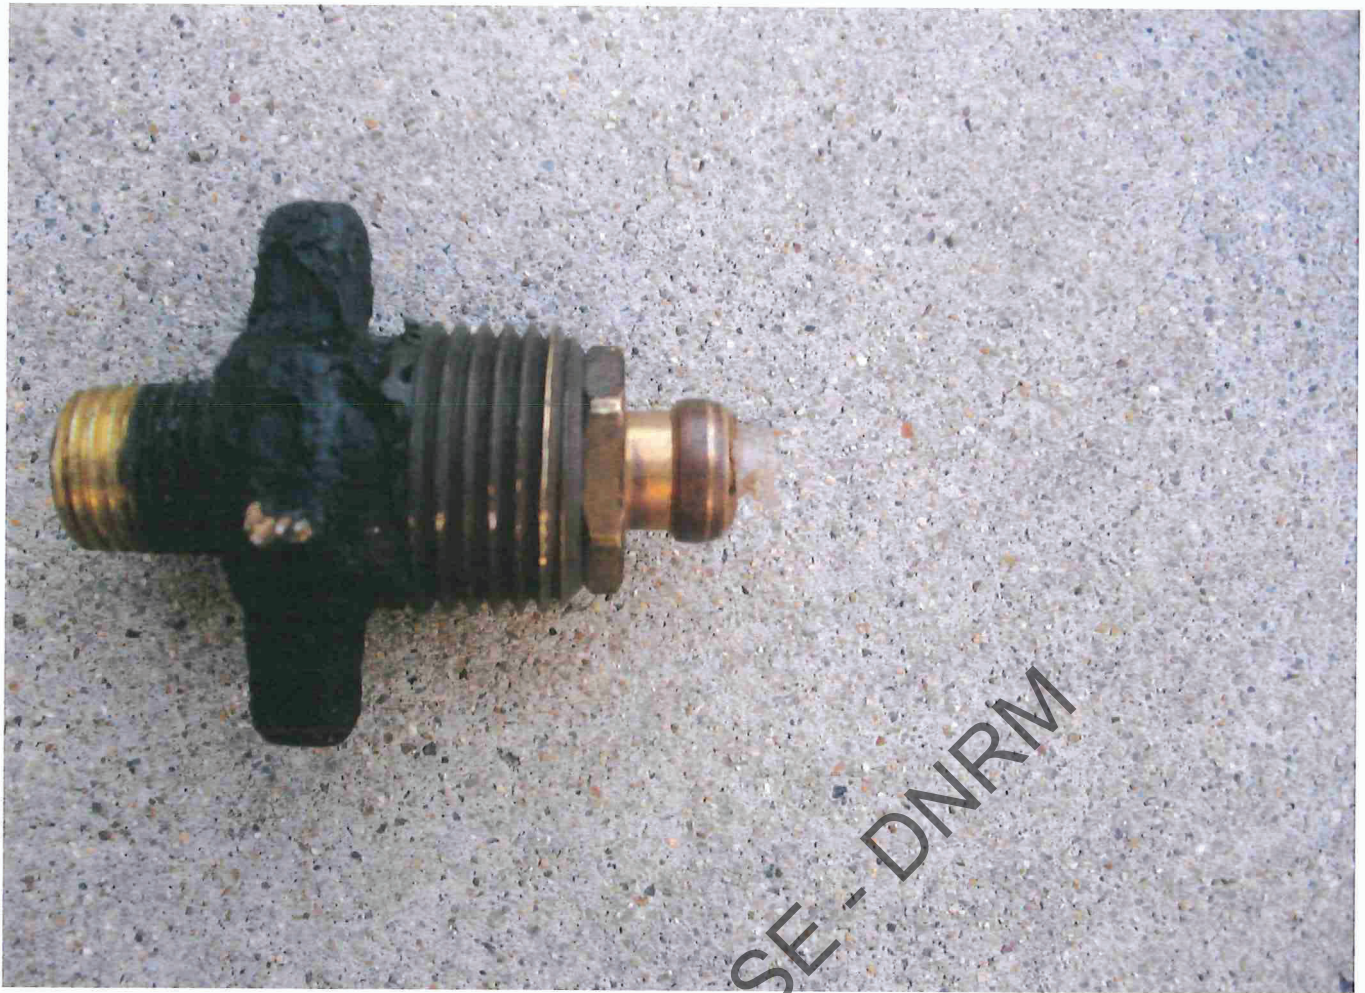
The evidence provided for the second cylinder being unrestrained leads to the belief the first cylinder which was filled by BCF may also had been transported in an unrestrained manner, this may have contributed to the cylinder being knocked slightly making it difficult to turn on. Although the gas cylinder was not tested for leaks at the time of being filled, it was not stated that there was a gas smell before it was turned on. The area the cylinder was stored in would suggest that if there was a significant leak there would of been a high possibility of gas being smelt. The evidence provided suggests that the leak is likely to have been caused from the missing sealing dome on the POL fitting attaching the cylinder.
