Mine Name	File No.	Operator	Activity Type	Region	Activity Date
South Walker Creek	21,350	BHP Mitsui Coal Pty Ltd		Central	01/11/2010

Mine Record Entry

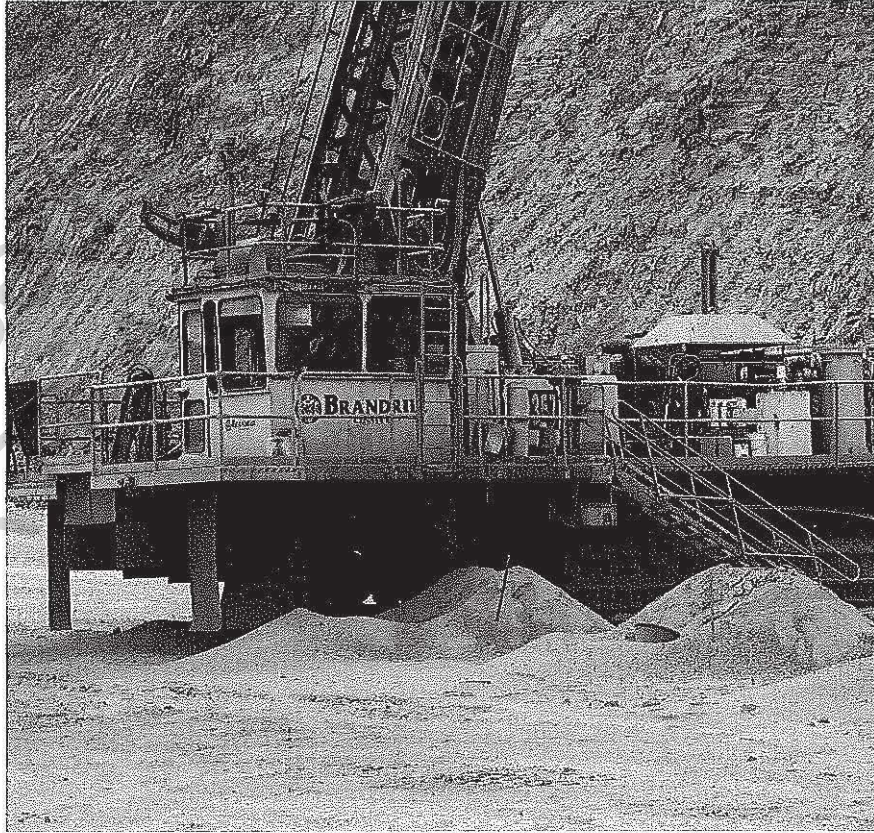
<p>Queensland Government Department of Mines and Energy</p>	<p>Inspection</p>
<p>Inspection</p>	<p>South Walker Creek</p>
<p>Date of Inspection</p>	<p>22nd July 2009</p>
<p>Location</p>	<p>9 kilometres off the Peak Downs Highway</p>
<p>Observation</p>	<p>Excessive Residual Ground Dust around the Brandrill DK90 overburden drill rig.</p>
<p>Photograph Cannon Digital IXUS 801S</p>

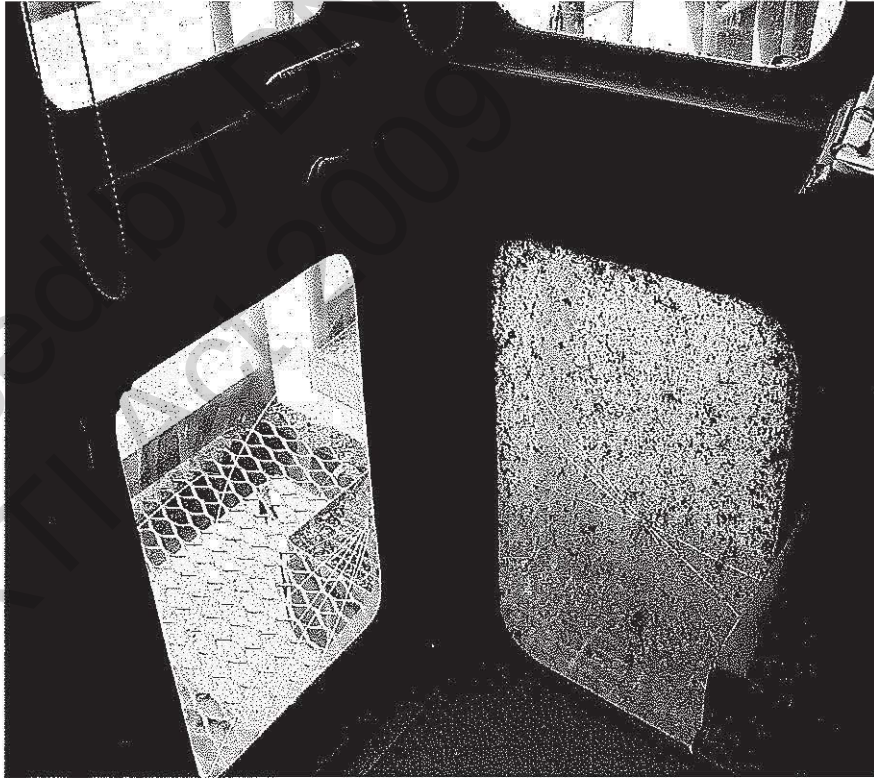
<p>Queensland Government Department of Mines and Energy</p>	<p>Inspection</p>
<p>Inspection</p>	<p>South Walker Creek</p>
<p>Date of Inspection</p>	<p>22nd July 2009</p>
<p>Location</p>	<p>9 kilometres off the Peak Downs Highway</p>
<p>Observation</p>	<p>Cracked Window Glasses in the Operators Cab – Brandrill DK90</p>
<p>Photograph Cannon Digital IXUS 801S</p>
