**PARADISE DAM**  
**FLOOD EVENT OF JANUARY TO MARCH 2013**  
**REVIEW OF DAM SAFETY MANAGEMENT**  
**ACTIONS**

**DRAFT REPORT FOR THE OFFICE OF WATER  
REGULATION**

**REPORT NO. DC 13127**

2<sup>ND</sup> AUGUST 2013

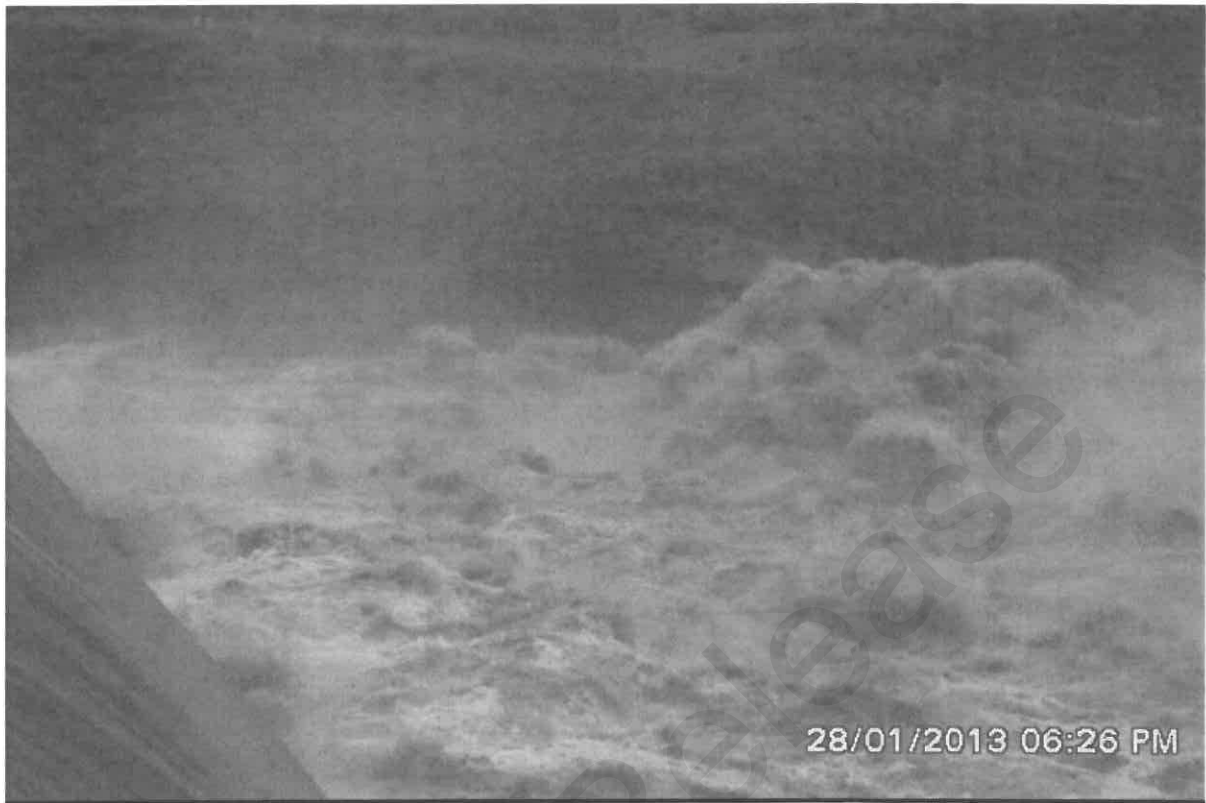
**Figure 2** shows the discharge under peak flow conditions at 1826h on 28 January 2013. The turbulence of the flow gives a graphic impression of the very large energy dissipation which is occurring.

**Figure 2 – Turbulent Flow at the Left End of the Spillway**

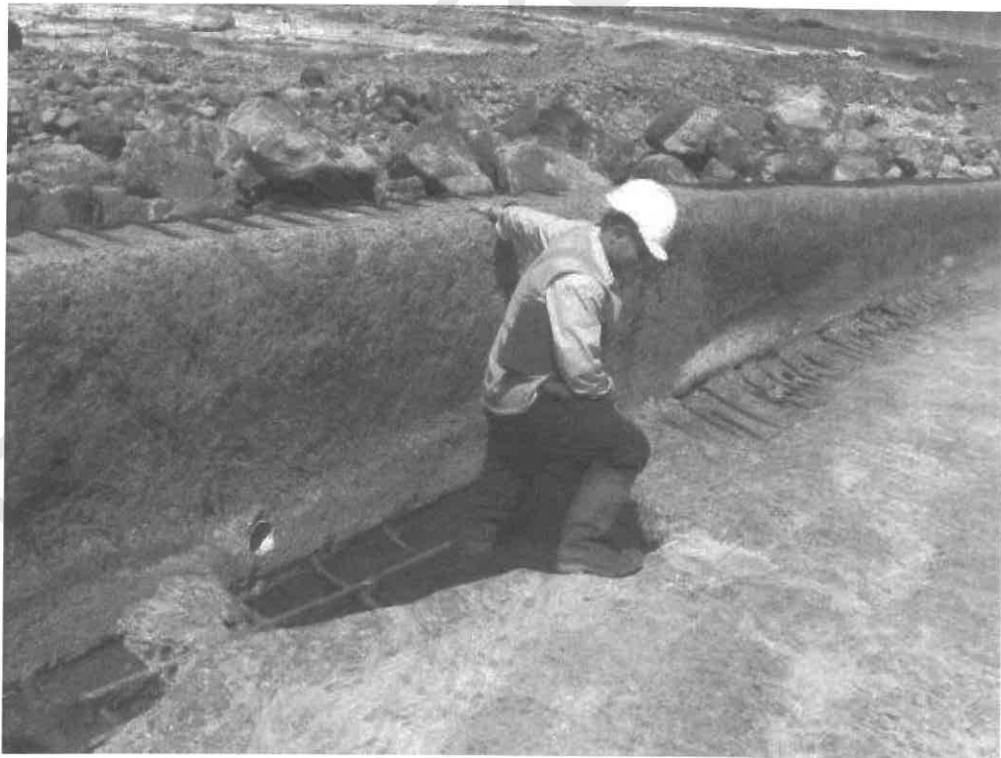
1. The spillway can continue to flow for very long periods – since December 2010 the spillway flowed continuously until September 2012 apart from three days in November 2011 and two days in January 2012. That is a period of 21 months with virtually continuous flow. Extended flow periods prevent detailed inspection of the energy dissipation zone and it is not reasonably practicable to undertake remedial works while the spillway has any significant discharge.
2. Rock and gravel are drawn into the dissipator – the end sill and the left training wall were rounded by abrasion to an extent that exposed the reinforcing steel. That damage was only of cosmetic significance in the short term but would cause problems of steel corrosion in the long term. There was some localised damage which was indicative of more serious abrasion as seen in **Figure 3**.

**Figure 3 – Abrasion through Dissipator Apron**

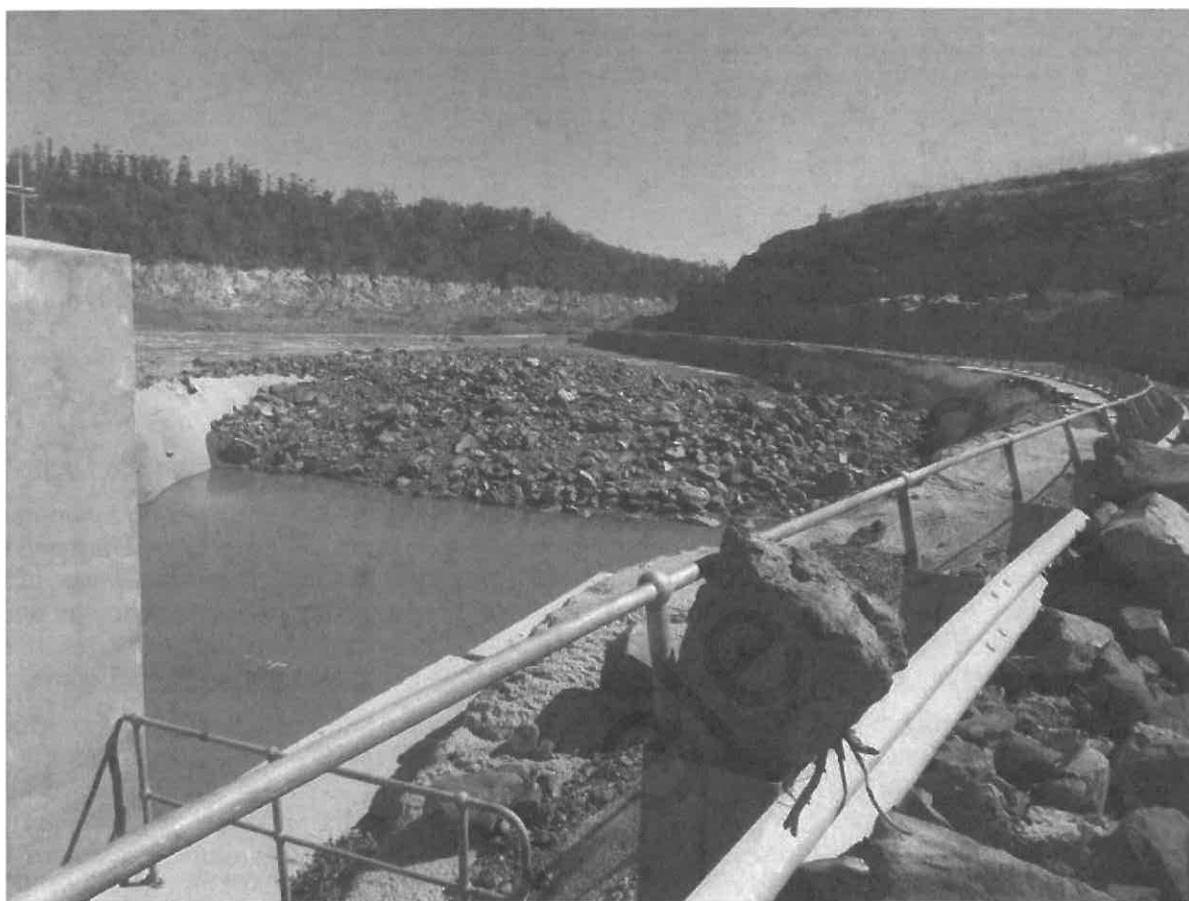
3. Observed behaviour of dissipation flows – a hydraulics specialist, Mr Eric Lesleighter, was engaged by SunWater to advise on the spillway performance during the 2010/2011 flood event. His report is Lesleighter (2012). The first issue to be noted from his advice is that the spillway flow is not two dimensional as would normally be expected in a long uncontrolled spillway. This is mainly attributed to the rise in the elevation of the dissipator apron toward the left end of the spillway. Eric Lesleighter believes that the recirculation pattern which has been set up is accentuated by the scour which occurred on the lower left abutment in the 2010/2011 flood event and that this recirculation is a mechanism for feeding rock and gravel back into the dissipator apron. Eric recommended that measures be taken to interrupt the recirculation flow. No such measures have yet been implemented. This relates to the potential abrasion problem mentioned under our preceding point.

**Figure 6 – Rock and Gravel in the Near Vicinity of the Dissipator**

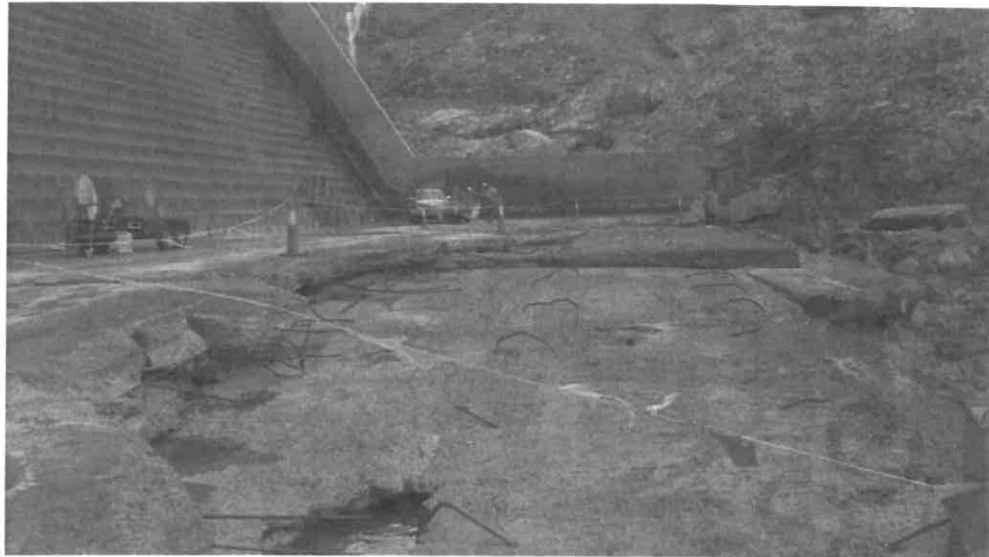
**Figure 8 – Damage to Dissipator Slab from 2013 Flood**

A point of significance in **Figure 8** is that there is a hole in the RCC below the plane of the reinforcement. The question is whether a future flood could destroy the dissipator slab. The damaged section shown in **Figure 8** has been replaced by anchored conventional concrete from Ch. 209 to Ch. 260. Another damaged section has likewise been replaced between Ch. 302 and Ch. 335. The “Ch.” refers to chainage measured parallel to the dam axis. The replaced sections of apron would be substantially more robust than the original RCC apron. The available evidence shows that:

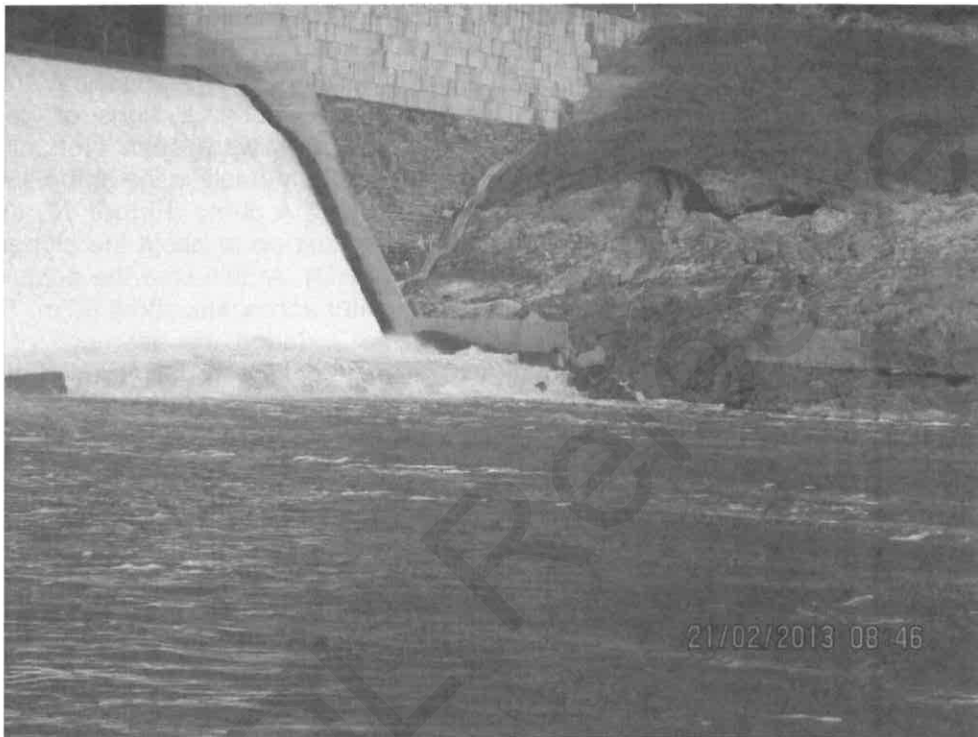
**Figure 10 – End Sills Destroyed at Left End of Dissipator**

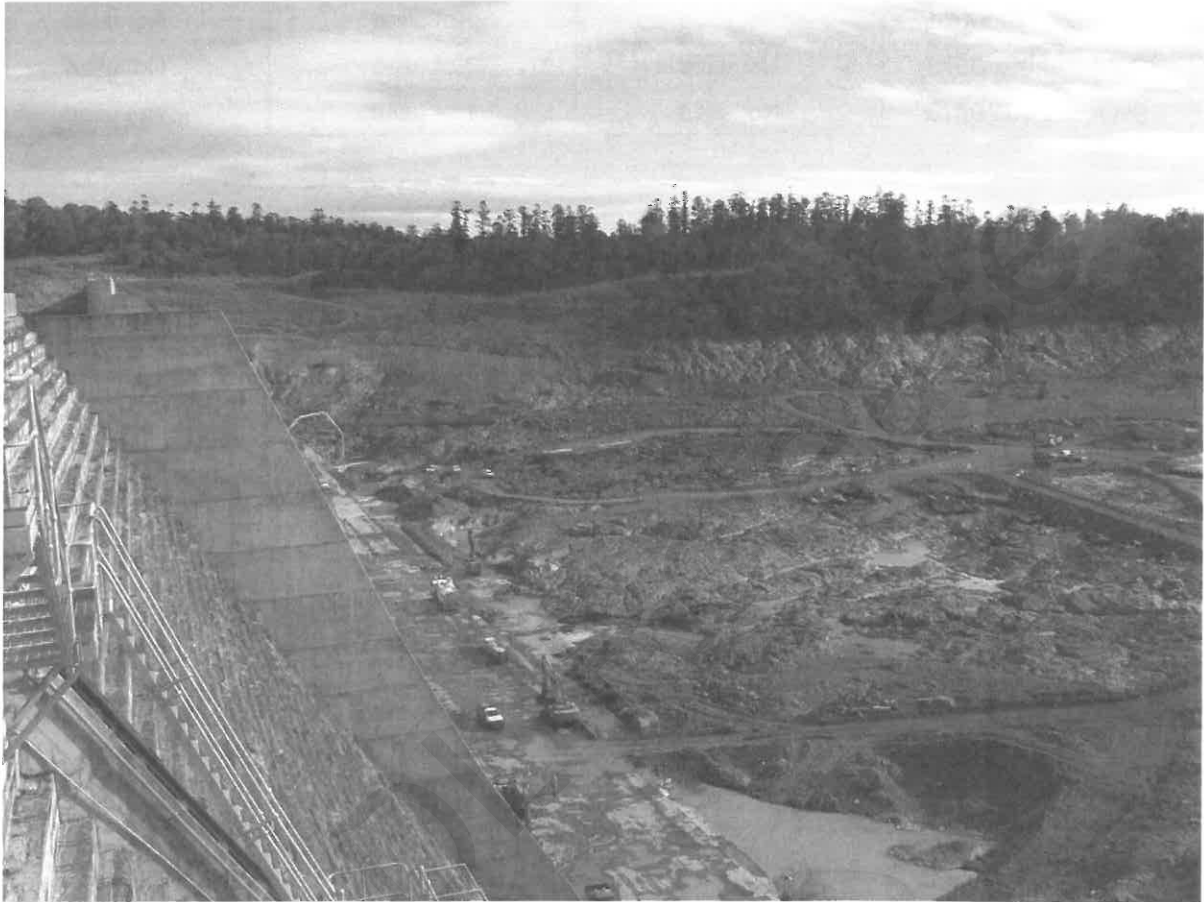
The inspection commenced on the crest at the right side of the spillway. There was a good overview here of the downstream side of the dam where concrete was being poured for the Phase 2 remedial work at the left end of the spillway. The extent of rock scour during the January to March 2013 flood event was evident. Damage to the valve house area could also be appreciated. **Photo 1** is an overview of the remedial works area.

**Photo 1 – Remedial Work**

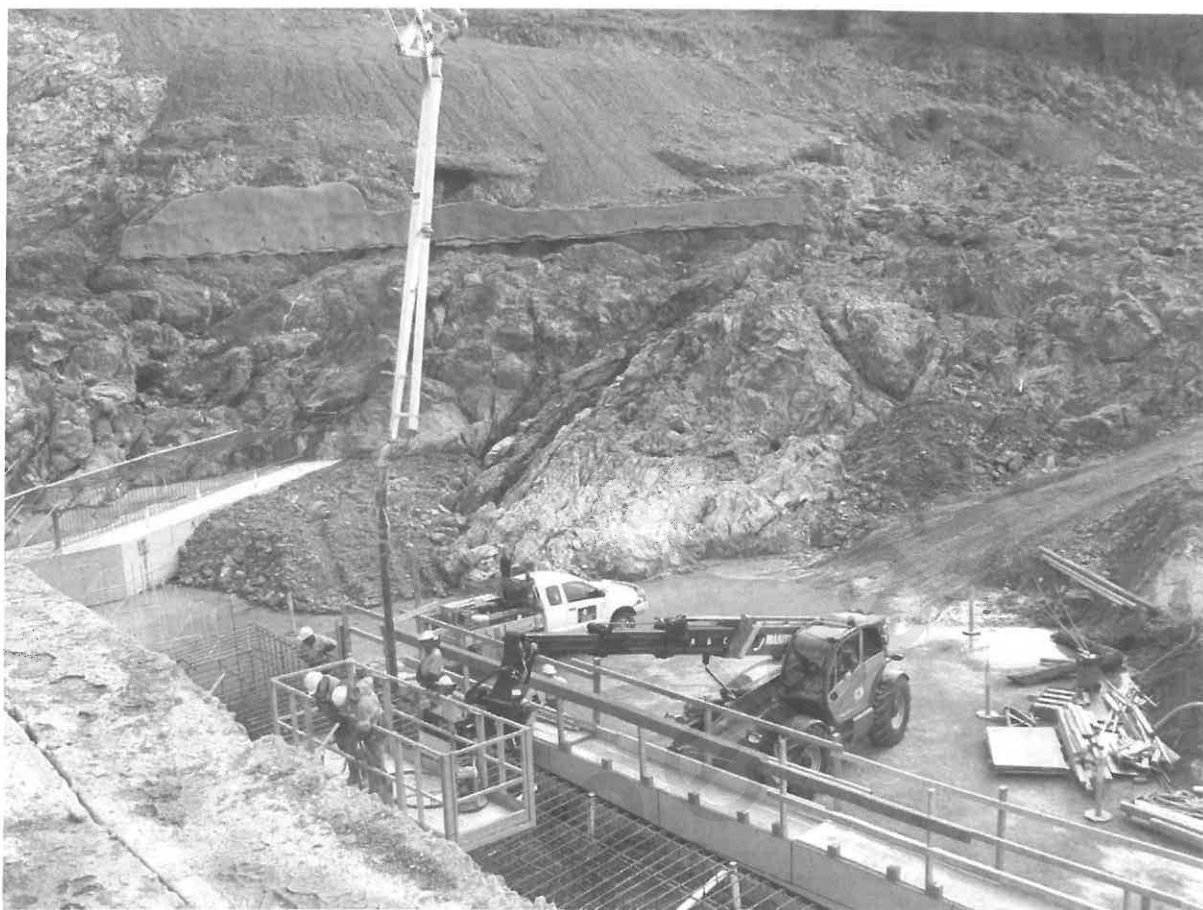
The left end of the spillway dissipator apron was then inspected. Concrete was being poured in the large scour hole immediately downstream of the apron. The damaged area of the apron had already been reinstated in conventional concrete. Geologic features were observed which it could reasonably be inferred had contributed to the deep scour in this area. **Photo 2** shows one such feature.

**Photo 2 - Shear Feature (just right of concrete boom)**

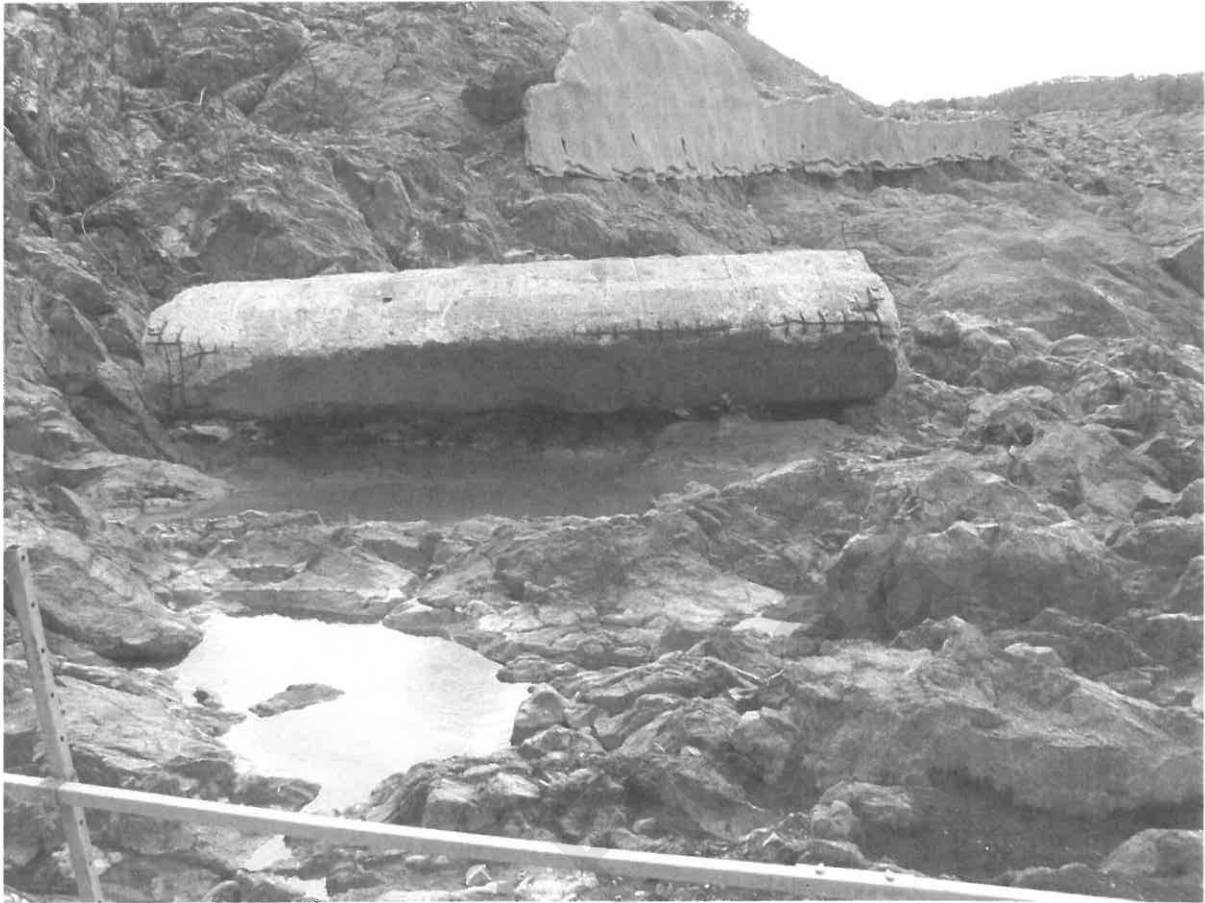
At the base of the left abutment slope a block of the dissipator end sill could be observed as in **Photo 3**. Many such blocks litter the downstream area, some hundreds of metres downstream. All of those observed had been abraded by rock and gravel drawn into the dissipator in the earlier 2010/2011 flood event. The abrasion had been sufficient to expose the reinforcing steel as is evident in the photo.

**Photo 3 – Sill Block at Base of Left Abutment**

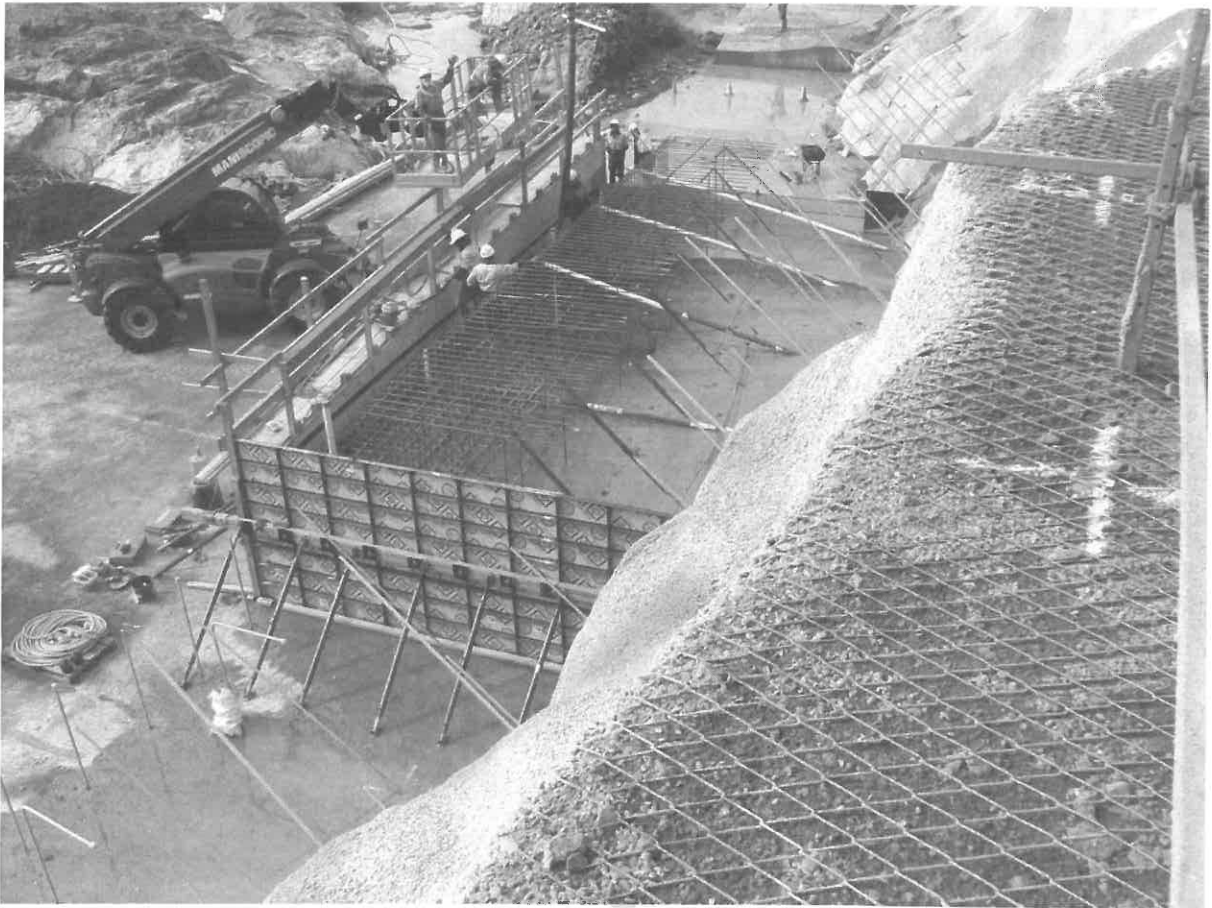
**Photo 4 – Preparing for Concrete to Protect Steep Scour Face at Left End of Spillway**

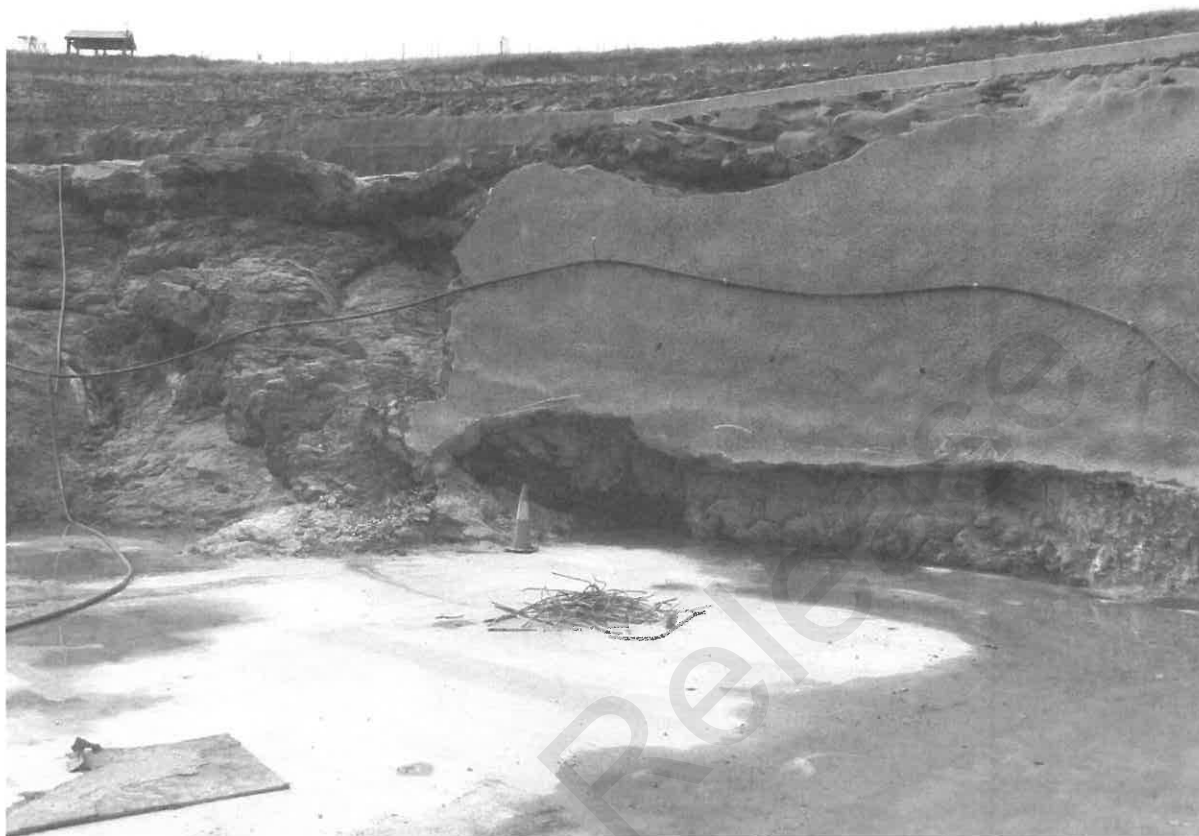
**Photo 5 – Scour Hole at Right End of Apron Repaired**

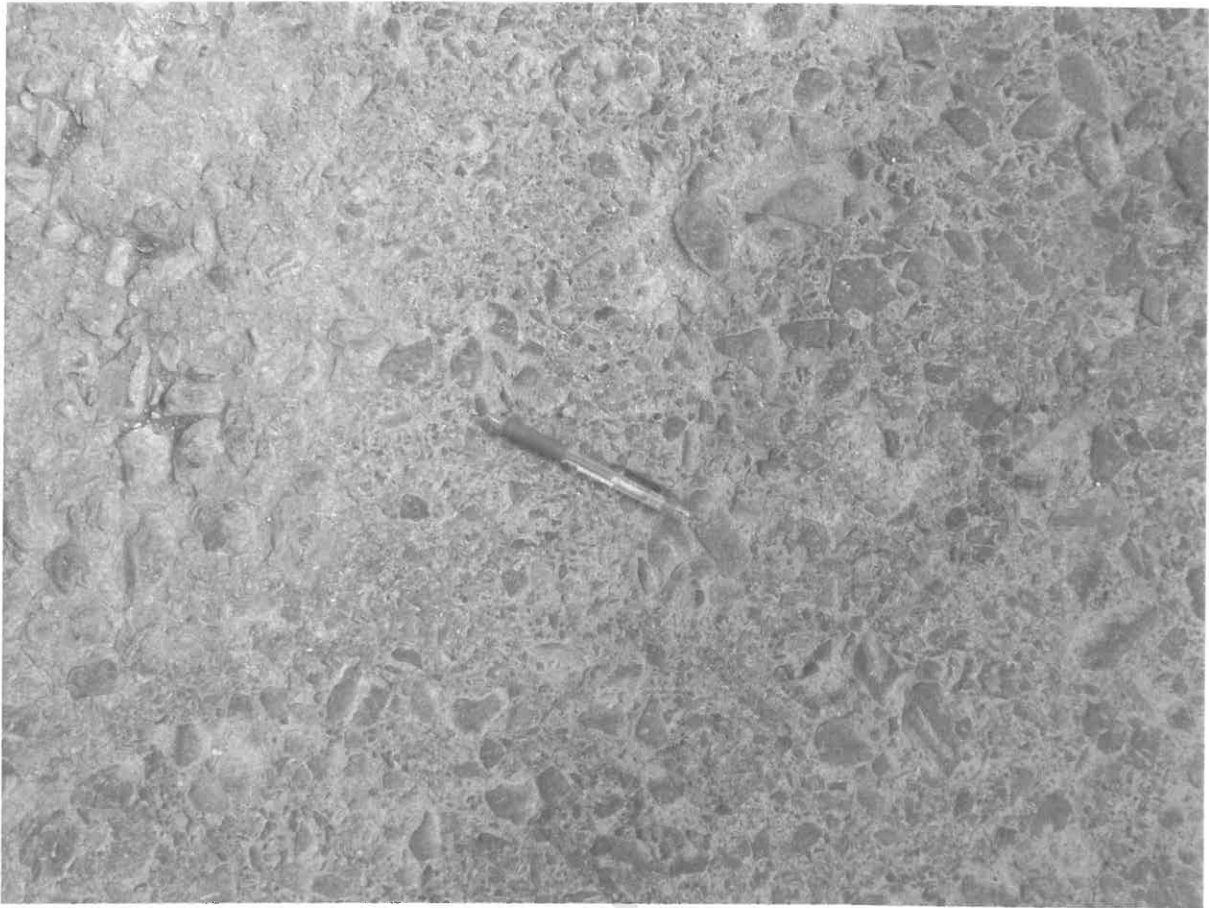
Examination of the remaining original RCC sections of the dissipator apron did not reveal any serious abrasion from the January to March 2013 flood. **Photo 6** shows the typical condition of the surface of the apron. This result is in contrast to the experience of the 2010/2011 flood when quite marked abrasion occurred on and adjacent to the end sill.

**Photo 6 – Condition of RCC Surface of the Dissipator Apron**

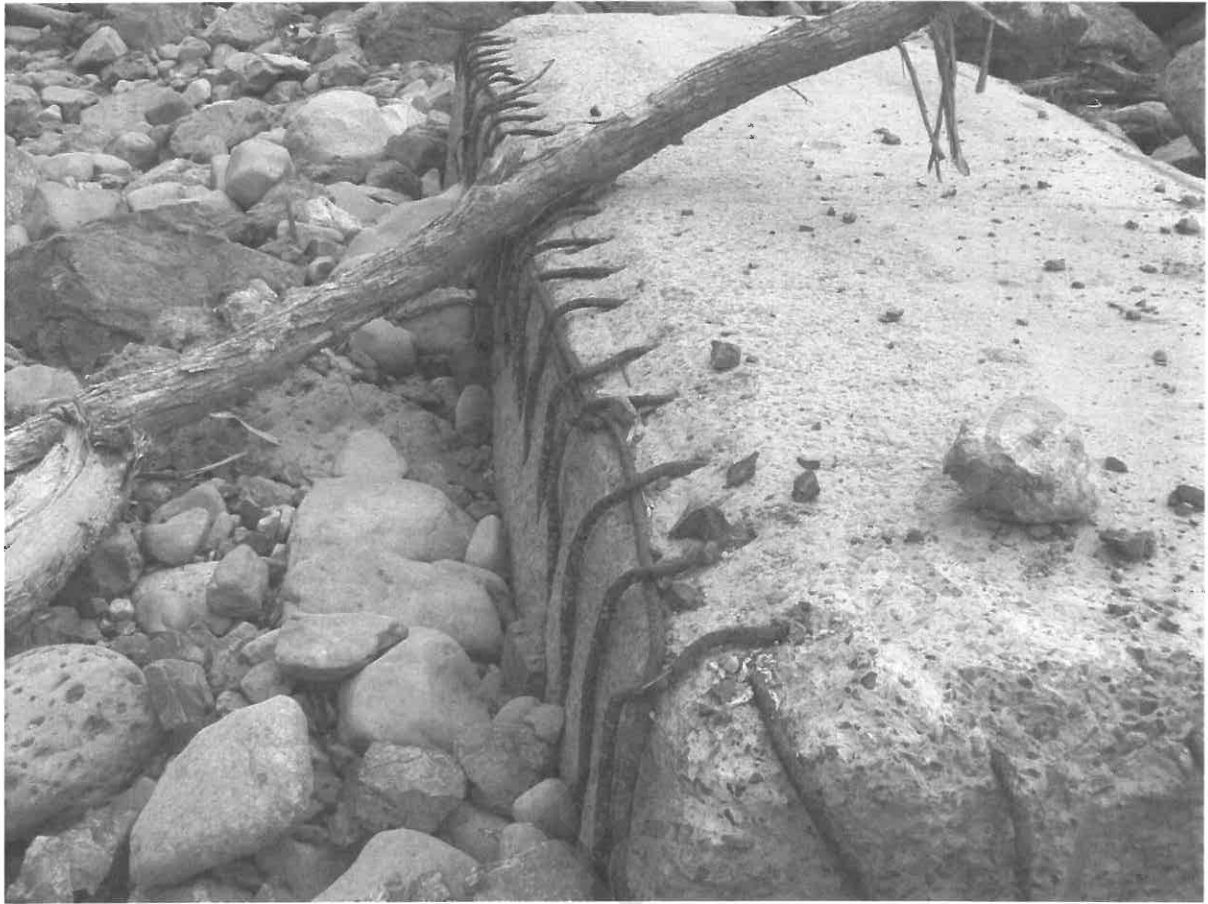
About 150m downstream of the apron an inspection was made of another end sill block. **Photo 7** shows this block. Though weighing some seven tonnes this block had been carried 150m from its original location. The abrasion by rock and gravel in the 2010/2011 flood is clearly seen. As observed with other blocks the reinforcing steel had failed in tension indicating that the high velocity water jet from the spillway had imposed loads in excess of the end sill's structural capacity. The classic "necking in" of reinforcement bars typical of a tensile failure is clearly evident in **Photo 8**.

**Photo 7 – A 7 tonne sill block carried 150m**

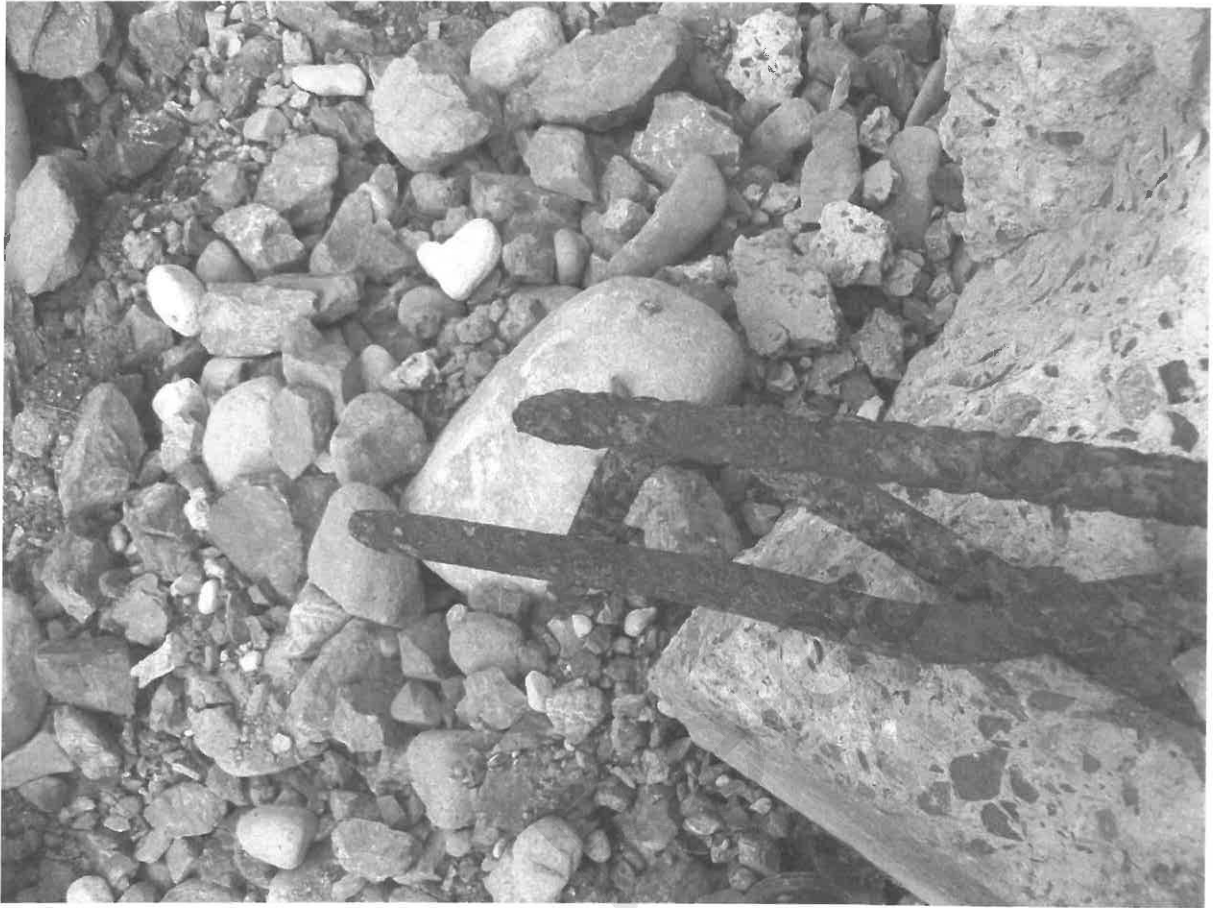
**Photo 8 – Necking of Reinforcement Bars Indicating Tensile Overload**

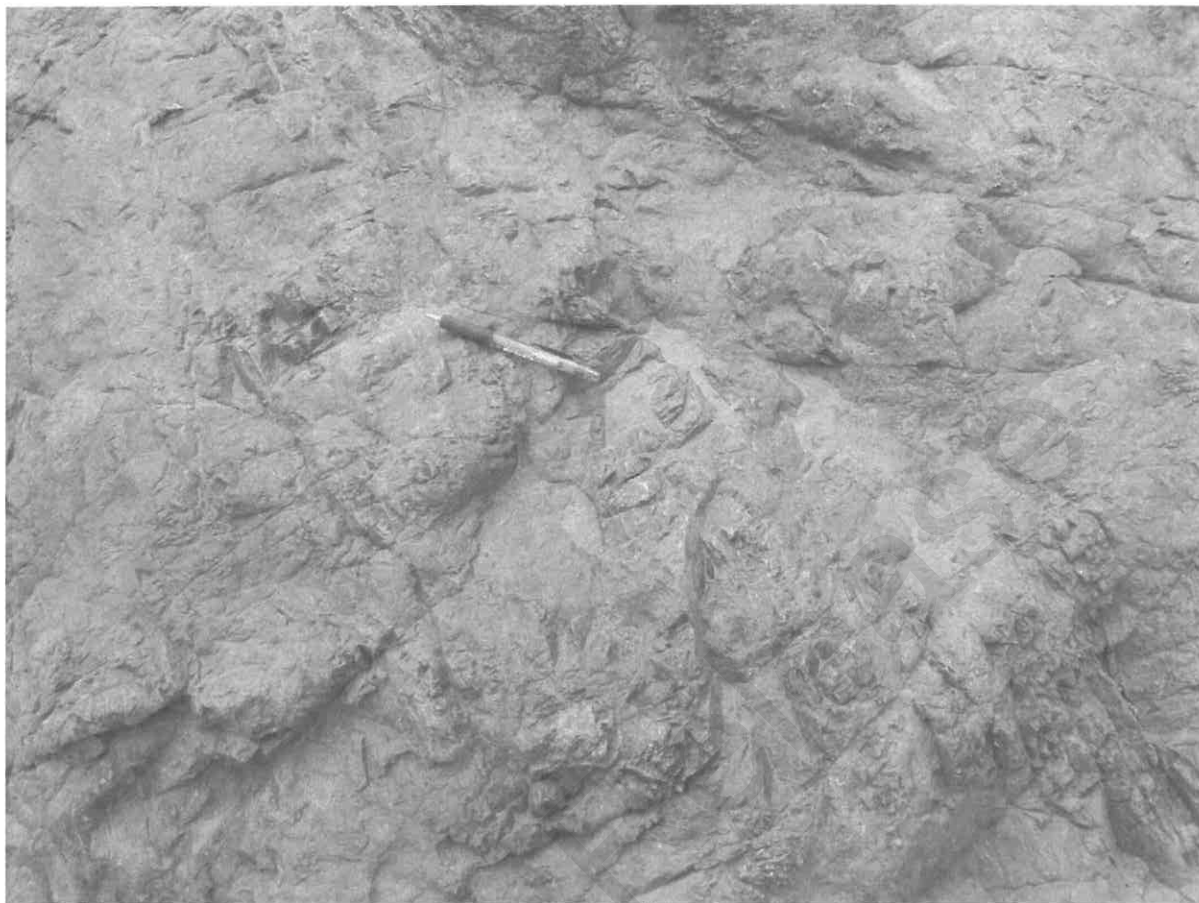
In this same vicinity a sample area of the exposed rock was examined. This inspection revealed a considerable variability in the rock conditions. In some places, as in **Photo 9**, the rock jointing was tight and the rock would be more resistant to scour. In other places the rock was very closely fractured with loose joints as can be seen in **Photo 10** and it would be less resistant to scour.

**Photo 9 – Rock More Resistant to Scour**

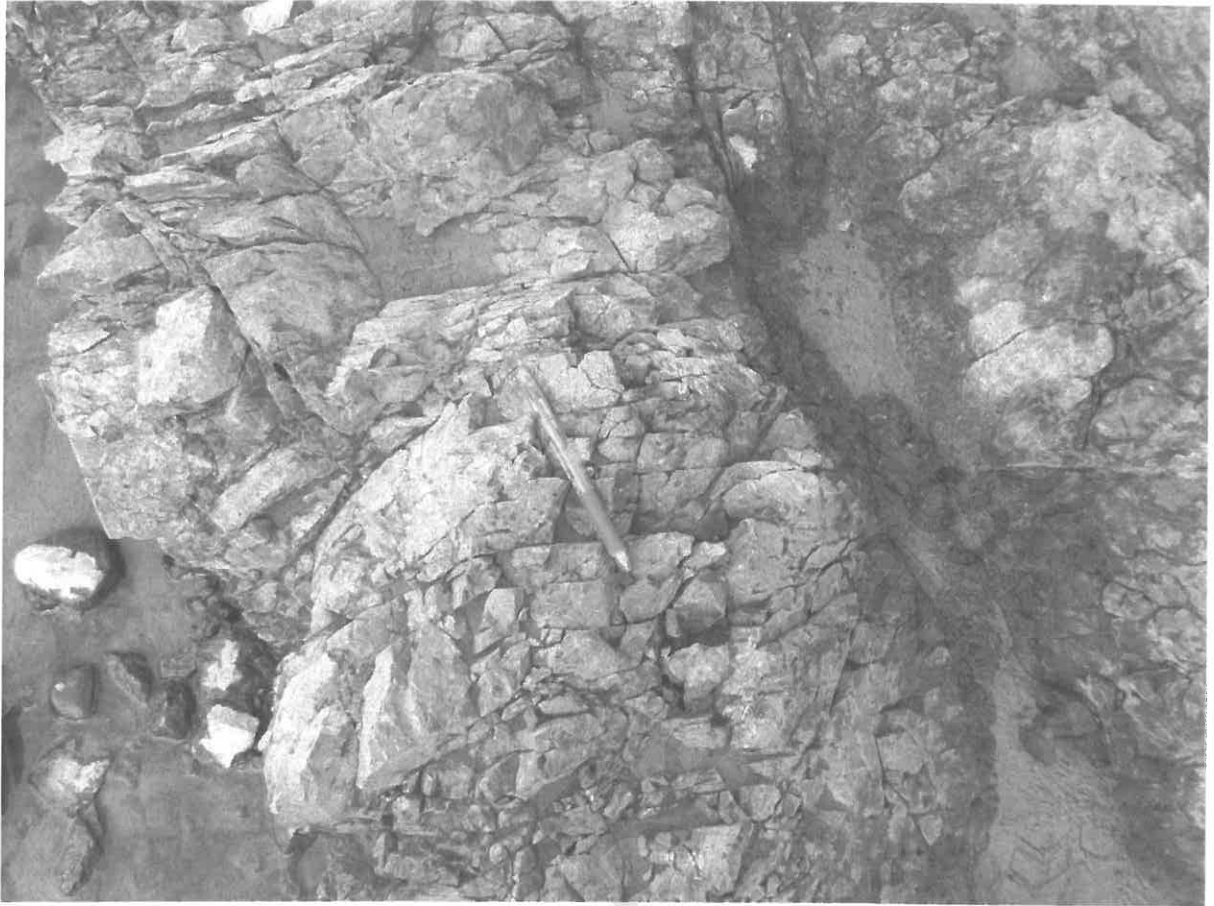
**Photo 10 – Closely Fractured Rock Less Resistant to Scour**

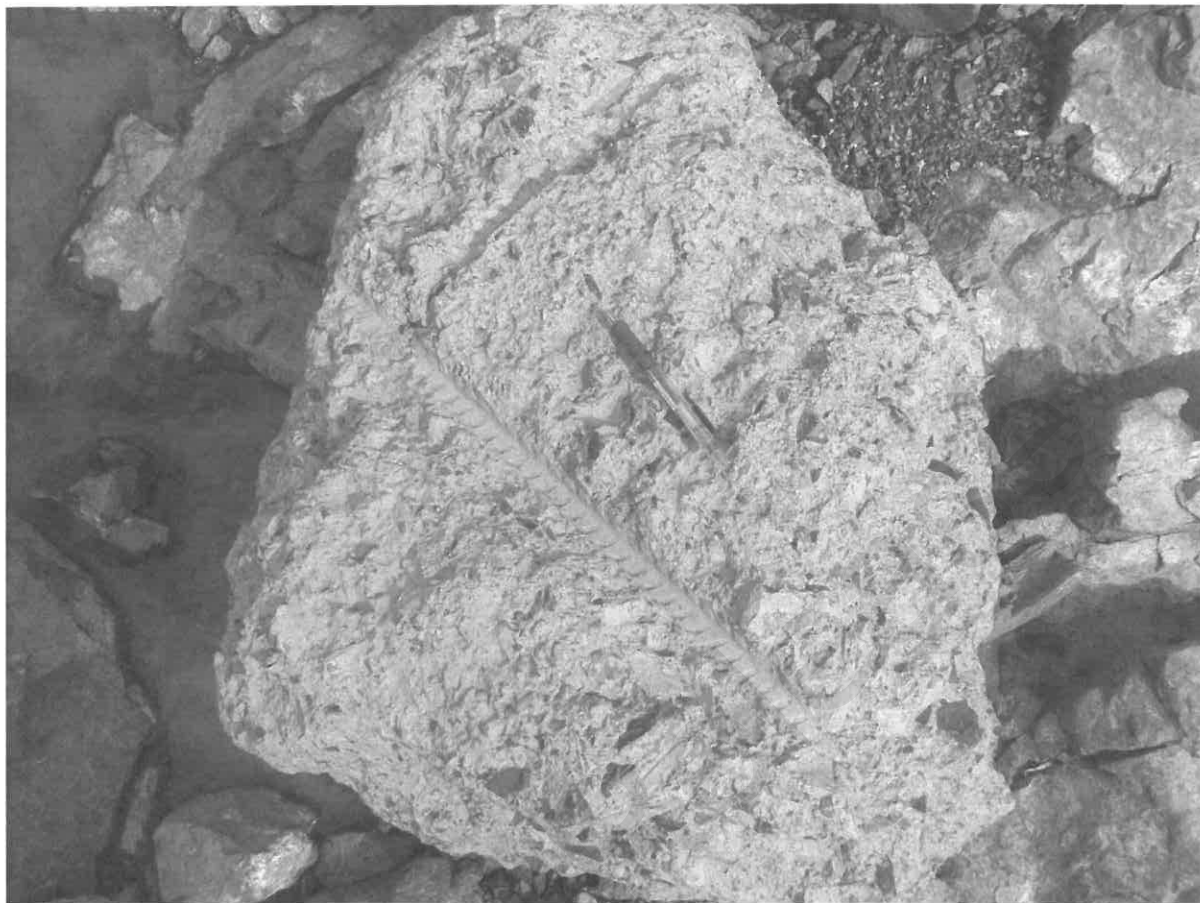
Nearby there was a slab of RCC from the dissipator apron. This slab had been rounded by abrasion in the turbulent flow of the flood. Significantly the impression of the reinforcing steel was visible, as seen in **Photo 11**. This is evidence of separation of the RCC along the plane of the steel under pounding of the overflow jet rather than failure by abrasion.

**Photo 11 – Apron RCC Showing Separation at the Steel Level**
