Mine Name	File No.	Operator	Activity Type	Region	Activity Date
Cannington Mine	9748 / 02	BHP Billiton Minerals Pty Ltd	Inspection	Northern	16/08/2011

Mine Record Entry

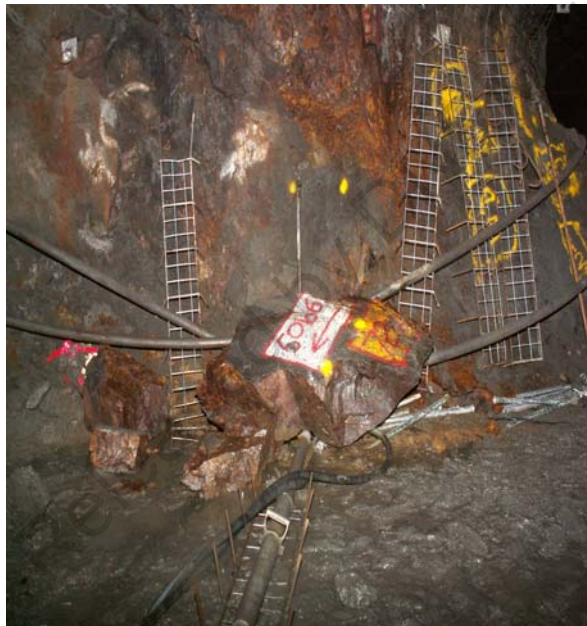
This record book entry refers to the rockfall that occurred on 16th March 2006 (see attached photograph) on 475mLv, while ground control rehabilitation activities were being undertaken using an airleg. The RBE should be read in conjunction with an email directive regarding this matter sent to Tim Purvis, Principal Engineer on 16th March 2006 from Rob O'Sullivan, Manager Safety and Health North Region.

The background to this activity was a large rockfall (estimated up to 4000 tonnes) that occurred on the intersection of 70 x/c and T71 decline on 475mLv on 1st March 2006. This rockfall occurred at the interface of a geological contact and a minor fault. The area had a history of smaller rockfalls.

At the time of the on site investigation by Phil Casey, Inspection Officer and Hermann Fasching, Acting District Inspector of Mines it was agreed that the mine would undertake a survey of mine workings to identify any areas similar to the site at the intersection of 70 x/c
