Mine/Quarry Name	File #	Operator	Activity Type	Region	Activity Date
Lady Annie Operations	4015	Lady Annie Operations Pty Ltd (Receivers and Managers Appointed) (Administrators Appointed)	Inspection	Northern	24/02/2009

## Mine Record Entry

**RE: Mine Record Entry – 24/02/09**

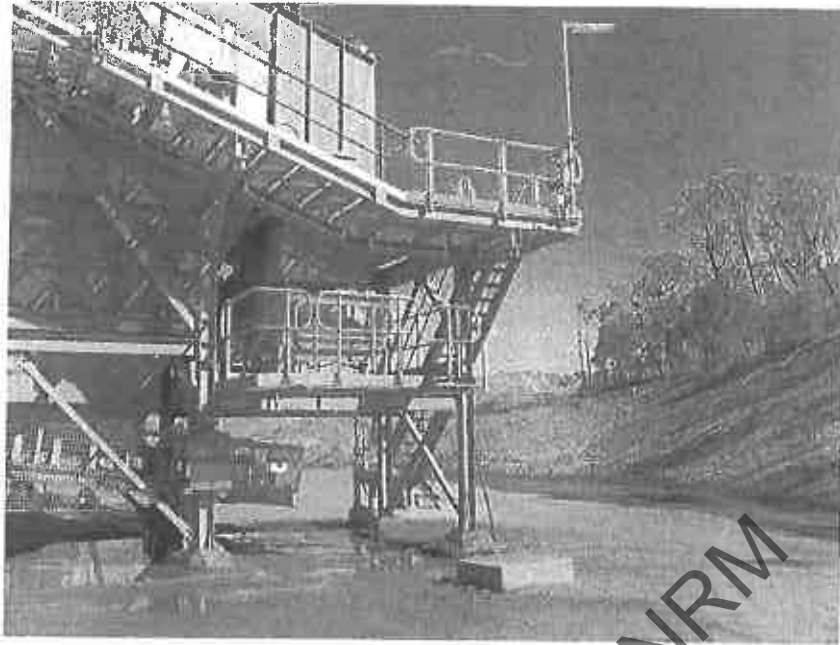
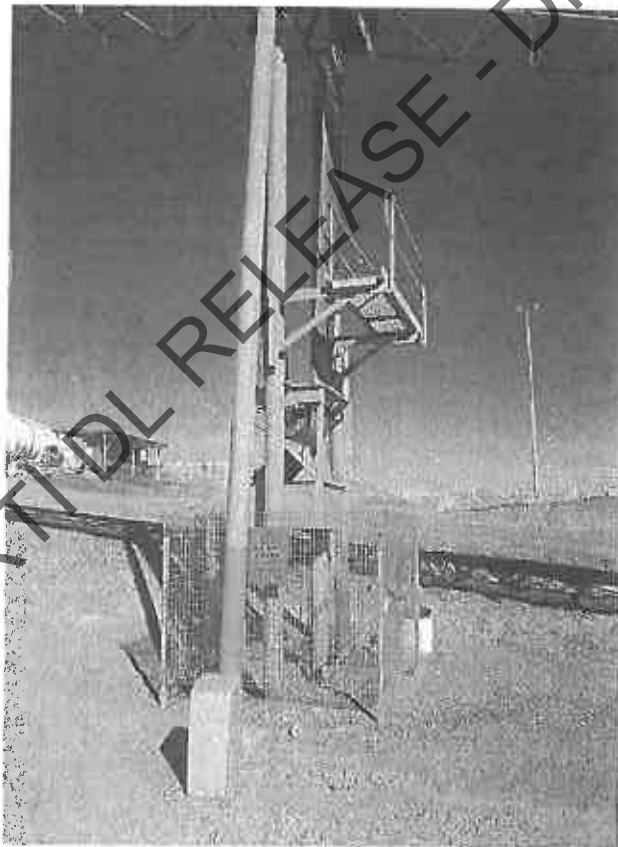
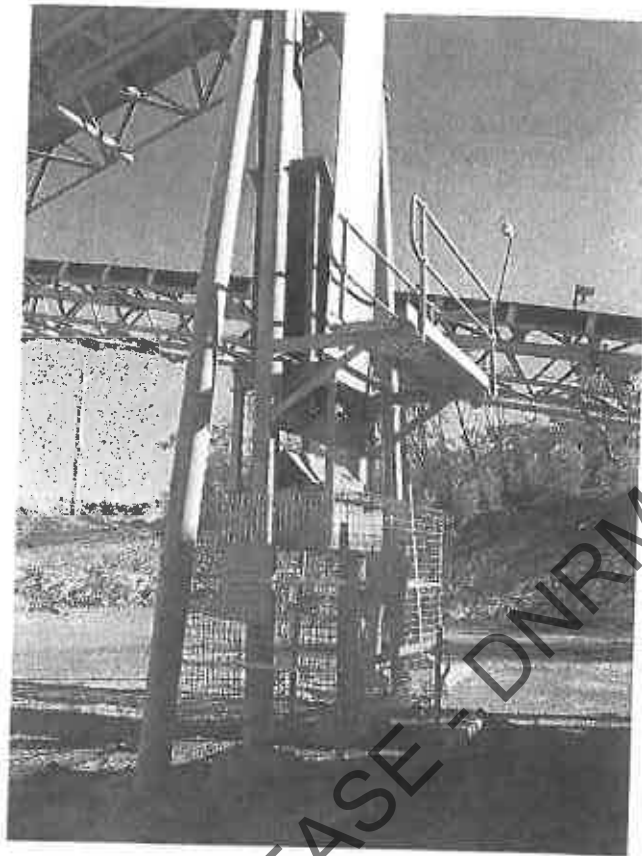
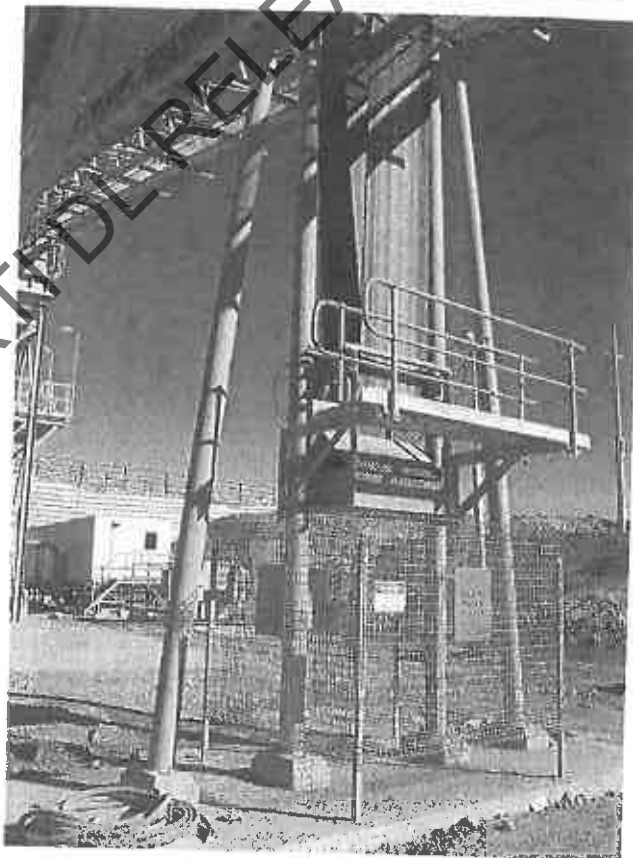
During the inspection a number of permanent access ladders at the ROM were found to be damaged. Questions were also raised as to whether they also require safety cages due to the height of the ladders. The mine is to repair all damaged permanent ladders and audit all access ways to ensure that they comply with the Australian Standard 1657 and are suitably protected from damage from vehicular traffic.

Since the inspection all ladders in the crusher area have been examined to determine compliance with AS 1657. Four non-compliant ladders were found at the conveyor take up towers and the access point to the tail of CV002. The non-compliant ladders have been removed as shown in the attached photos.

All crushing and stacking activity ceased on Sunday March 8, 2009 as per the instructions of the Receiver / Manager. The ladders will be re-installed with the appropriate safety cages prior to the re-commencement of crushing operations, if or when that occurs in the future.
