EH3500AC2
Rear Strut.

Frame Suspension

Mine Name	File No.	Operator	Activity Type	Region	Activity Date
Middlemount Mine	1762	Middlemount Mine Management Pty Ltd ABN: 62 140 398 143	Inspection - Weekend or Backshift	Central	20/06/2013

Mine Record Entry

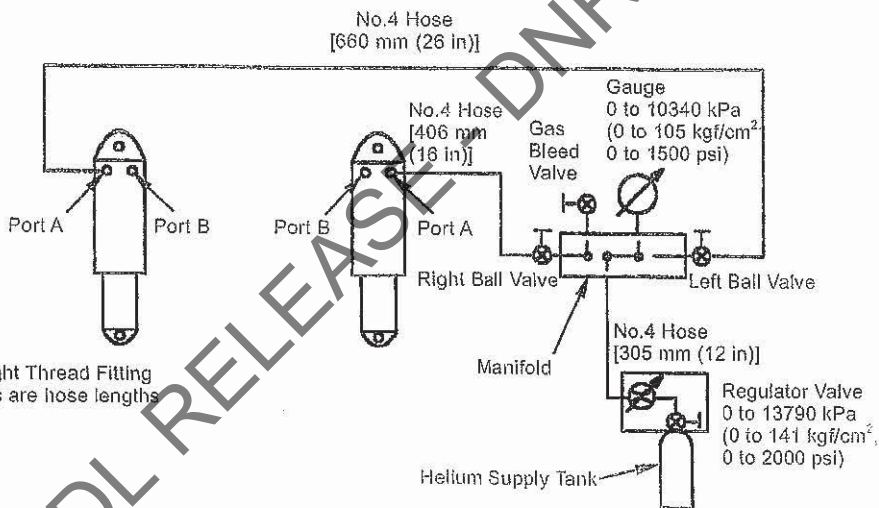
Helium Gas/Neocon Oil Charging Procedure Diagram

- P-1A conversion from MPa to psi incorrect

- P-1A spec incorrect

Mpa 0.77 should be 0.97 MPa
pg W2-11-34

- Step 6 has incorrect spec pressure
not 5.88 Mpa but 1.66 MPa.
pg W2-11-38

incorrect conversion
which is correct?
