From: hermann.fasching@deedi.qld.gov.au
Sent: Thursday, 17 March 2011 7:45 AM
To: Thomson Vicki; Casey Phillip; O'Sullivan Robert
Subject: New Form 1A #HFAG-8EZT6J

RE: Notification of Serious Accident, High Potential Incident, Lost Time Injury or Reportable Incident.

2. SUMMARY/TITLE OF INCIDENT (eg Electrical shock whilst repairing generator, Vehicle collision at cutthrough , etc)
A contractor was transporting copper anode to the QR Terminal via the on-site haul road. As he neared the QR Terminal the vehicle tracked to the left hand side of the road & rolled over.

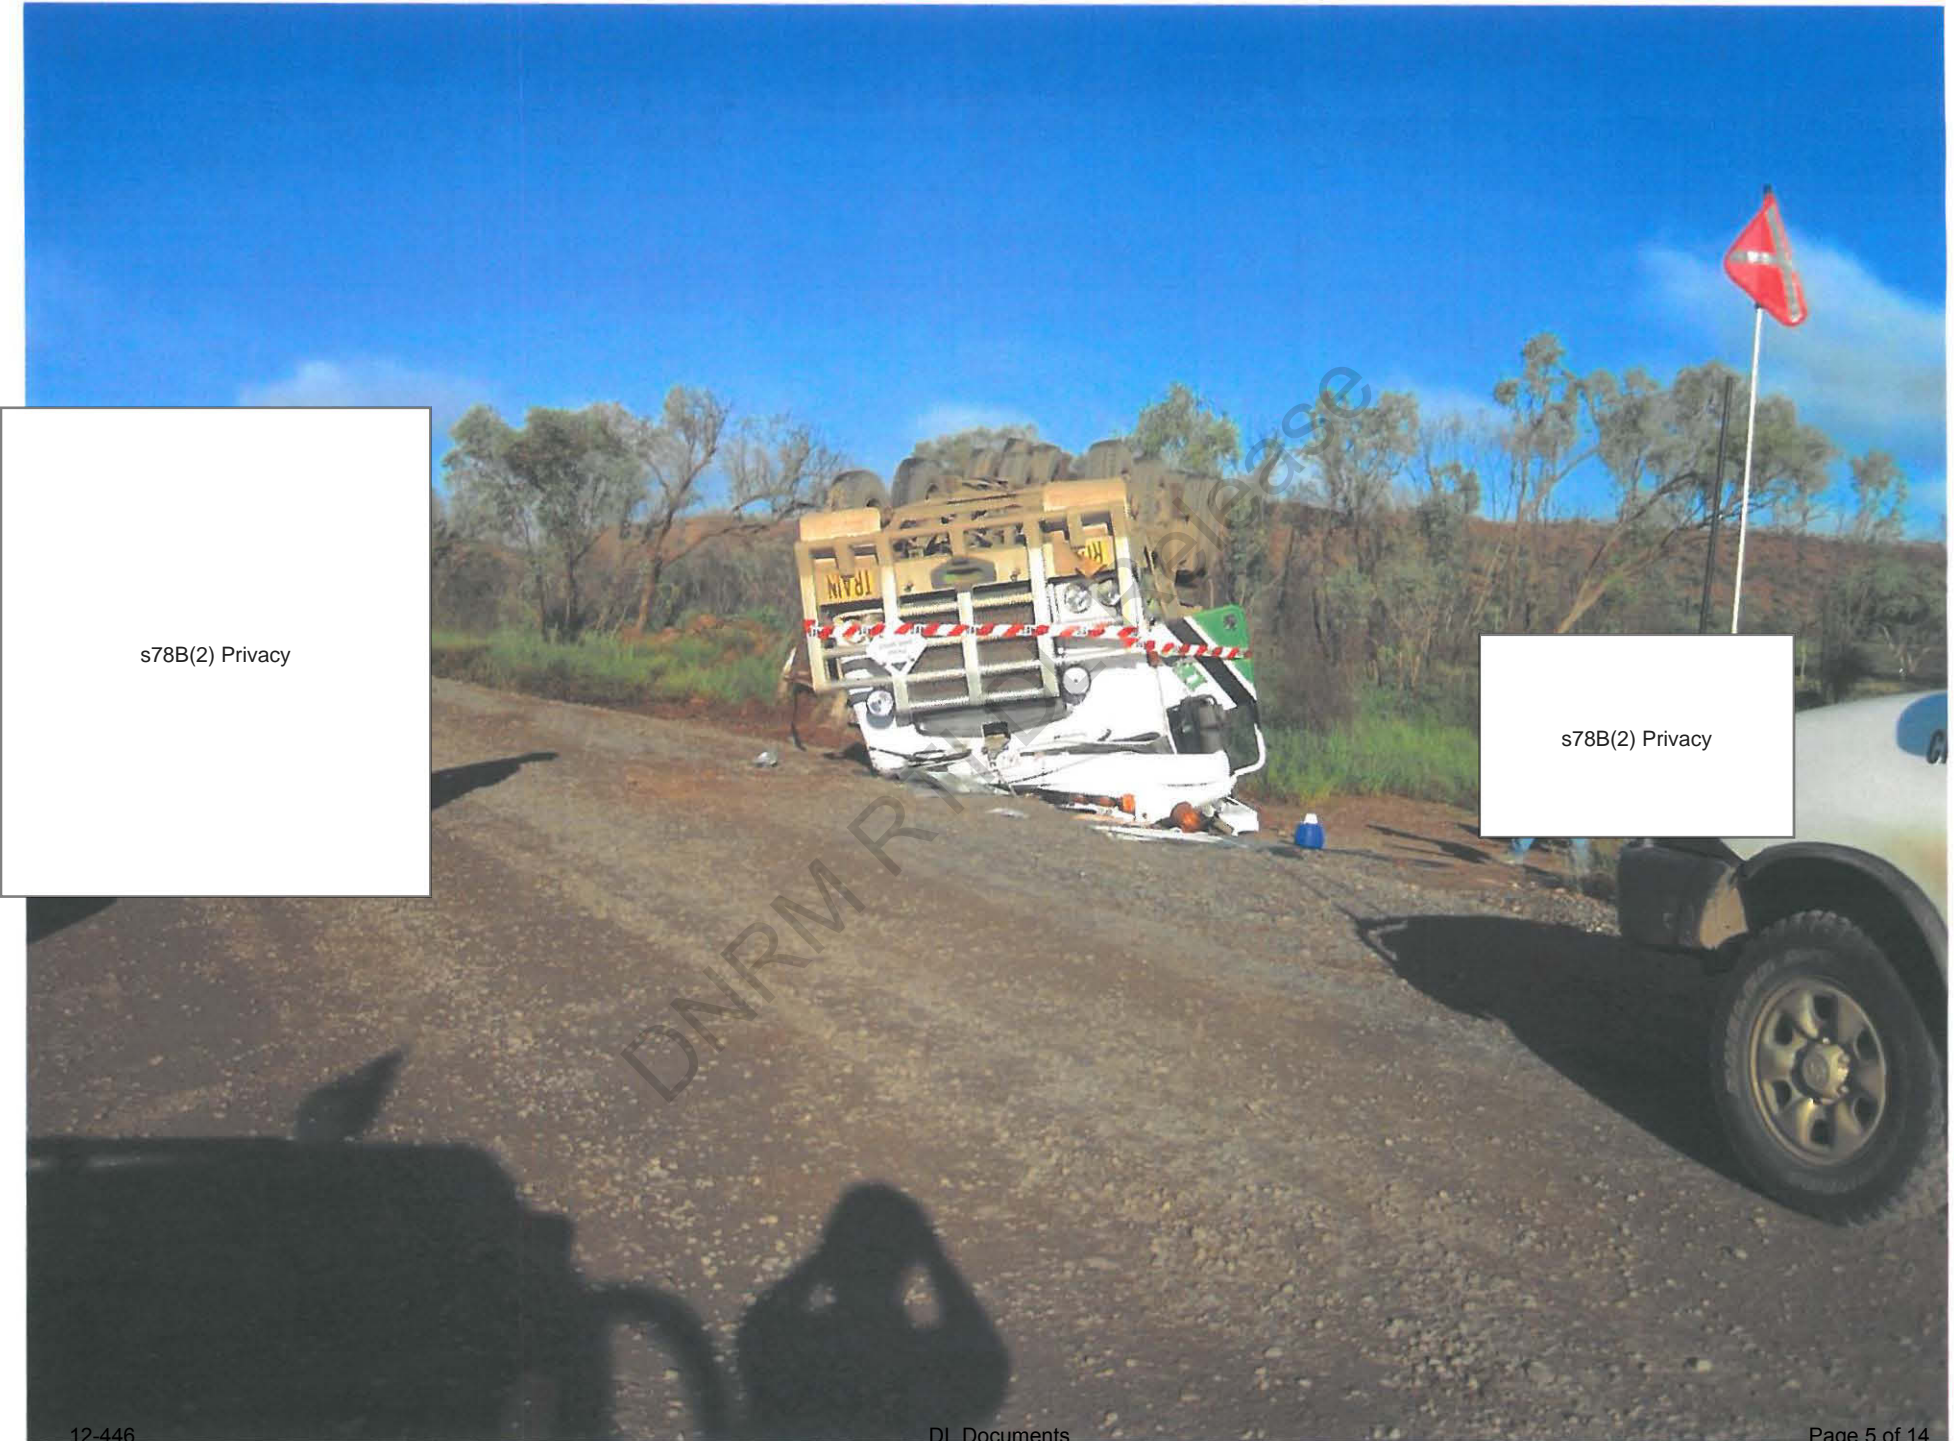
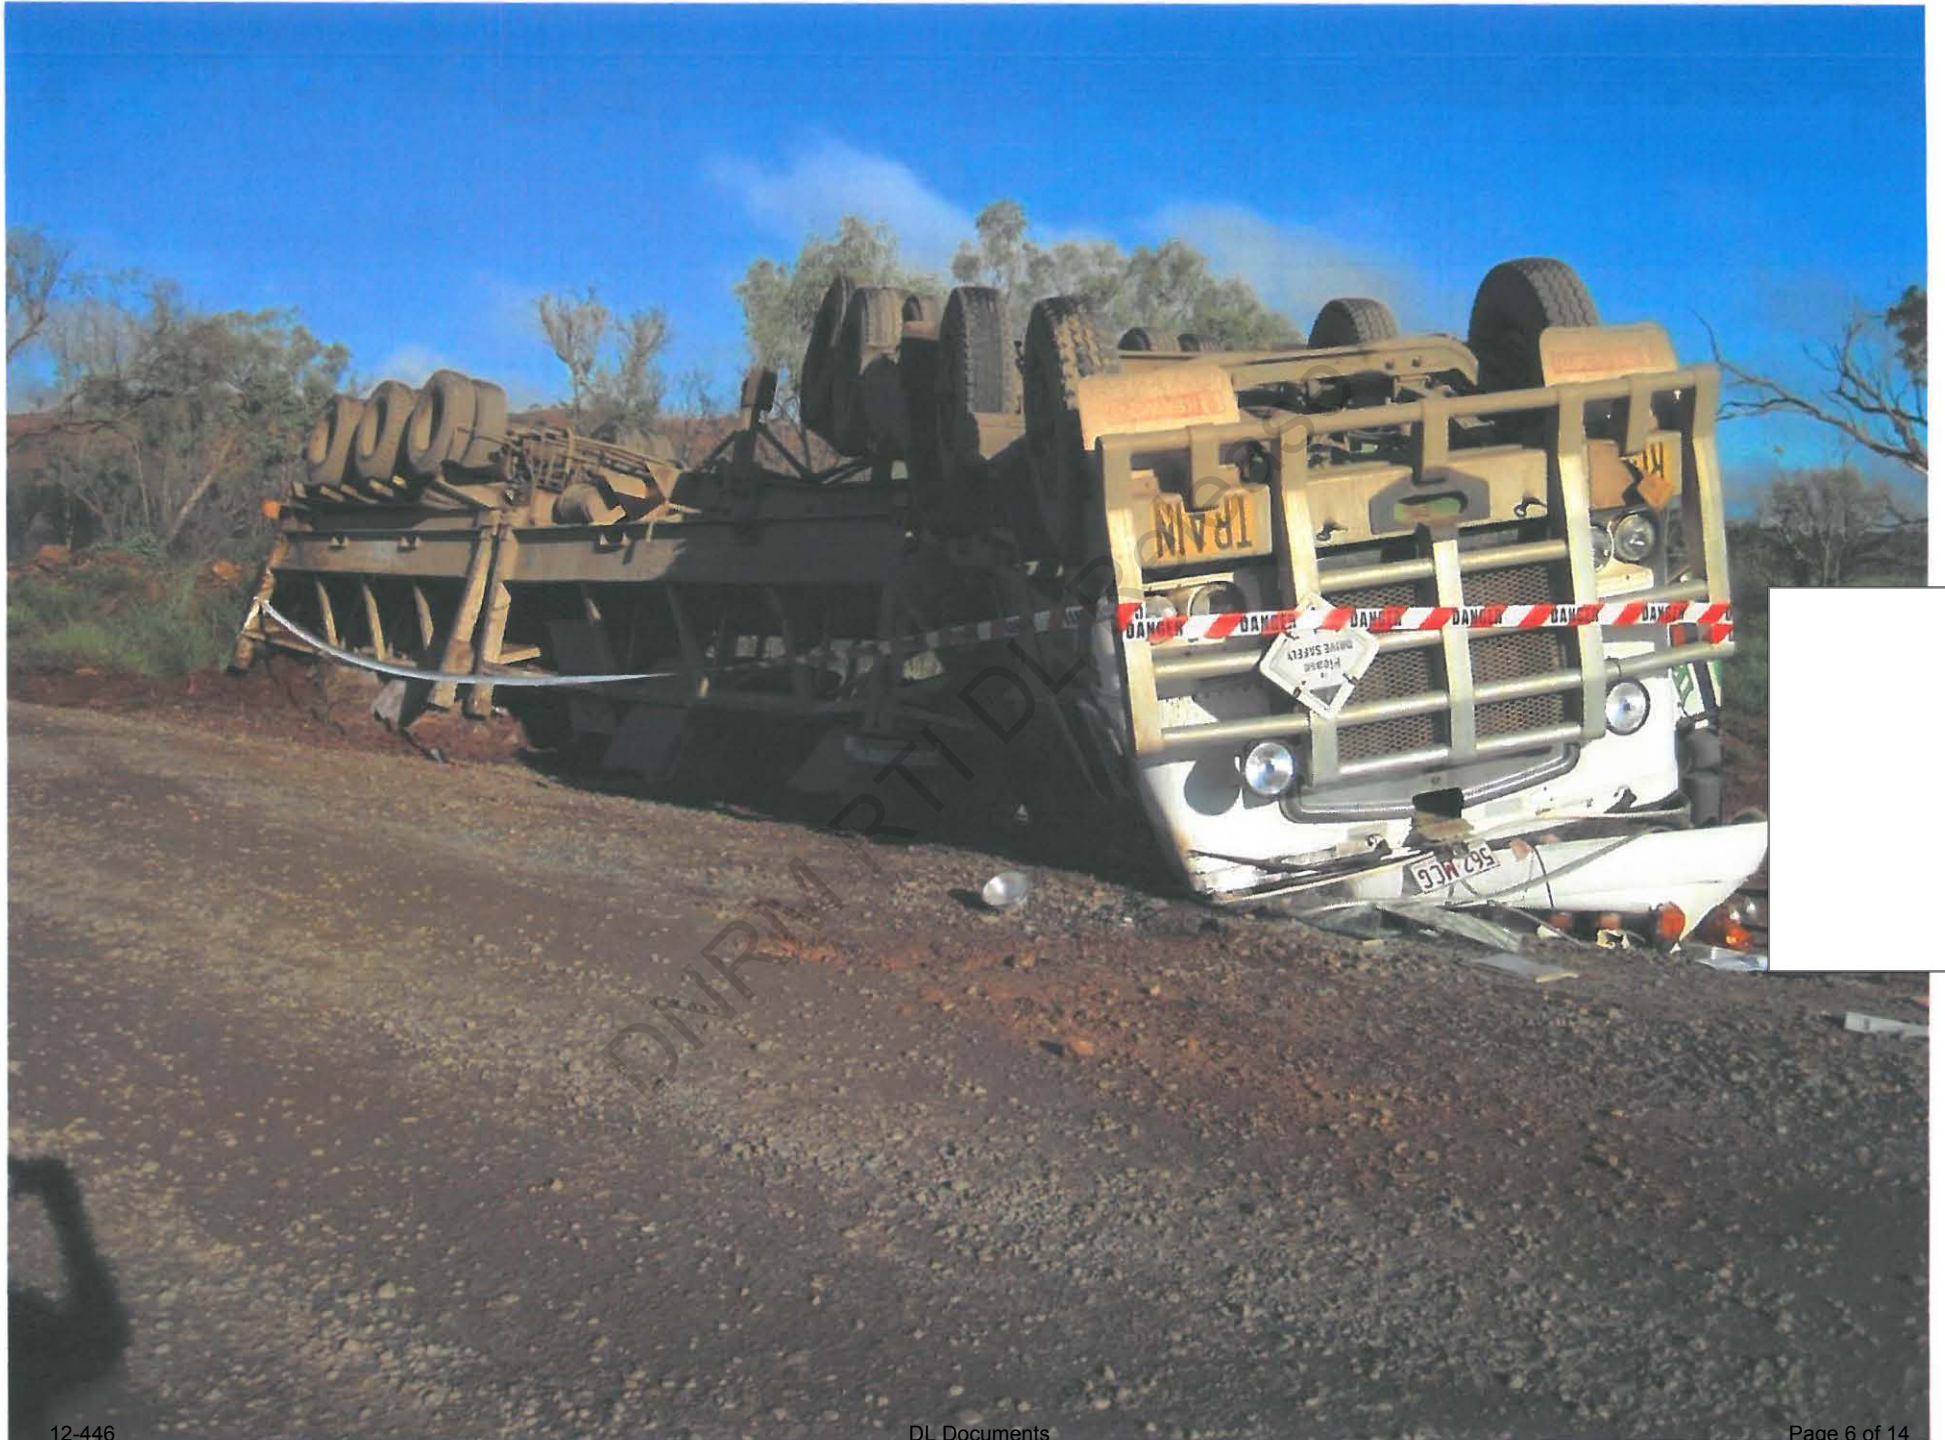
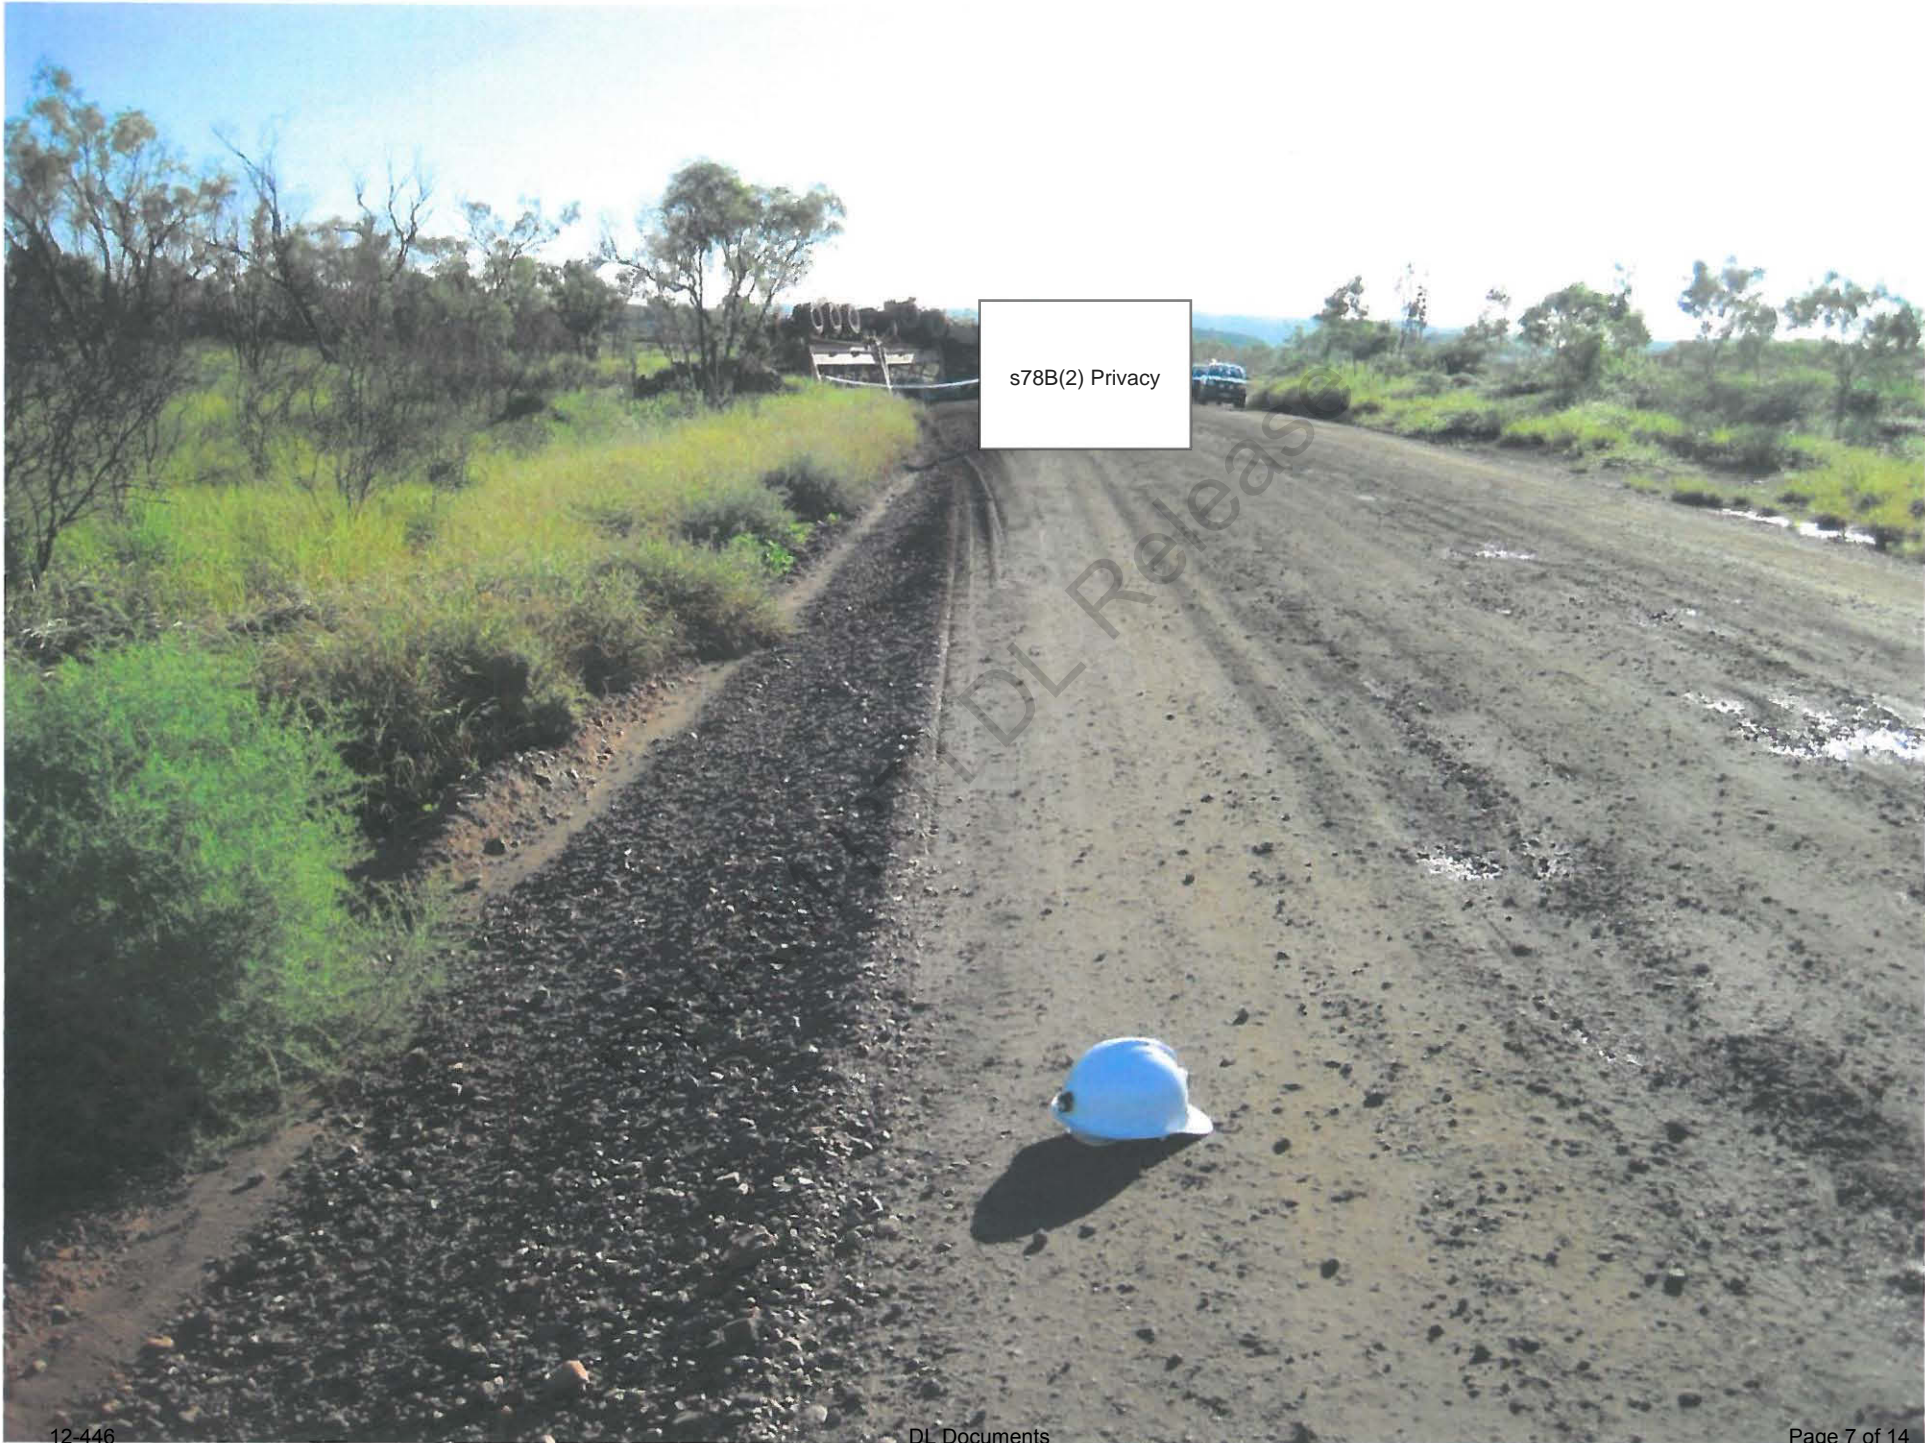
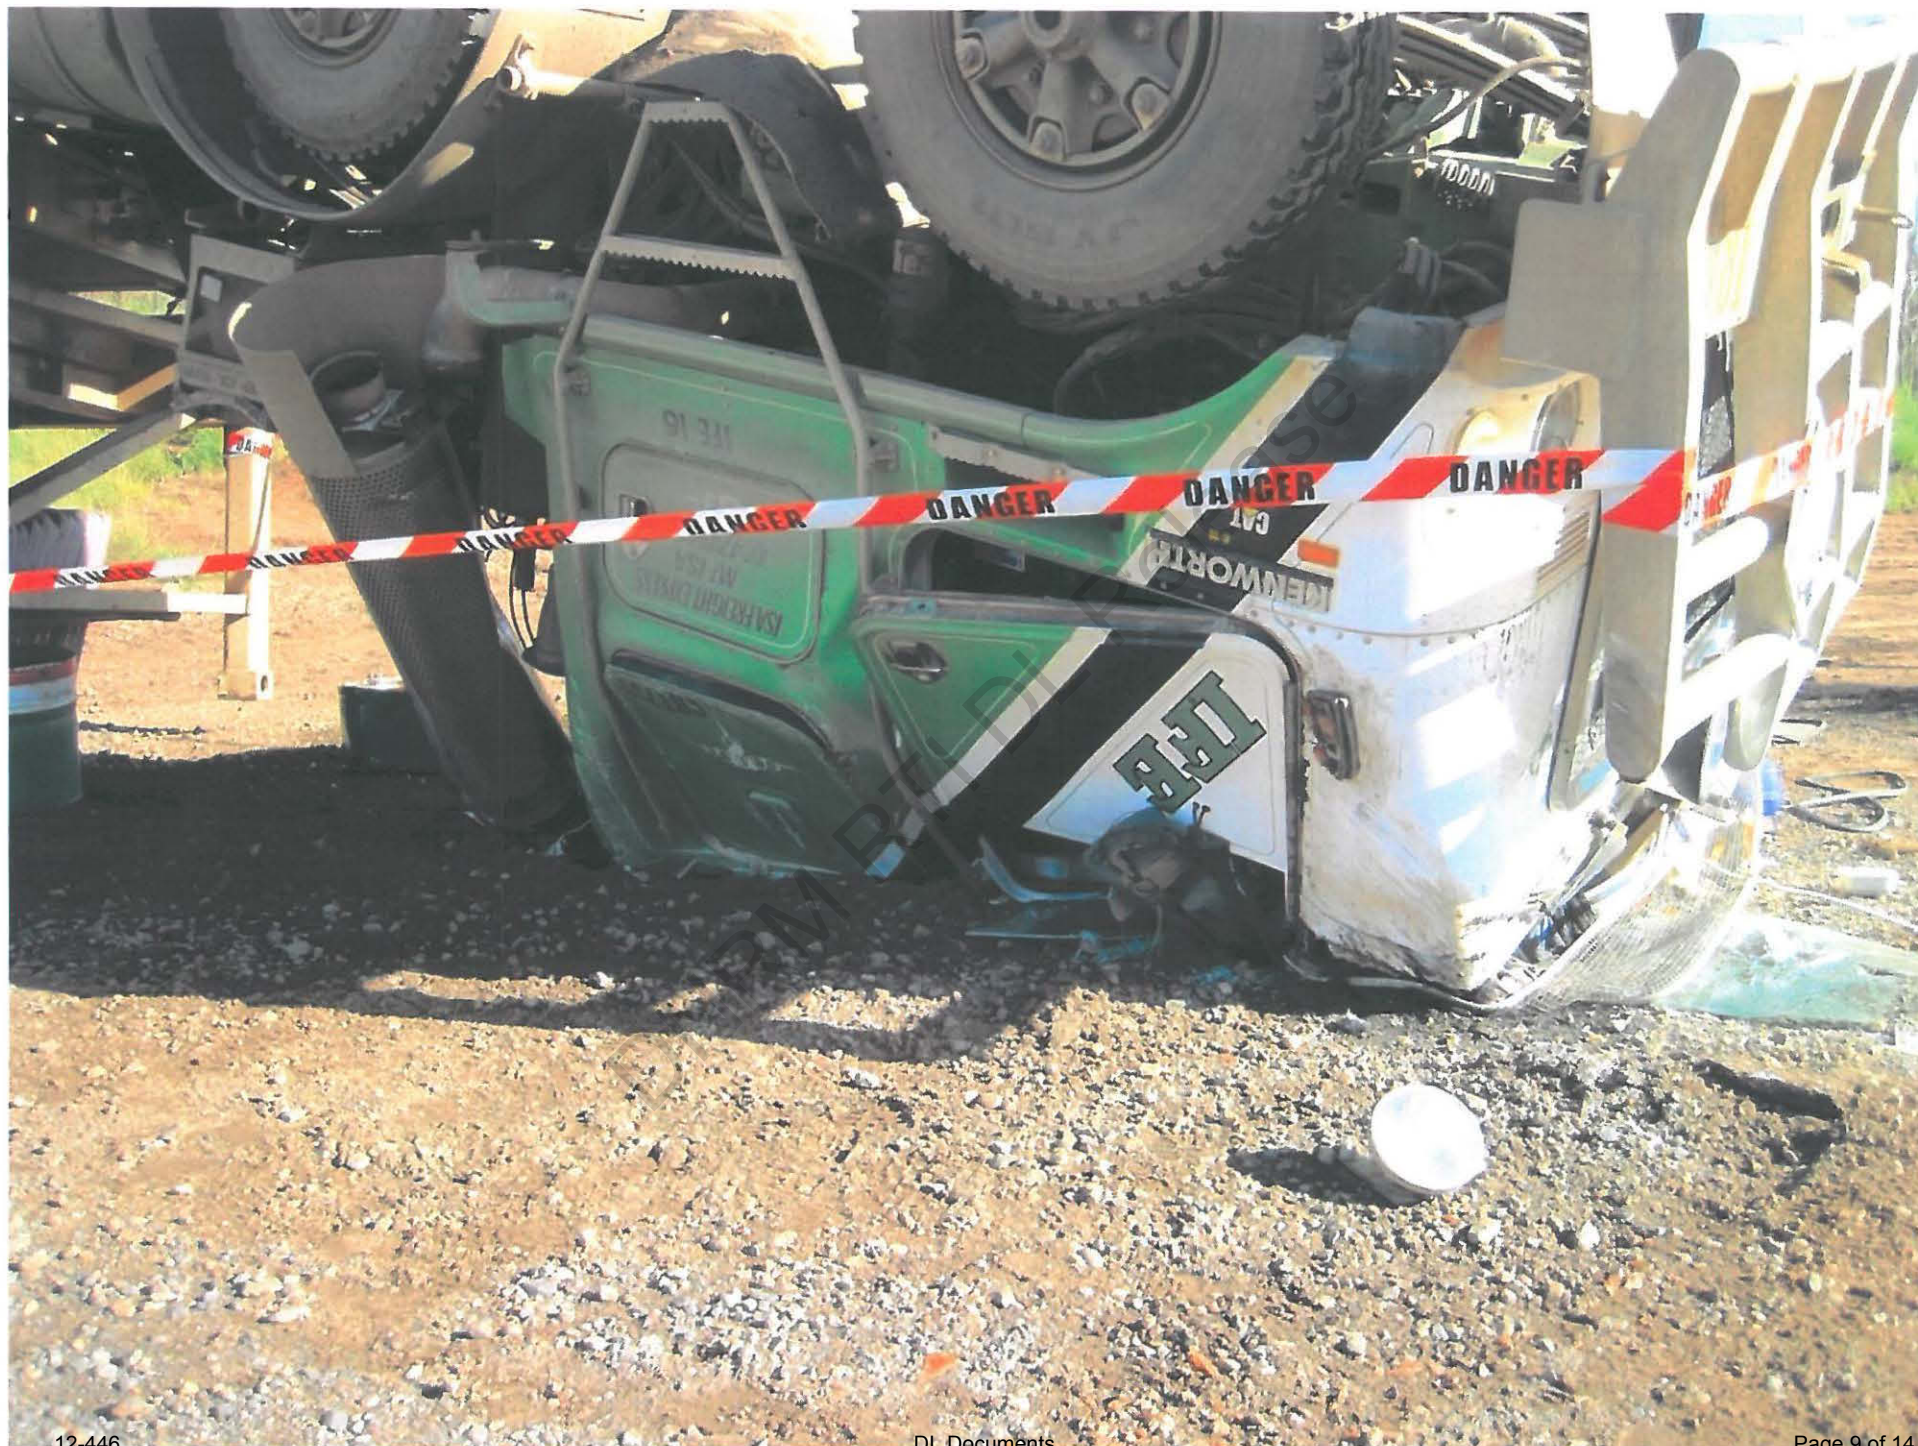
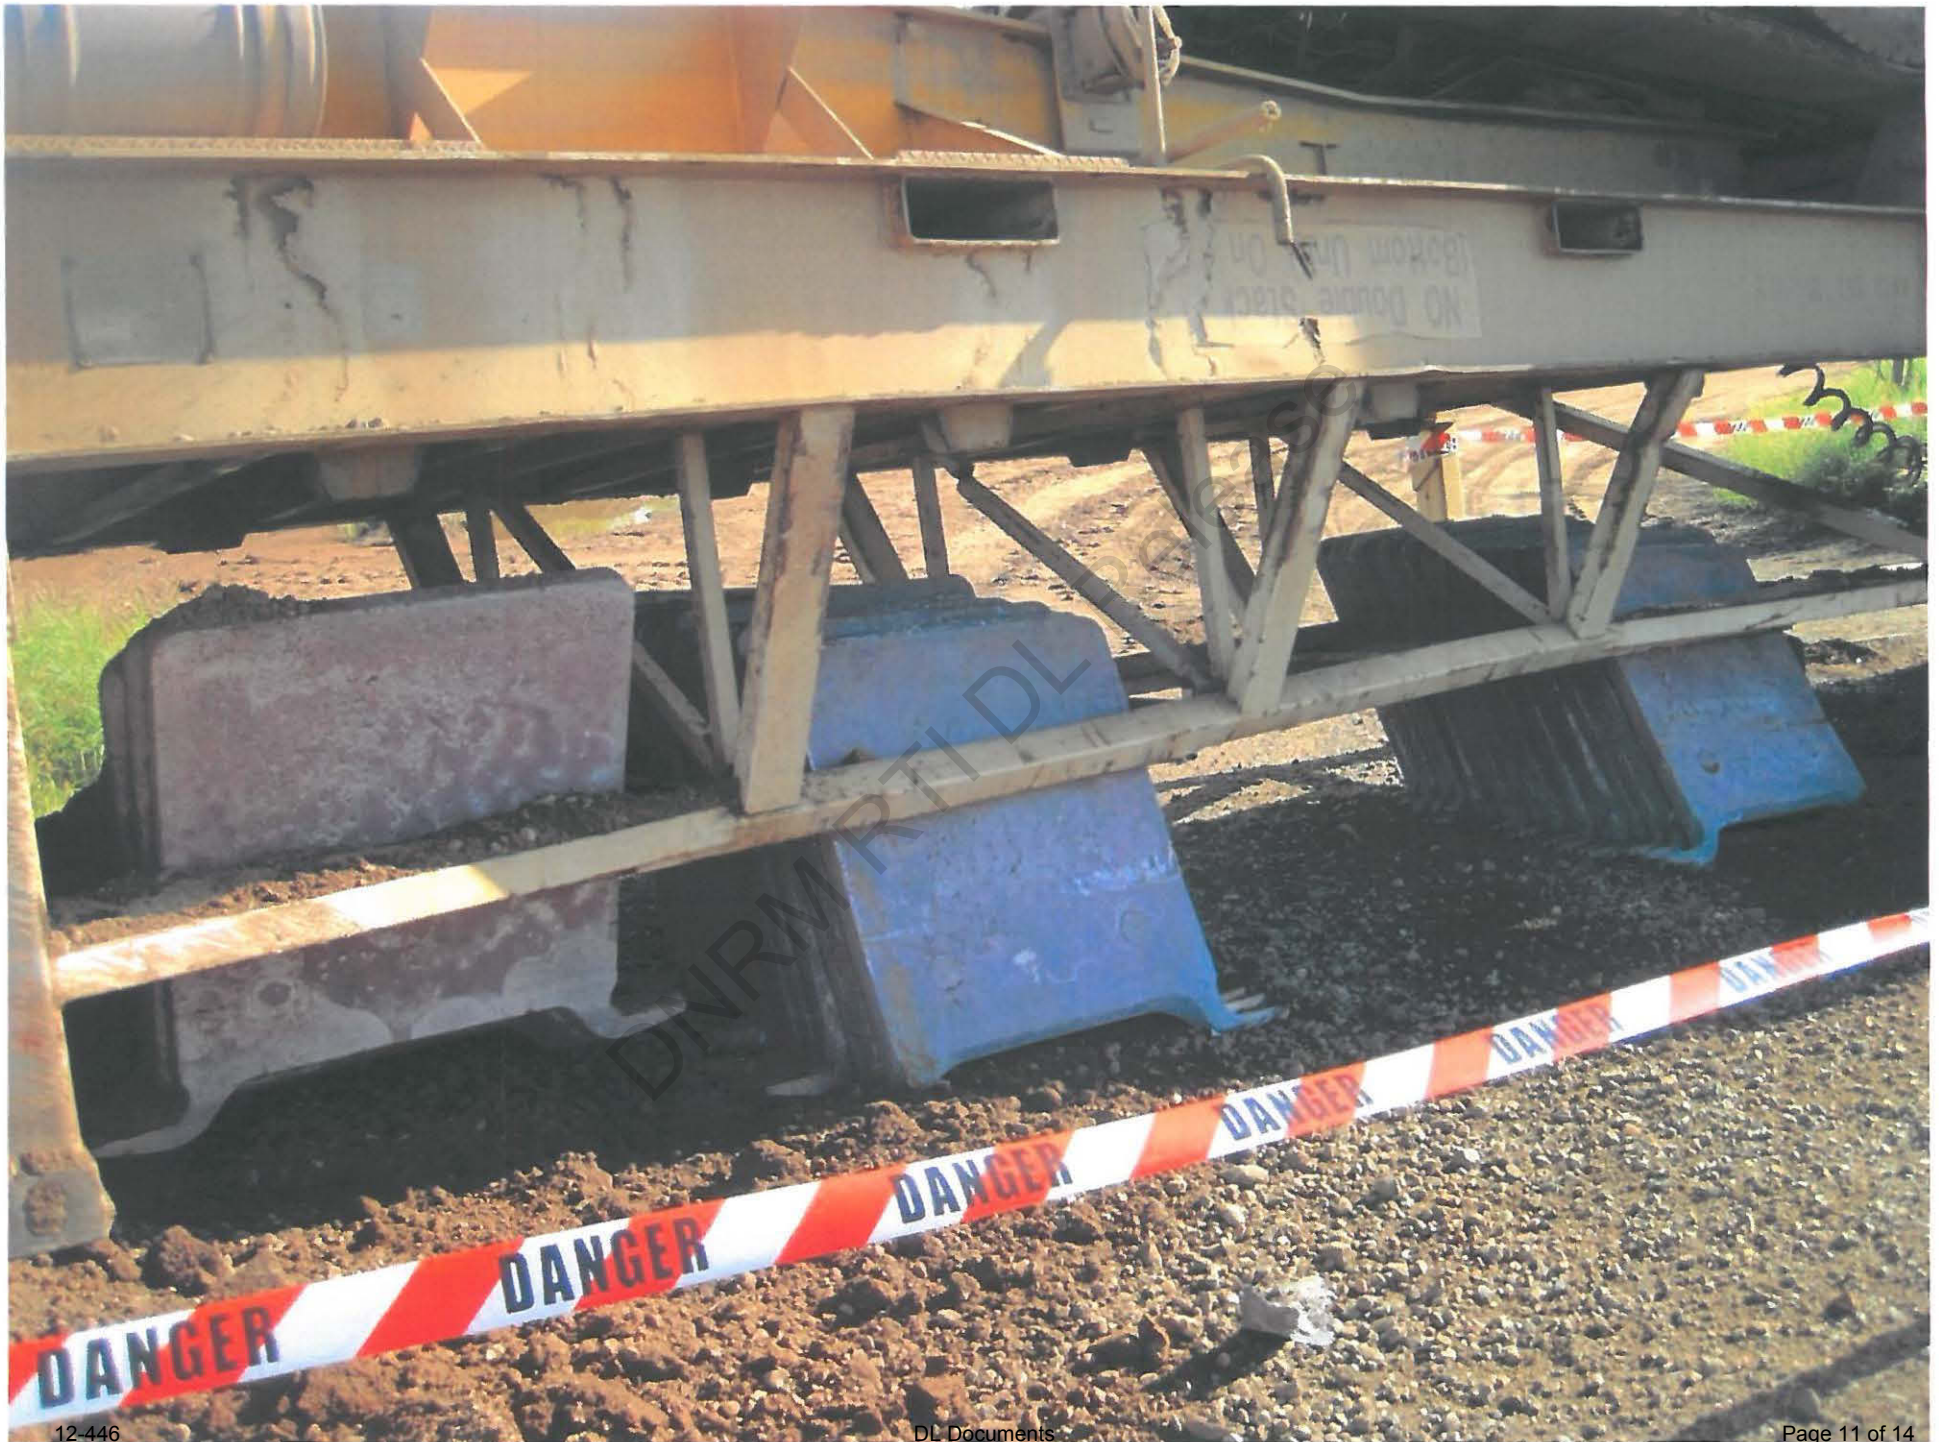
<input type="checkbox"/> Xstrata <input checked="" type="checkbox"/> Contractor Contracting Company (if applicable): CRT Group		
Description of Incident: A Contractor was transporting copper anode to the QR terminal via the on-site haul road. As he neared the QR terminal the vehicle tracked to the left hand side of the road and rolled over. The truck operator received treatment for		Travel (Journey) Yes <input type="checkbox"/> No <input checked="" type="checkbox"/>
Preliminary Findings/Causes of Incident: Truck deviating from roadway		
Actual Consequences (injuries/environment/property equipment/financial impact): <div style="border: 1px solid black; padding: 2px; display: inline-block;">Section 78B</div> damage to truck cab and trailer and minor release of diesel fuel		
Potential Consequences (injuries/environment/property equipment/financial impact): <div style="border: 1px solid black; padding: 2px; display: inline-block;">Section 78B</div>

12. DESCRIBE HOW EXACTLY DID THE INCIDENT OCCUR (INCLUDE THE NAME OF ANY PARTICULAR CHEMICAL, PRODUCT, PROCESS OR EQUIPMENT)
A CONTRACTOR WAS TRANSPORTING COPPER ANODE TO THE QR TERMINAL VIA THE ON-SITE HAUL ROAD AS HE NEARED THE QR TERMINAL THE VEHICLE TRACKED TO THE LEFT HAND SIDE OF THE ROAD AND ROLLED OVER.

INDIVIDUAL/TEAM ACTIONS: CODES: 1) [2][0][2] 2) [] [] [] 3) [] [] []
THE OPERATORS DRIVING LINE WAS CLOSE TO THE LEFT HAND EDGE FOR SOME DISTANCE BEFORE THE VEHICLE LEFT THE ROAD

INSTALL SIGNAGE AND ROAD REFLECTORS; AUDIT CONTRACTOR FOR ACCREDITATION COMPLIANCE (SMS); CONDUCT ENGINEERING REVIEW ON CENTRE OF GRAVITY AND LOAD SECURING
