Ref: GPN 4056 Notified 21/02/2011

Petroleum & Gas Investigation Report
Gas escape on Cameron # 1 Well at Wondoan

CSG Well Cameron 1 Pure Energy Resources Wandoan QLD 4419

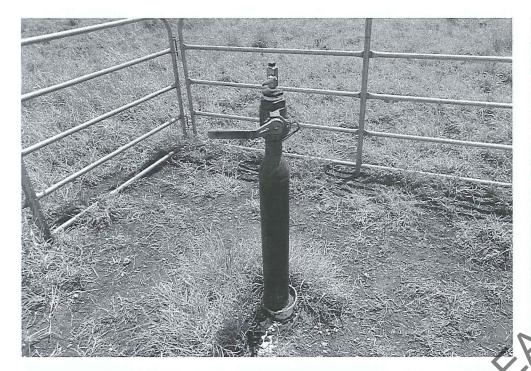
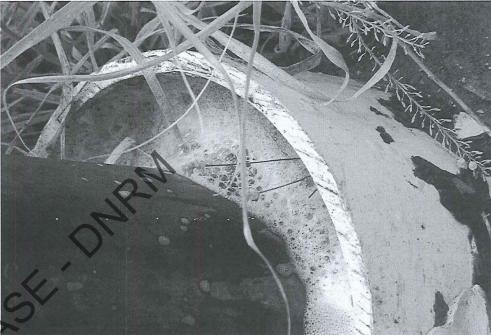
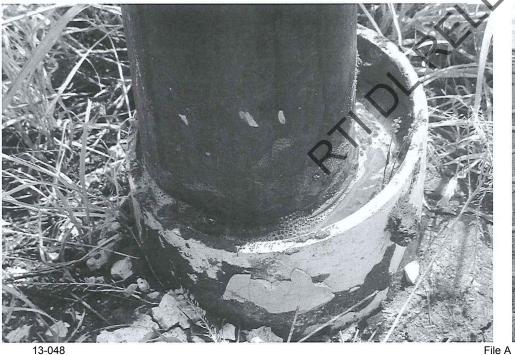
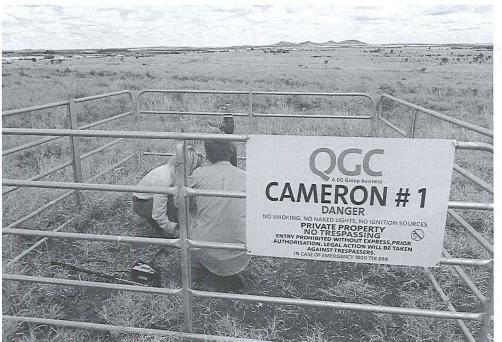
- A GMI Gassurveyer 500 series s/n 517685 calibration due date of 25/5/11 was the tool used to conduct the gas leak detection inspection. At the time of testing a slight breeze was present in the area.
- Test # 1 taken around the reducing bush at top of well. 0 gas reads registered. See GPO # 15485 for the gas reads prior to this visit. 25% LEL was identified then.
- Test # 2 taken around the inner well head casing. 23% LEL . These reads did fluctuate from 2% LEL to 25% LEL.
- Soapy water was also used as a gas leak detection tool. Bubbles were clearly identified in the area where Test # 2 was conducted. No bubbles were visible in the area of Test # 1. Photos enclosed, taken at the time of inspection clearly indicate the bubbles around the casing.
- P&G Inspectors witnessed what appeared to be a tiny 'pin hole' in the weld where the greatest gas reads and bubbles were identified.
