Mine Name	Mine ID	Operator	Activity Type	Activity Date
Peak Downs	MI01190	BM Alliance Coal Operations Pty Ltd	Postal Mine Record Entry	13/04/2021

The meeting purpose to discuss Structural failures of buildings during severe weather events.

Mine Name	Mine ID	Operator	Activity Type	Activity Date
Peak Downs	MI01190	BM Alliance Coal Operations Pty Ltd	Investigation	18/11/2020

Wednesday 18 November I Michael (Mick) Scully Inspector of Mines attended Peak Downs Mine for the purpose of inspecting damage to Igloos and other structures caused by a severe weather event on the afternoon of Friday 13 November. On arrival I participated in the site drug and alcohol screening programme and was escorted to a meeting room.

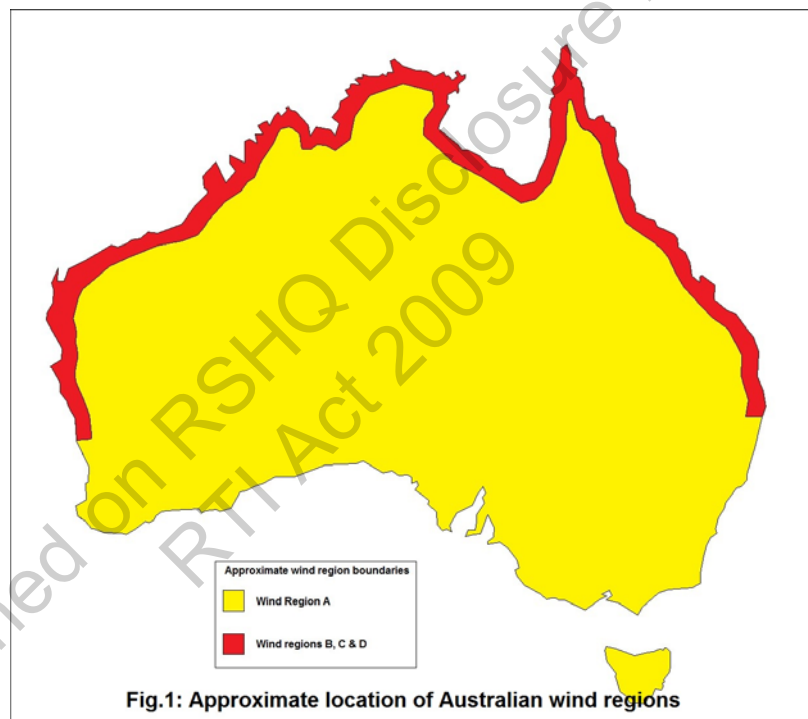
The map indicates that most of inland Australia lies within Region A, an area of lower expected wind velocities.

Incidents 1, 2, and 4 occurred within Region A where structural requirements were lower. According to the coroner's report, incident 3 occurred in Region C, but near the boundary with Region A (note that the version of AS/NZS 1170.2 current at that time did not include a Region B in this area).

The above shows that stronger than expected winds can and do occur within Region A. Structures designed for this region may fail under the actual wind conditions. High wind speeds in Region A originate from storm cells, cyclones, tornadoes or other weather systems. Climate change may play a role too.

- Assess the risks associated with winds that are higher than predicted for the region containing the mine.
- Tie-downs and anchors should be designed by a suitably qualified and competent person, who should consider all relevant conditions the structure may be subject to.
- Measures should be in place to ensure the actual installation conforms to the design.
