**Subject: INVESTIGATION INTO FIRE FROM FIREWORKS DISPLAY AT PENGARI STEINER SCHOOL**

INVESTIGATION REPORT  
TO  
CHIEF INSPECTOR OF EXPLOSIVES

ON THE  
**FIREWORKS DISPLAY FIRE ON 15 NOVEMBER AT NOOSA  
PENGARI STEINER SCHOOL, 86 NYELL ROAD DOONAN  
INVOLVING KC FIREWORKS DISPLAYS AUSTRALIA PTY  
LTD**

At  
86 Nyell Road, Doonan QLD  
on  
15 November 2012

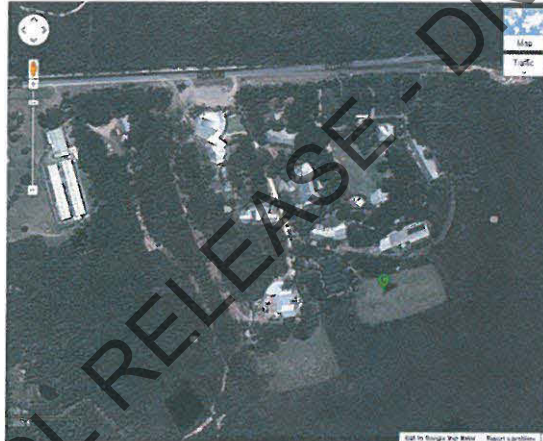
Investigation site plan

2.2 **Property Damage.** The damage to property included local vegetation, two fixed in situ caravans, two water tanks, and a tin shed all located at 129 Grays Rd. Please refer to attached QFRS Incident Report for further information. **Annex 1**

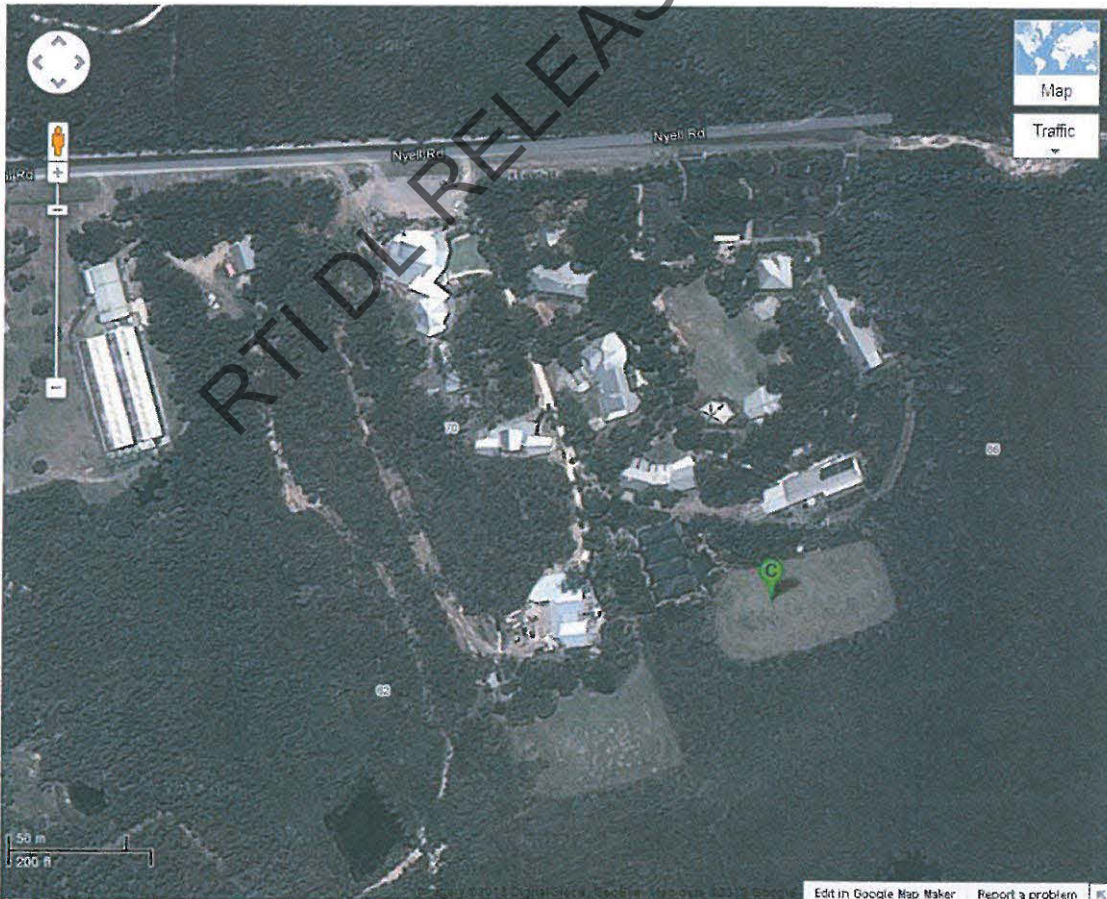
Google Image 1 Noosa Pengari Steiner School (Field – C)

4.3.1 Initial observations of the scene noted that the firing point was a school playing field. There was some debris remaining from the display in the form of coloured streamers still on the field, however very little of the actual firework product remained. The firing points of several products were visible owing to localised debris on the grass; however investigations could not identify an exact firing point.

4.3.2 To the south of the playing field it was noted that the vegetation was brown in the foreground and burnt in the background.
