**PARADISE DAM**  
**FLOOD EVENT OF JANUARY TO MARCH 2013**  
**REVIEW OF DAM SAFETY MANAGEMENT**  
**ACTIONS**

**DRAFT REPORT FOR THE OFFICE OF WATER  
REGULATION**

**REPORT NO. DC 13127**

2<sup>ND</sup> AUGUST 2013

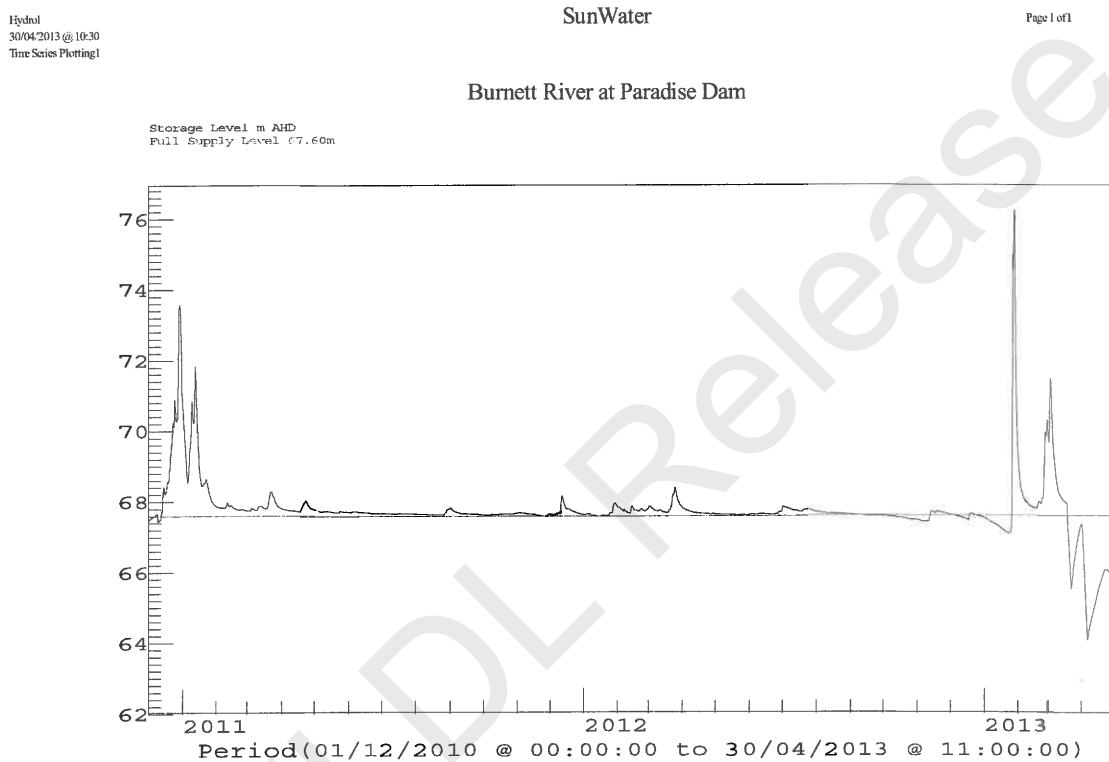
**Figure 1 – Hydrograph of Paradise Dam Headwater Level**

It will be seen from **Figure 1** that the difference between headwater level and crest level reached about 6.0m on 29 December 2010 at 0400h. The actual peak was recorded as 5.96m. There was a later peak of around 4.2m on 12 January 2011 at 2000h.

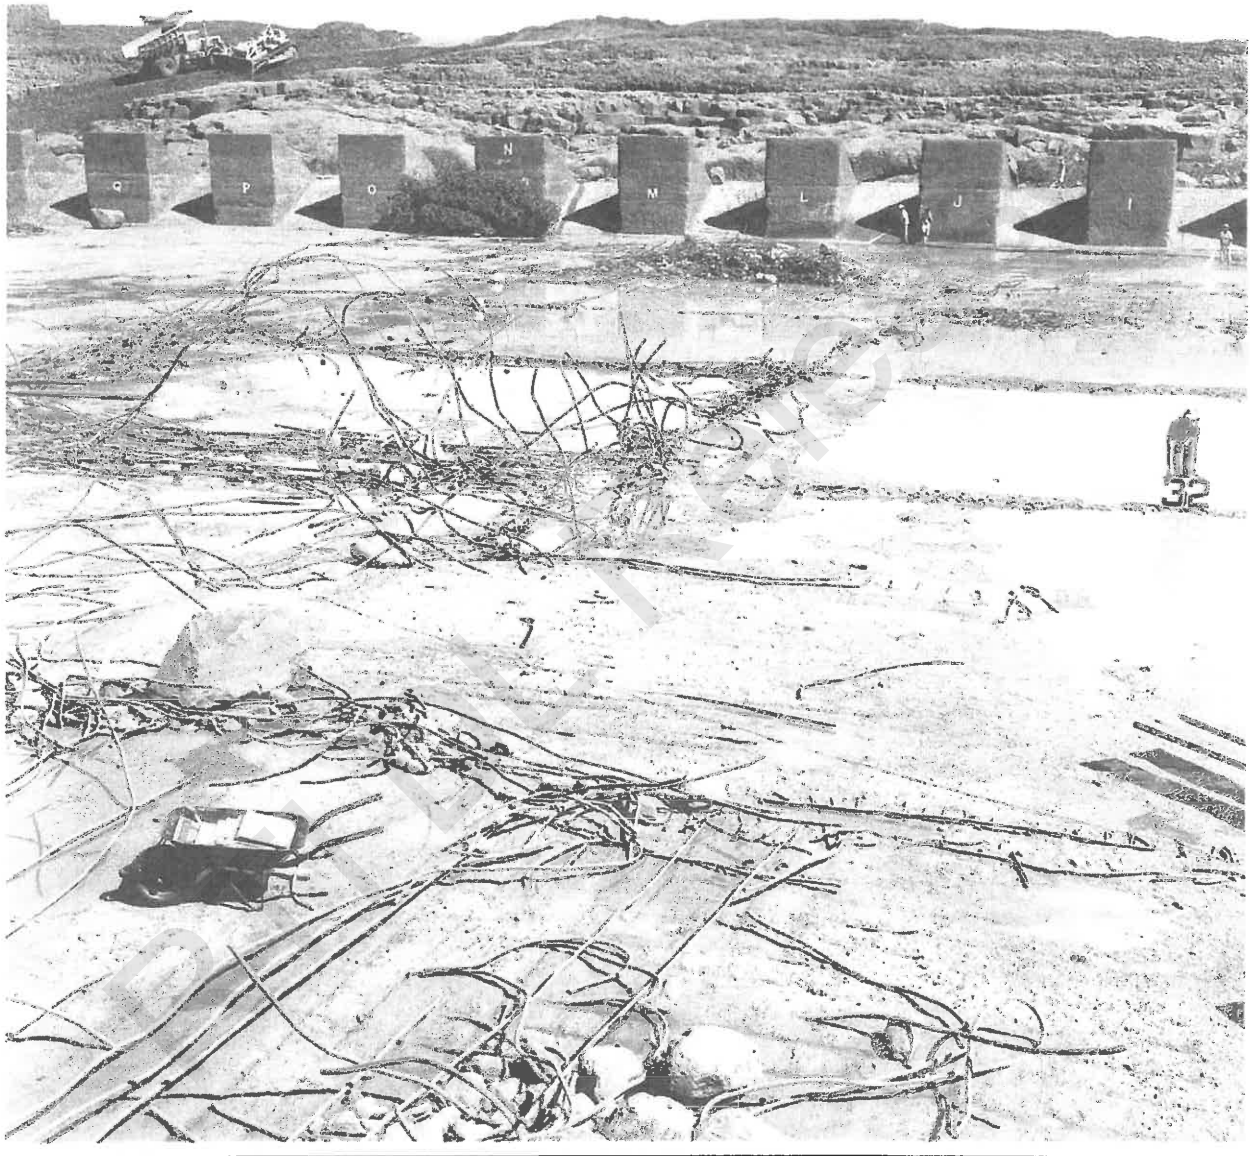
**Figure 4 – Abrasion Damage to Marimbondo Dam Dissipator**

Abrasion by rock and gravel has the potential to destroy a dissipator slab. CBDB (2002) describes the case of Marimbondo Dam in Brazil. In that case release of up to  $6,356\text{m}^3/\text{s}$  through the left hand spillway gates caused a recirculation flow which drew rock and gravel into the hydraulic jump dissipator. The dissipator apron was extensively abraded, in some places through to the foundation rock. Over significant areas up to 500mm of conventional concrete had been removed. **Figure 4** is an overview in which reinforcing steel can be seen rolled up by the flood in front of block N.

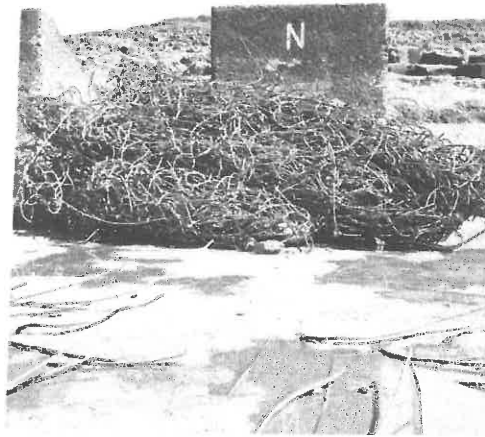
**Figure 5 – Steel Torn out of the Dissipator Slab at Marimbondo Dam**

**Figure 5** below is a closer view of the steel rolled up by the flood.

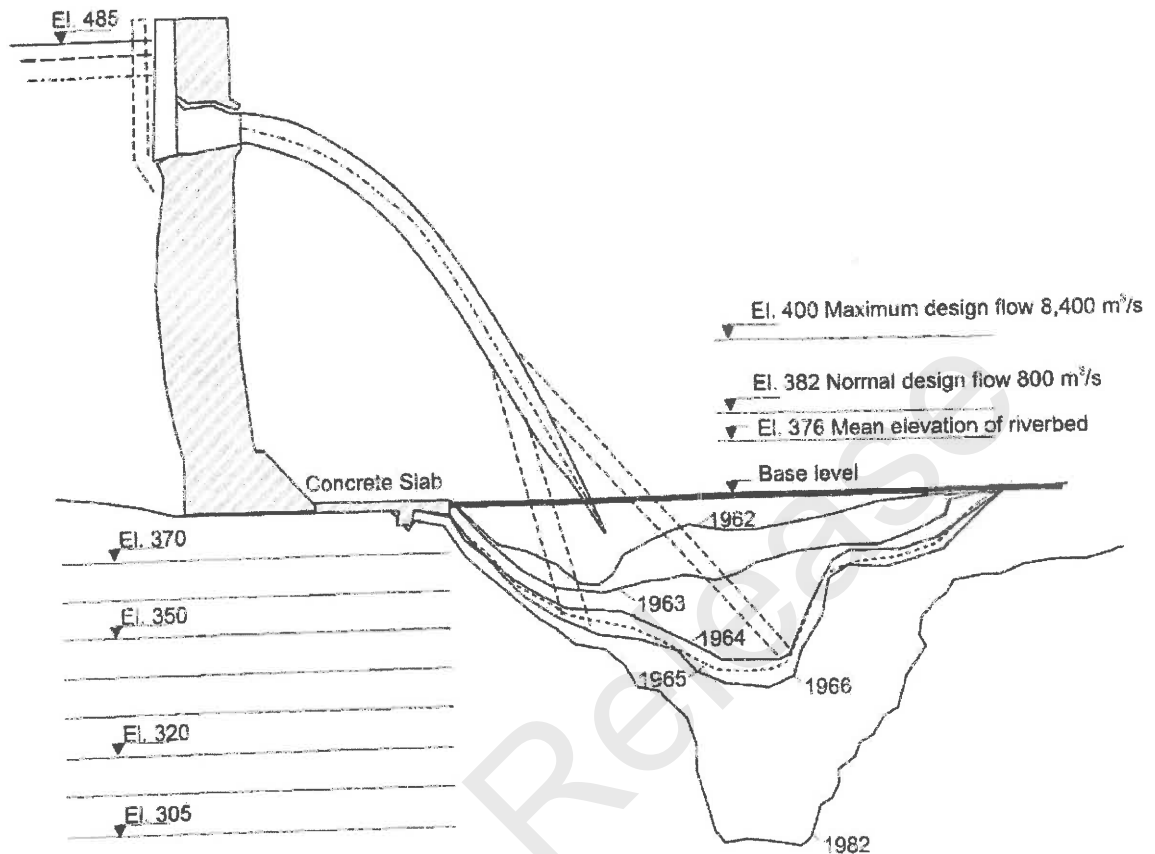
Figure 7 – Progression of Scour at Kariba Dam

2. The rock in the energy dissipation zone is susceptible to deep scour – inspection after the flood revealed major rock scour. There are some points to be made about rock scour in the energy dissipation zones of dams. Firstly, experience shows that major rock scour in a large flood is not necessarily the end of the scour process. The classic demonstration of this reality is the case of Kariba Dam on the Zimbabwe/Zambia border (Bollaert 2005). In that case scour continued from successive floods over decades, eventually leading to a scour hole over 80m deep. **Figure 7** from CBDB (2002) shows the progression. Conditions at Paradise Dam are quite different but the possibility of further scour cannot be ruled out on the evidence available at this stage. Secondly, experience of scour at large dams is highly variable for reasons which are not immediately obvious. Because of large flows in its rivers, Brazil offers instructive lessons on rock scour at dams (CBDB 2002). Foz do Areia and Salto Santiago dams on the Iguacu River and Machadinho and Ita Dams on the Uruguay River are all within the one geologic province of more or less horizontal basalt flows. All four dams have experienced large floods with comparable peak discharges in the order of 10,000m<sup>3</sup>/s to 19,000m<sup>3</sup>/s and comparable energy dissipation heads in the range of 90m to 130m. Yet Ita and Machadinho Dams experienced major rock scour with up to 200,000m<sup>3</sup> of fresh rock being removed whilst the experience at Salto Santiago and Foz do Areia Dams was negligible rock scour. When these dams are examined in more detail it becomes clear that engineering judgment is a poor guide to the likelihood of rock scour and that account needs to be taken of detail metrics of unit power, stress relief factors, rock joint spacing, orientation and cementation among other factors. This reality points to the need to apply rock scour estimation methodologies such as those developed by Annandale and separately by Bollaert as an aid to judgment.

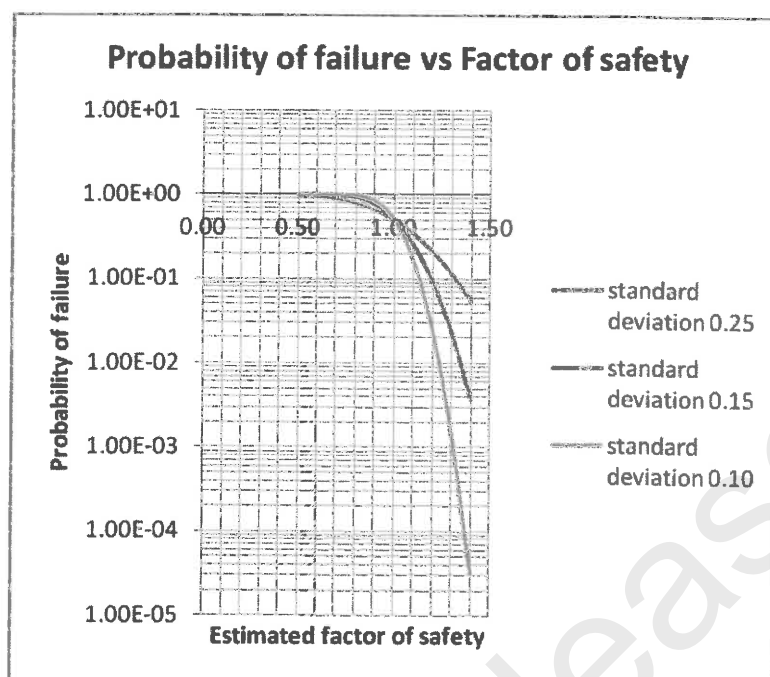
**Figure 9 – Probability of Failure versus a Safety Factor**

(SunWater June 2013). Perhaps the analysts regarded sliding as certain for such scour. That branch should be included in risk assessments for two reasons. Firstly, it keeps before the reader the full failure mechanism. Secondly, it is unlikely that the probability of sliding would be 1.0 (certain) for all load scenarios. Providing the estimates of demand (load) and capacity (resistance) are “best estimate” the probability of sliding can be informed by some equations from *reliability analysis*, especially for low values of the sliding stability factor. These equations estimate the probability that the real sliding stability factor is less than 1.0 (the definition of failure), given the estimated value of the sliding stability factor. If the uncertainty in the sliding stability factor is Normally distributed, an estimated sliding stability factor of 1.0 equates to a probability of failure of 0.5 neglecting model error, which is generally unknown. It is usually accepted that a Normal distribution is a reasonably good assumption. The uncertainty of the sliding stability factor has little influence at values of the factor close to 1.0 but has a large influence for large values of the factor. **Figure 9** is based on two formulae from *reliability analysis*.

Analysts should not rely on **Figure 9** but should consult authoritative texts on *reliability analysis* and make their own assessments. A brief treatment of the concept can be found at pages 339 to 342 of Hartford and Baecher (2004).

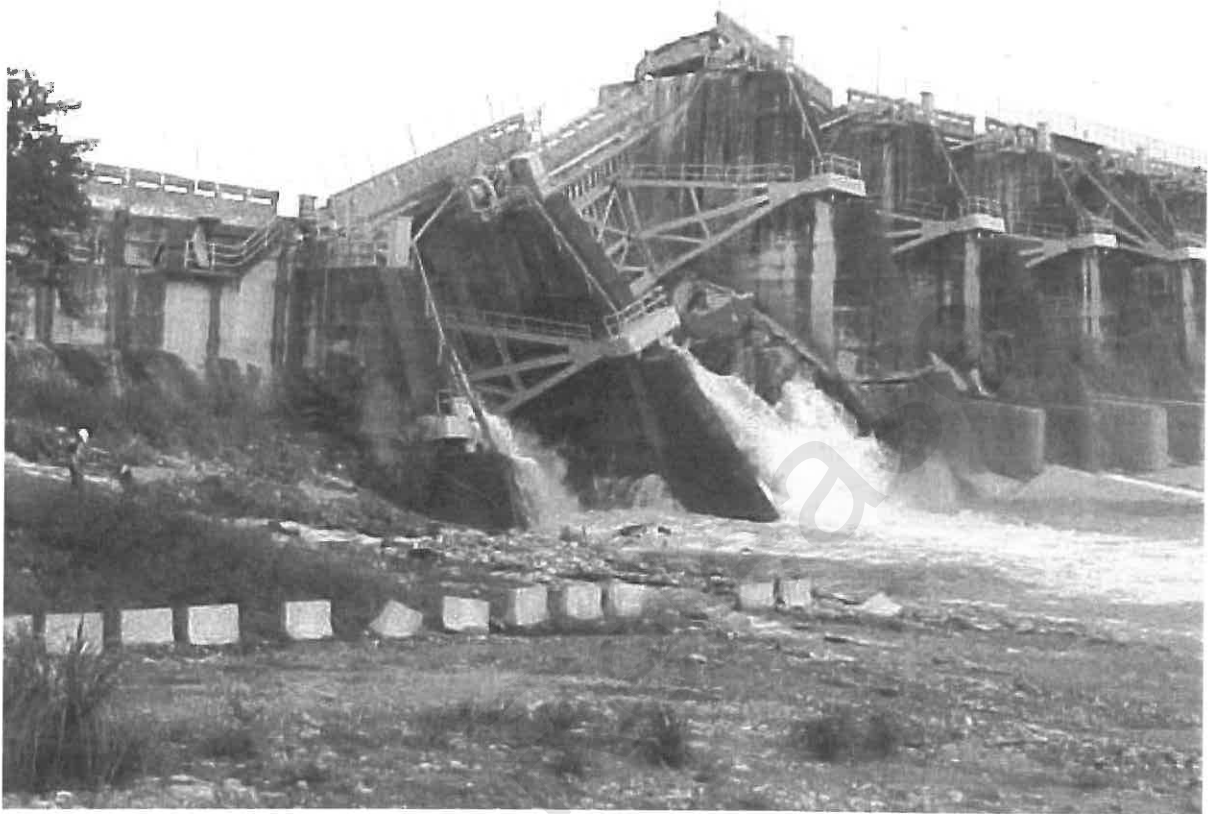
**Figure 11 – Earthquake Damage to Shih-Kung Dam Taiwan**

Activation of the EAP was a precautionary approach because it is highly unlikely that a gravity dam with the reservoir at or below FSL would fail after it has just survived the loading of a major flood. However, the time required for remedial works is such that the probability of strong earthquake shaking cannot be ruled out. No gravity dam has ever yet failed from earthquake shaking. An instructive case is that of Shih-Kung Dam in Taiwan, shown at **Figure 11**.

In the Shih-Kung Dam case a fault displacement of some 8m or more in the foundation of the dam destroyed two gravity blocks. But the significant point is that the adjacent blocks, though subjected to very strong shaking, did not fail and suffered little damage.
