EH3500AC2
Rear Strut.

Frame Suspension

Mine Name	File No.	Operator	Activity Type	Region	Activity Date
Middlemount Mine	1762	Middlemount Mine Management Pty Ltd ABN: 62 140 398 143	Inspection - Weekend or Backshift	Central	20/06/2013

Mine Record Entry

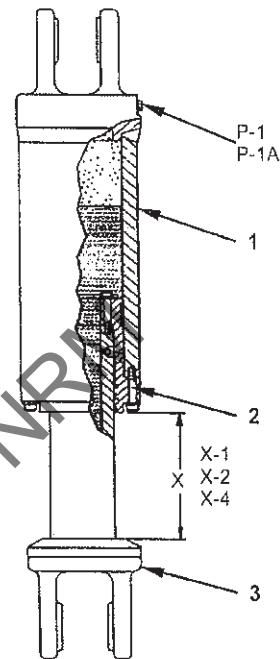
Suspension Cylinder Rod Dimension

Mpa 0.77 should be 0.97 MPa
pg W2-11-34

- Step 6 has incorrect spec pressure
not 5.88 Mpa but 1.66 MPa.
pg W2-11-38

incorrect conversion
which is correct?
