Mine/Quarry Name	File #	Operator	Activity Type	Region	Activity Date
Broadmeadow Sustaining Operations	1	Bechtel/BMA	Investigation	Central	27/03/2012

Mine Record Entry

Today the 13th March 2012 Principal Investigator Andrew Smith and Inspector of Mines Keith Brennan commenced an investigation at Broadmeadow Sustaining Operations into a High Potential Incident that occurred on Tuesday 12th March 2012 at 2:55pm

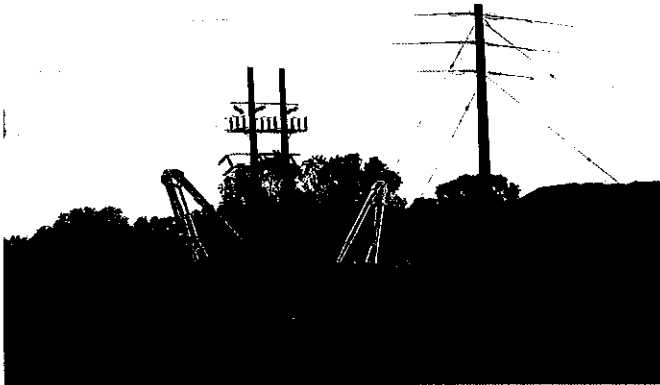
We travelled from Broadmeadow Sustaining Operations administration South along the Red Hill Road to the location of the incident, the incident location was approximately 200 meters West of Red Hill Road, the area had been quarantined. We observed the jibs of two Mobile Elevated Work Platforms (MEWP) adjacent to three concrete power poles; one pole was carrying live 66kv power lines, the two remaining concrete poles had metal support poles, workers at the time of the incident were in the process of installing cross member brackets to support a 415v transformer to the concrete poles.

The area had been quarantined pending our investigation. We accessed the site and commenced observations and a photographic record of the equipment's location. We attempted to gain an understanding of the sequence of events that lead to the incident from the equipment location.
